## Operational Inspection

North Hill Parish Council

North Hill Village Hall

Lynher Close, North Hill, Launceston, Cornwall, PL15  
9PQ

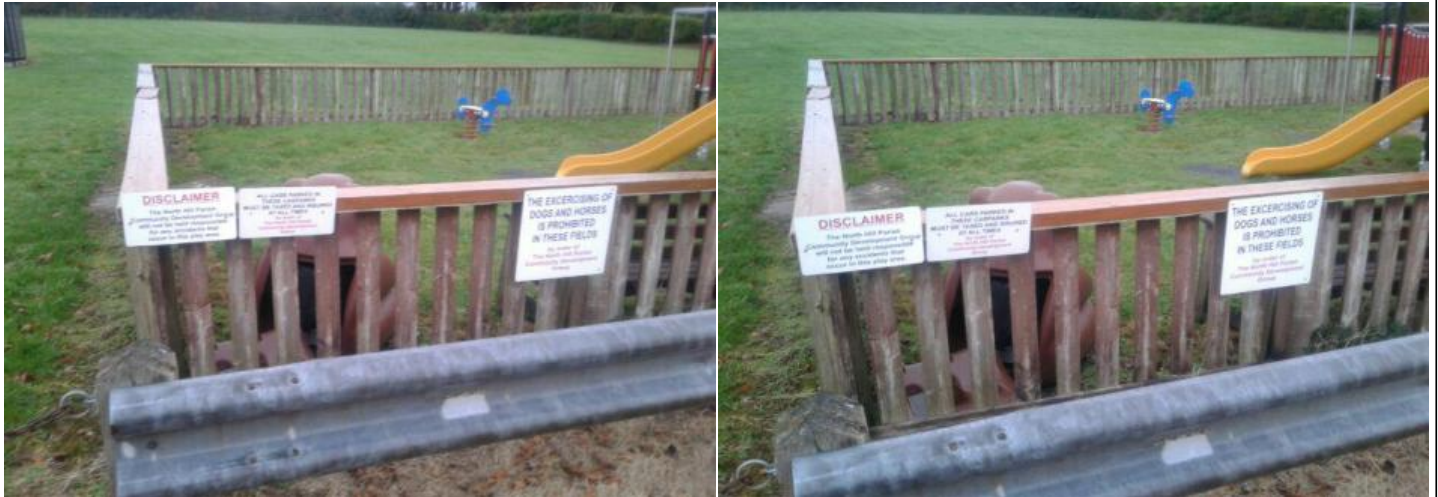
**Item:** Ancillary Items - Sign  
**Manufacturer:** Owner/Operator

**Finding:** BS EN 1176 Part 7 recommends that signage shall include emergency contact details and contact details of owner / operator for reporting maintenance issues  
**Action:** Provide additional information

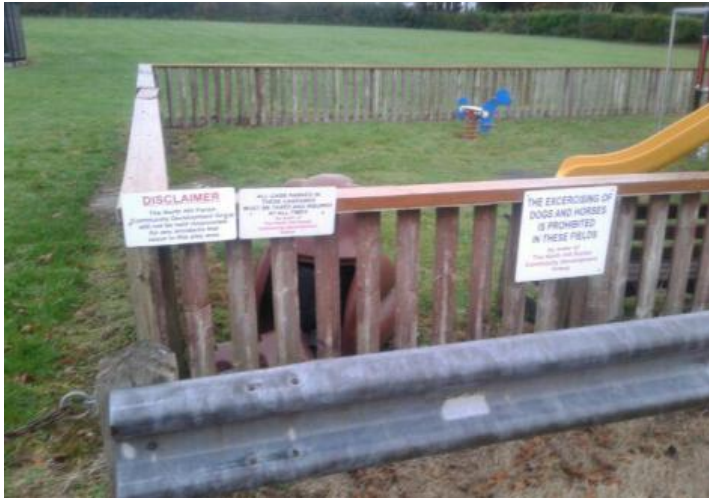
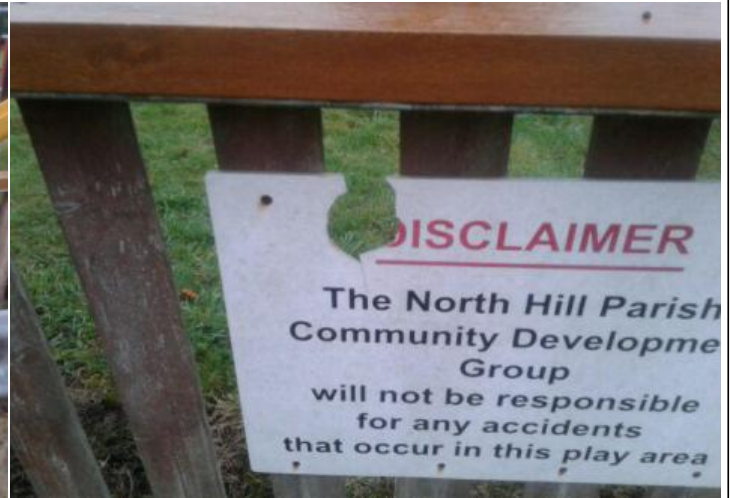
**Item:** Ancillary Items - Sign  
**Manufacturer:** Owner/Operator

**Finding:** There is some damage to the sign

**Action:** Replace

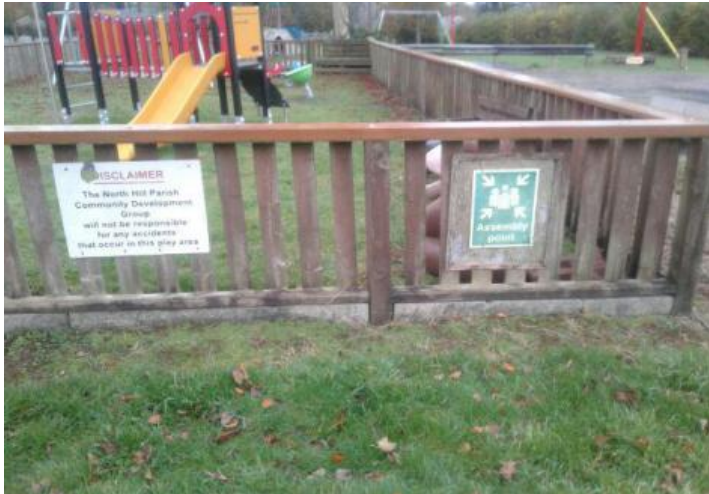
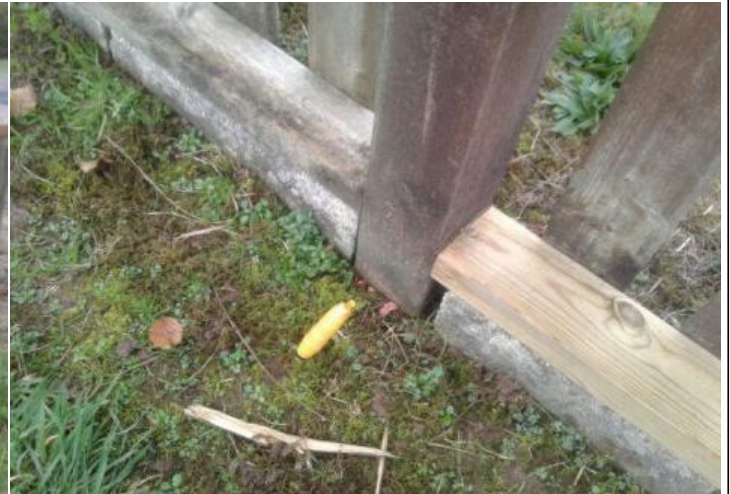
**Item:** Fences - Fencing - Timber  
**Manufacturer:** Not Identified

**Finding:** There is some evidence of rot in the timber

**Action:** Monitor for any further deterioration and replace as required

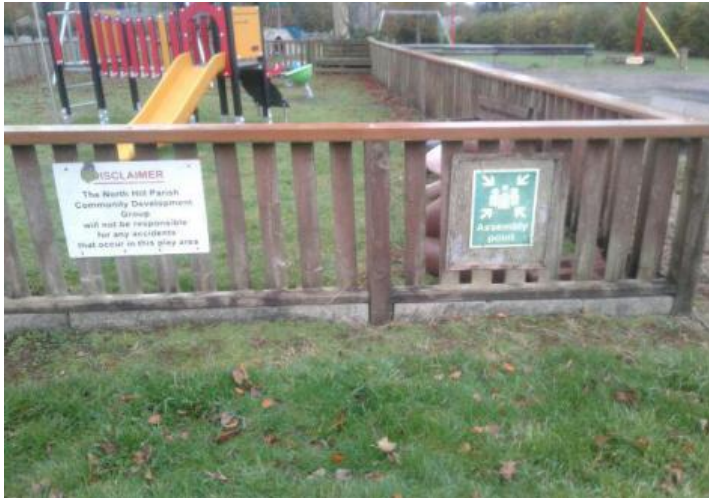
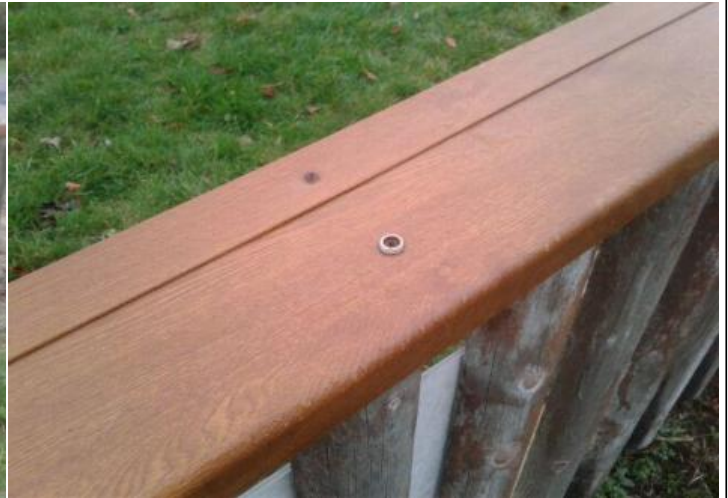
**Item:** Fences - Fencing - Timber  
**Manufacturer:** Not Identified

**Finding:** There is/are screw cap covers missing or damaged **Action:** Monitor and replace if required on the item

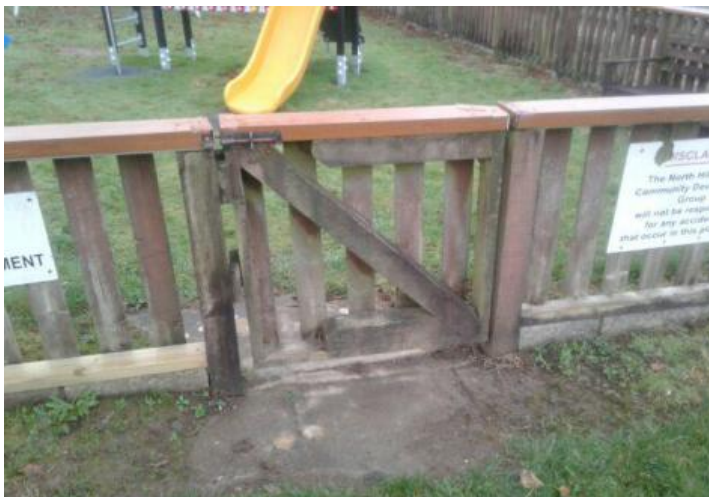
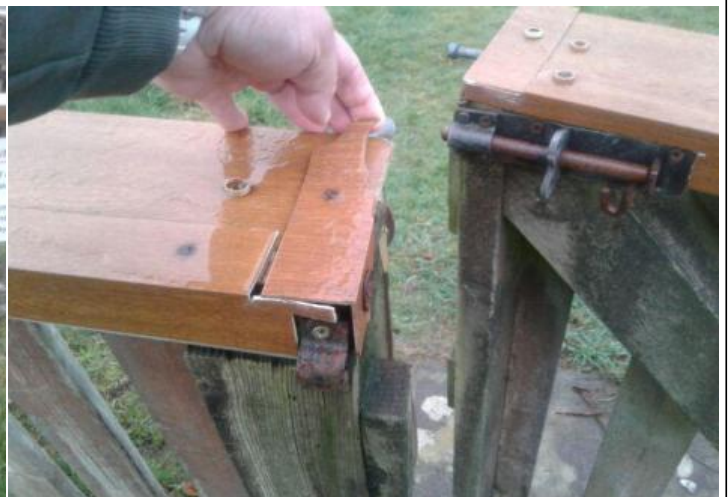
**Item:** Gates - Gate - Self Closing  
**Manufacturer:** Not Identified

**Finding:** There is sharp sections of plastic on the fence next to the gate **Action:** Repair or replace

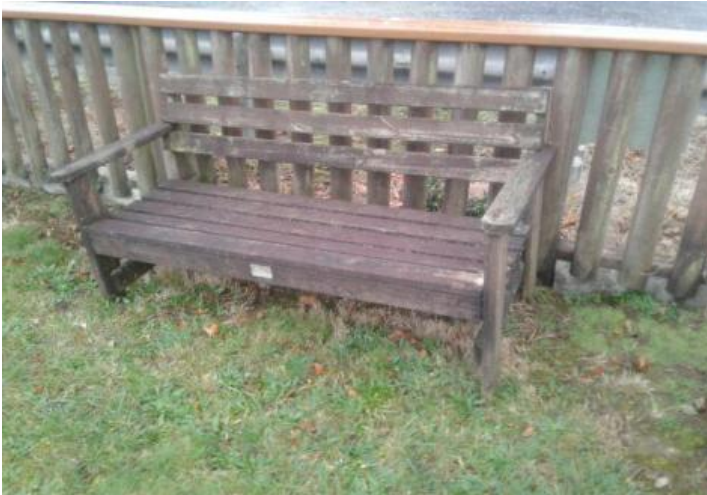
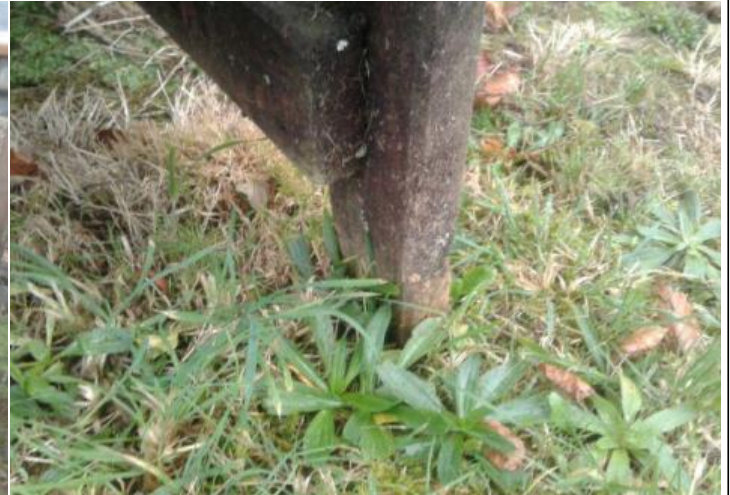
**Item:** Ancillary Items - Bench  
**Manufacturer:** Not Identified

**Finding:** There is some strimmer / machinery damage apparent on the posts, this can penetrate the preservative applied to the timber and accelerate the rotting process

**Action:** Monitor for any deterioration (rot) and replace as required

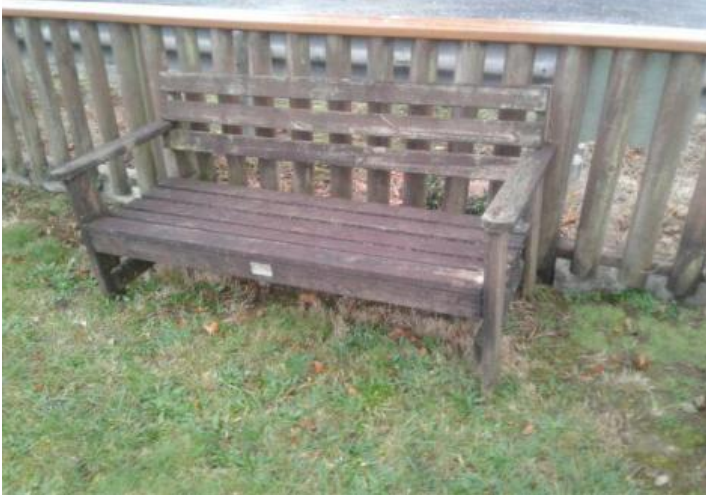
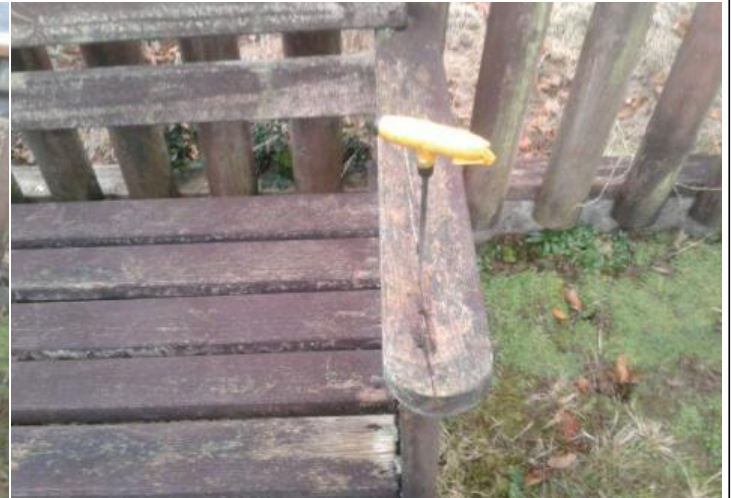
**Item:** Ancillary Items - Bench  
**Manufacturer:** Not Identified

**Finding:** There is some evidence of rot in the timber

**Action:** Monitor for any further deterioration and replace as required

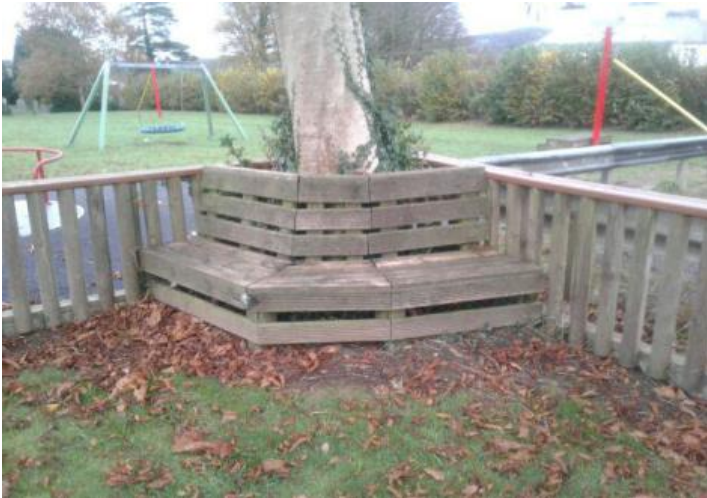
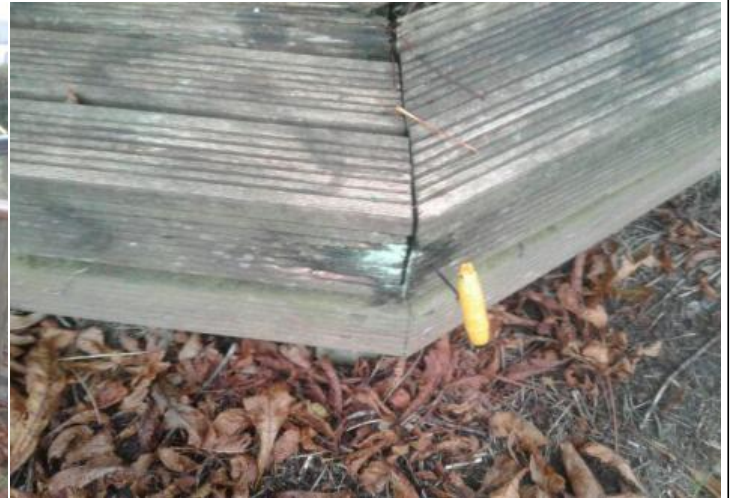
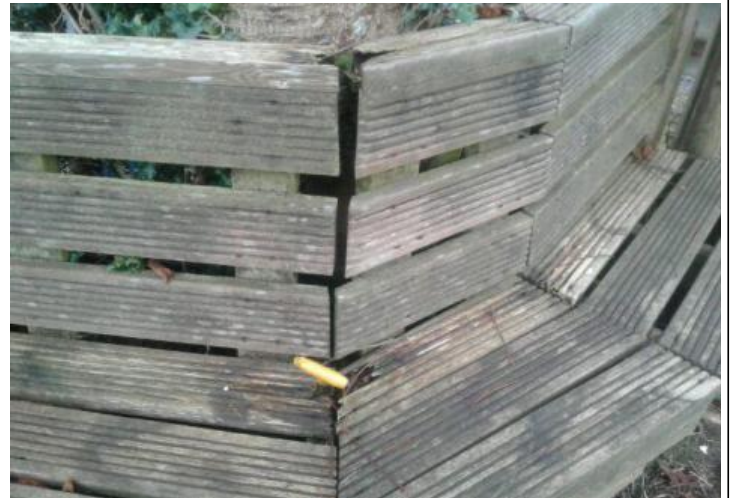
**Item:** Ancillary Items - Bench  
**Manufacturer:** Not Identified

**Finding:** There are areas or parts of the timber on the structure that have rotted

**Action:** Replace all affected timbers

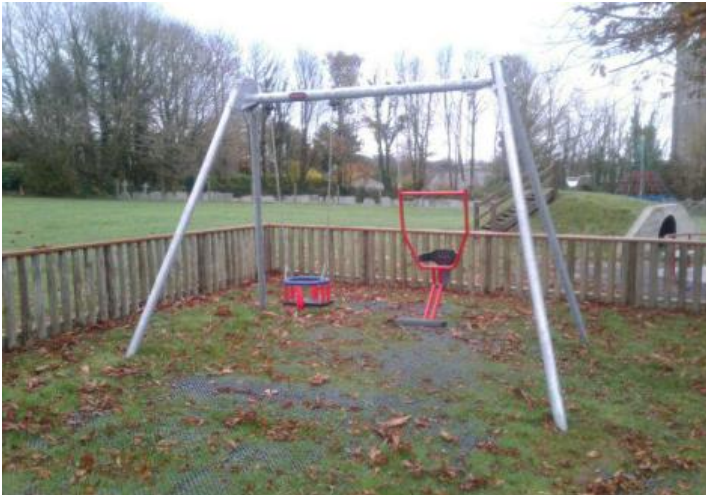
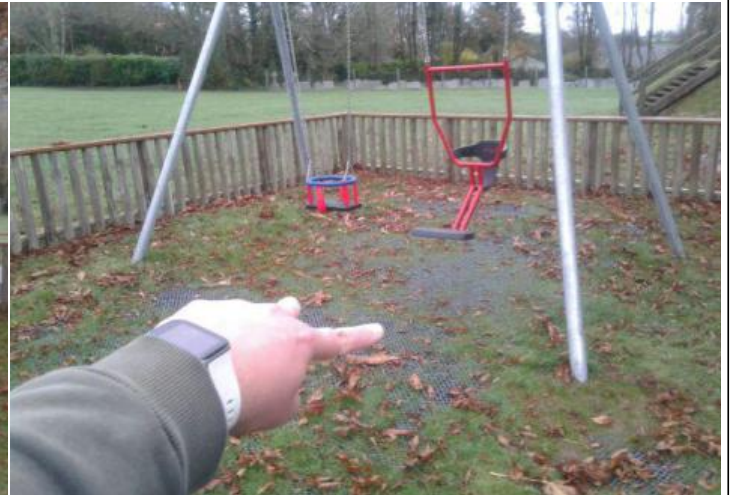
**Item:** Swings - 1 Bay Swing  
**Manufacturer:** Kompan Ltd

**Finding:** The surface has subsided in some areas

**Action:** Monitor for any further deterioration and repair as required

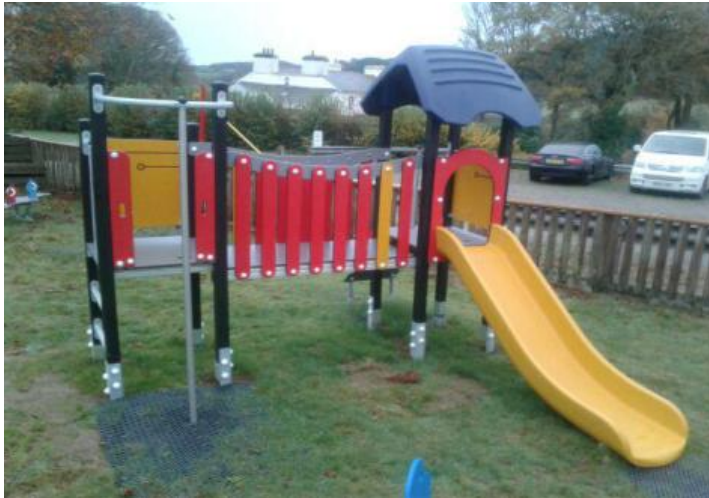
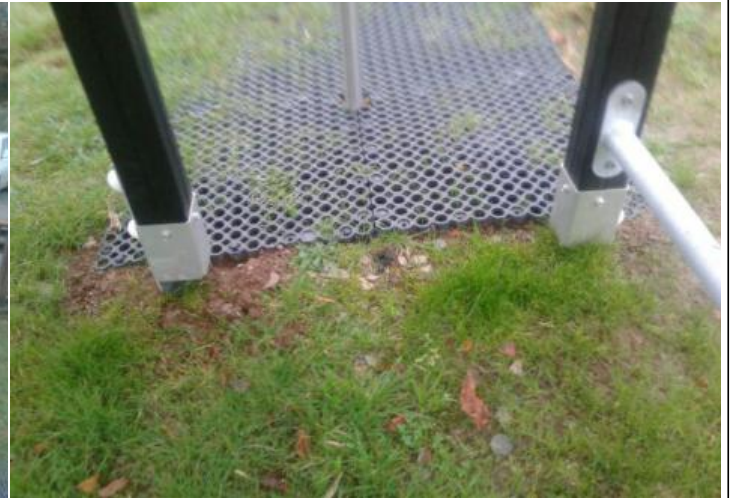
**Item:** Activity Equipment - Multi Play (Junior)  
**Manufacturer:** Kompan Ltd

**Finding:** The edges of the grass mat surface have not been installed in accordance with the API Code of Practice  
**Action:** Tuck in edges of grass mat to remove trip hazards

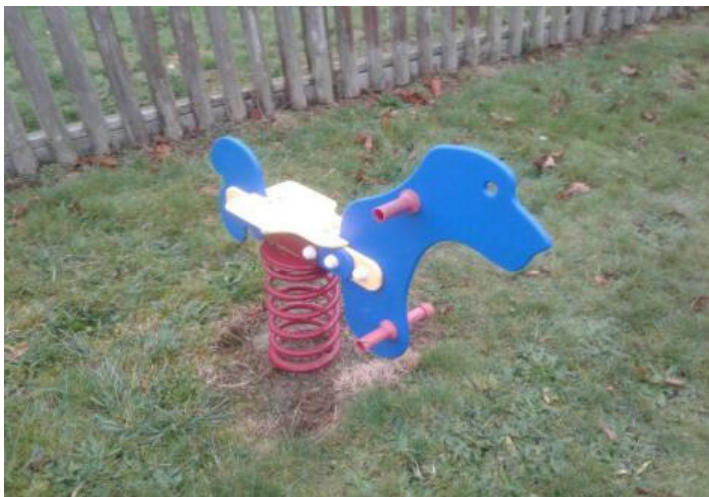
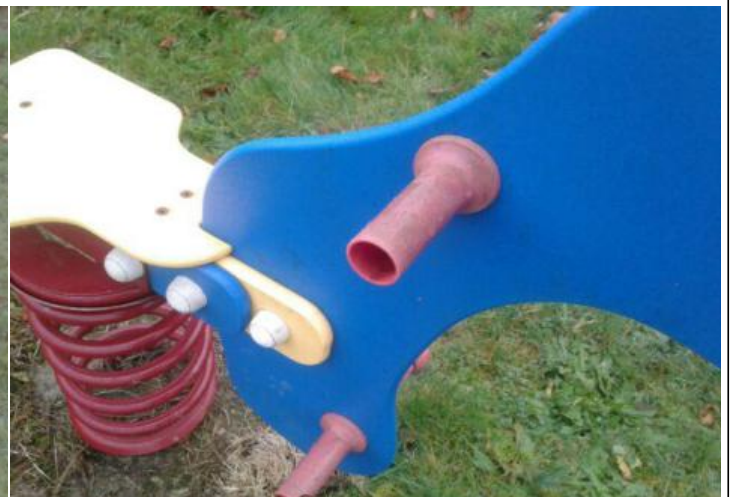
**Item:** Rocking Equipment - Spring Dog  
**Manufacturer:** Not Identified

**Finding:** The end caps are missing on the Handgrips/Footrests  
**Action:** Replace missing end caps

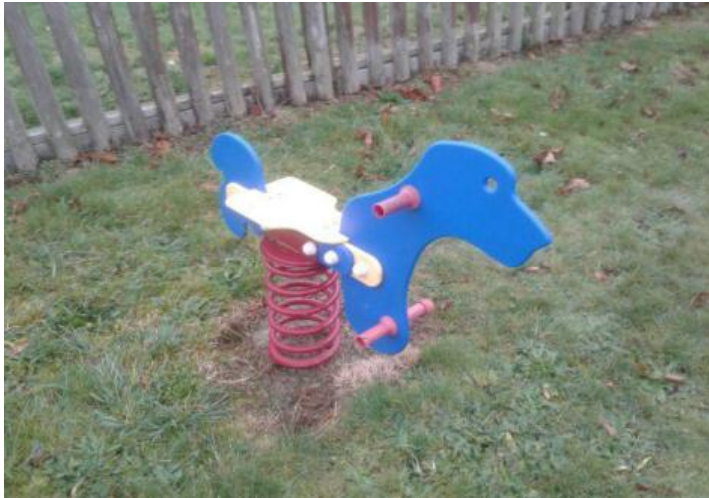
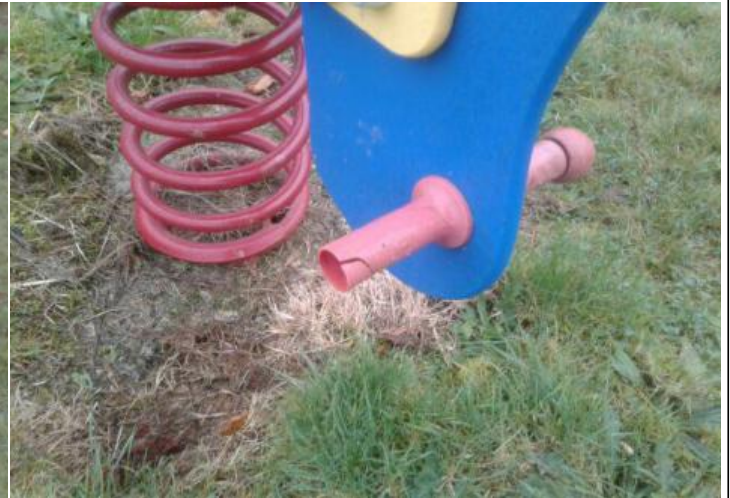
**Item:** Rocking Equipment - Spring Dog  
**Manufacturer:** Not Identified

**Finding:** The item has been severely damaged

**Action:** Repair or replace the item

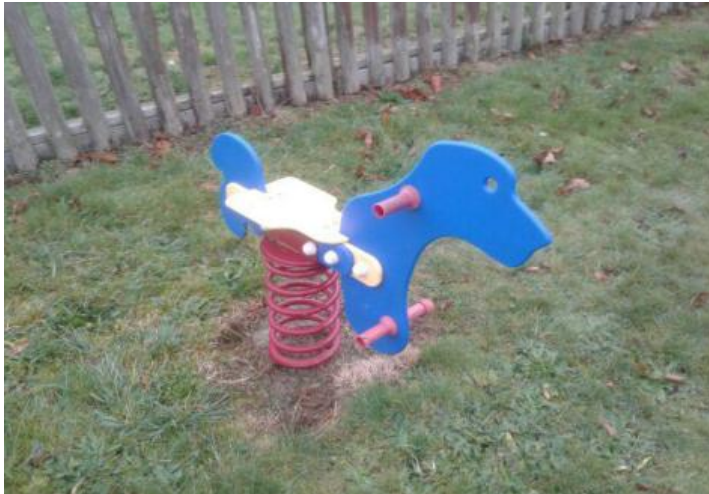
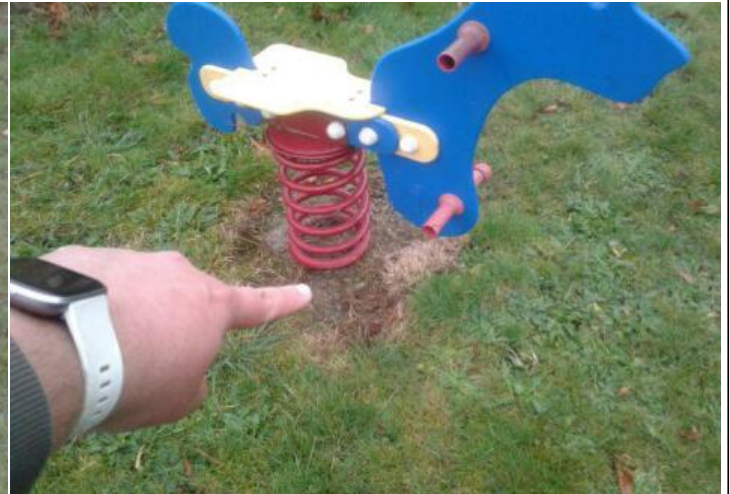
**Item:** Rocking Equipment - Spring Dog  
**Manufacturer:** Not Identified

**Finding:** The surface has eroded and the foundations are exposed

**Action:** Reinstate surrounding surfaces to cover the foundations

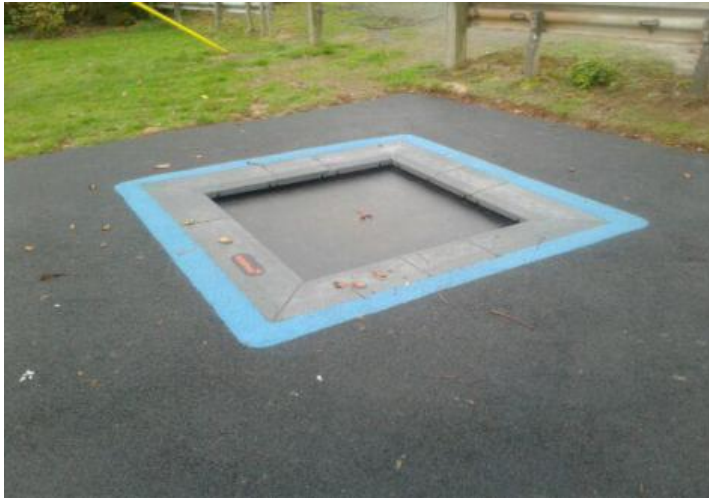
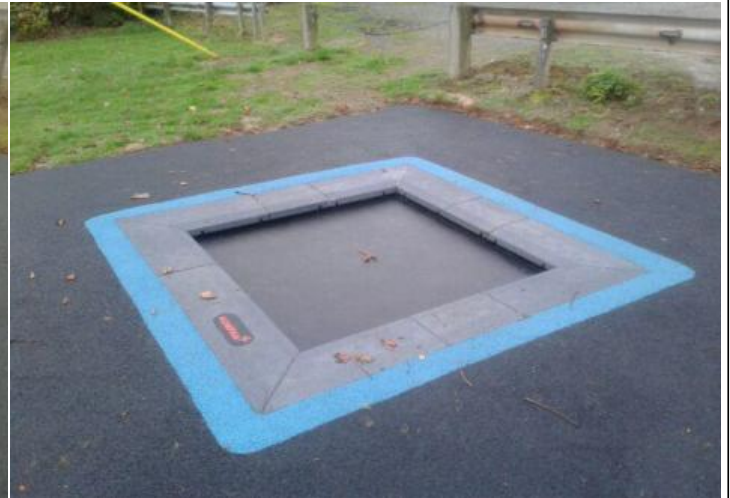
**Item:** Other - Bouncing Facility  
**Manufacturer:** Kompan Ltd

**Finding:** On site visits it is not possible to test the ground clearance of the Bouncing Facility bed as specified in BS EN 1176; ensure that the clearance between the Bouncing Facility Bed and the ground underneath is in accordance with the manufacturers recommendations (it was not possible to measure the depth at time of inspection measured unloaded due to the design of the bed of the bouncing facility).

**Action:** Refer to the manufacturers recommendations

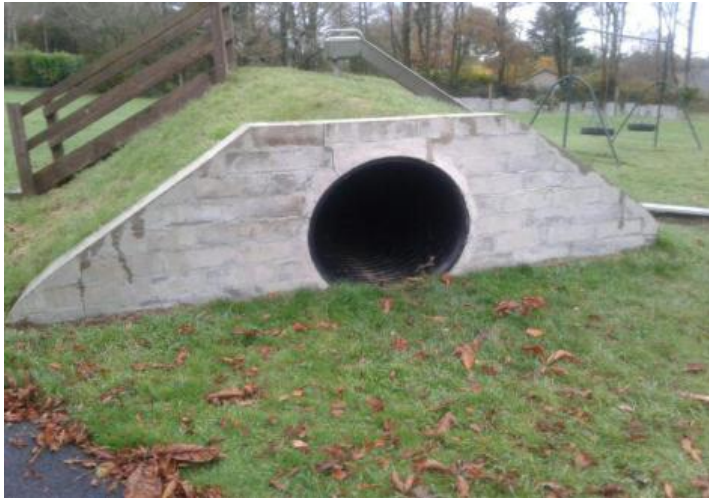
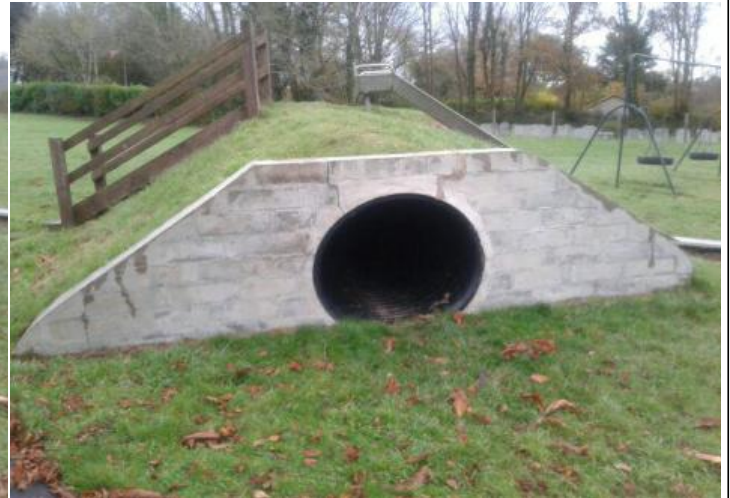
**Item:** Activity Equipment - Crawling Tunnel  
**Manufacturer:** Not Identified

**Finding:** This design / configuration of tunnel mound is well established and has been successfully included in large quantities of playgrounds throughout the UK. Whilst the design does not fully meet the requirements of BS EN 1176 with regards to falls in excess of 600mm over the edge of the tunnel to the surface below, it has been risk assessed as fit for purpose and no changes are recommended to the design

**Action:** Monitor - No remedial work recommended

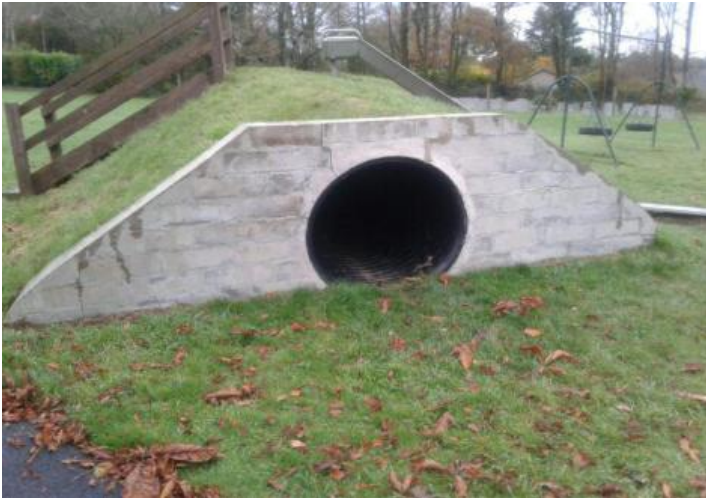
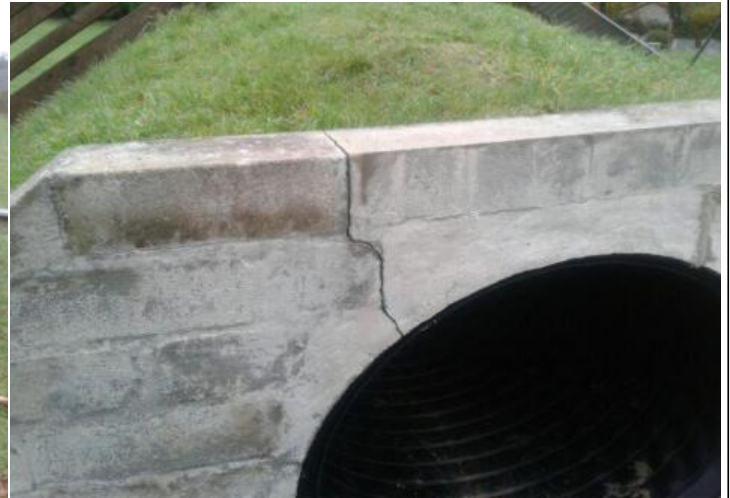
**Item:** Activity Equipment - Crawling Tunnel  
**Manufacturer:** Not Identified

**Finding:** There are cracks in the wall

**Action:** Monitor for any further deterioration and repair as required

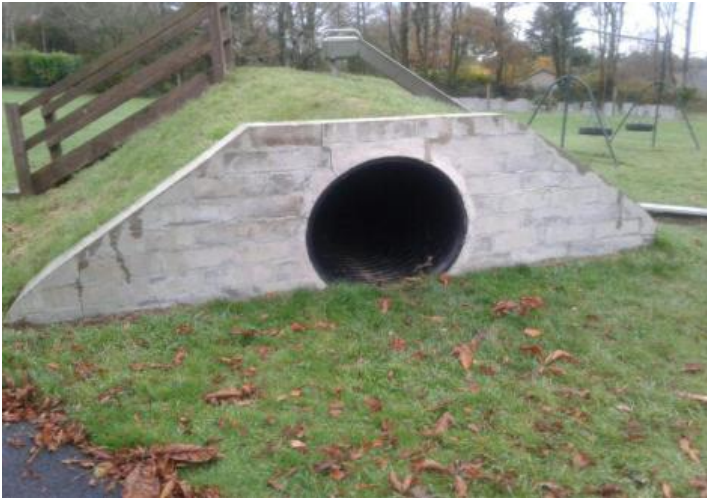
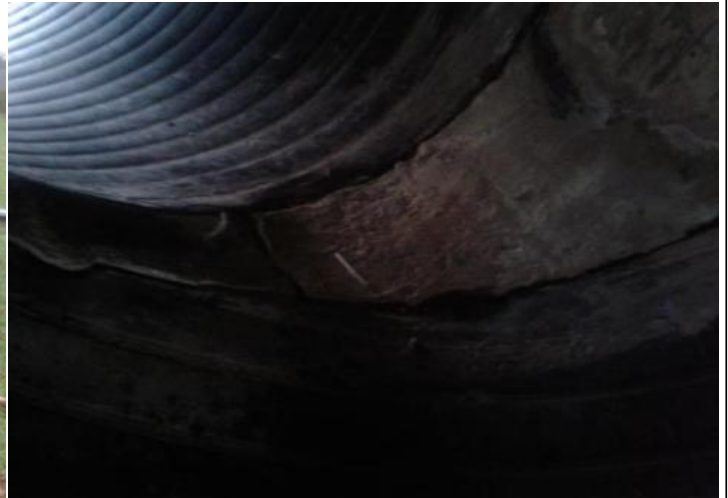
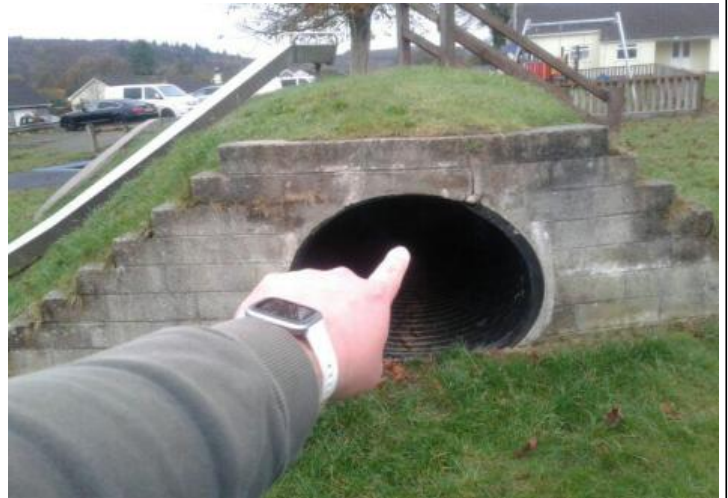
**Item:** Activity Equipment - Crawling Tunnel  
**Manufacturer:** Not Identified

**Finding:** There is some minor damage to the cement work in the tunnel

**Action:** Monitor for any further deterioration and repair as required

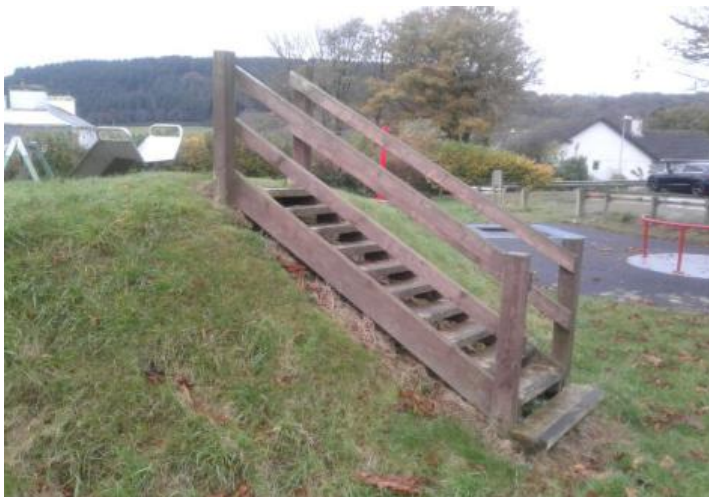
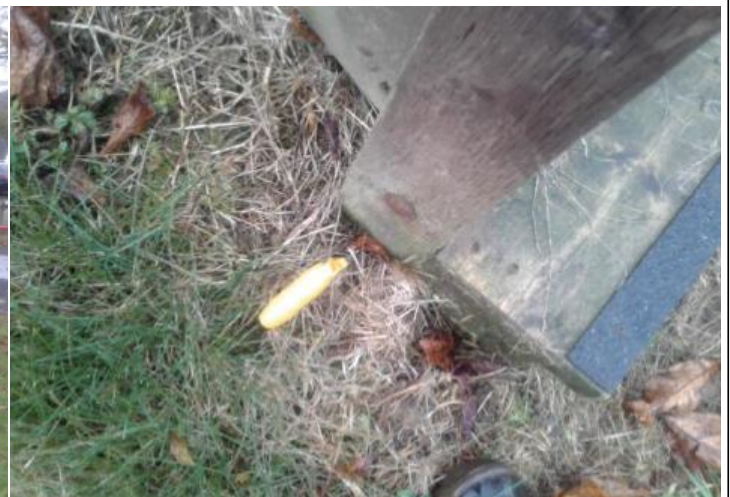
**Item:** Ancillary Items - Steps  
**Manufacturer:** Not Identified

**Finding:** There is some evidence of rot in the timber

**Action:** Monitor for any further deterioration and replace as required

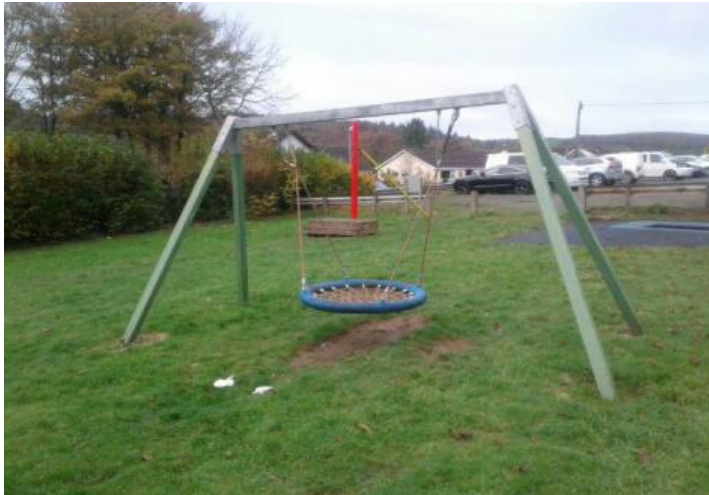
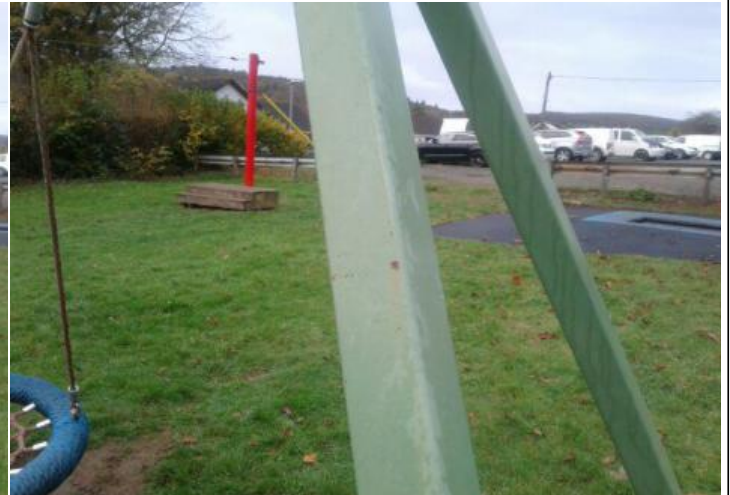
**Item:** Swings - Basket Swing - Type 1  
**Manufacturer:** Not Identified

**Finding:** There is surface corrosion present on the item

**Action:** Consider treating the item

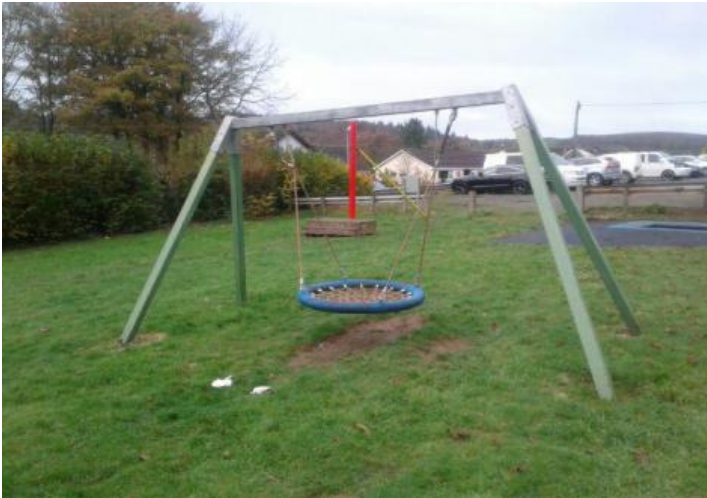
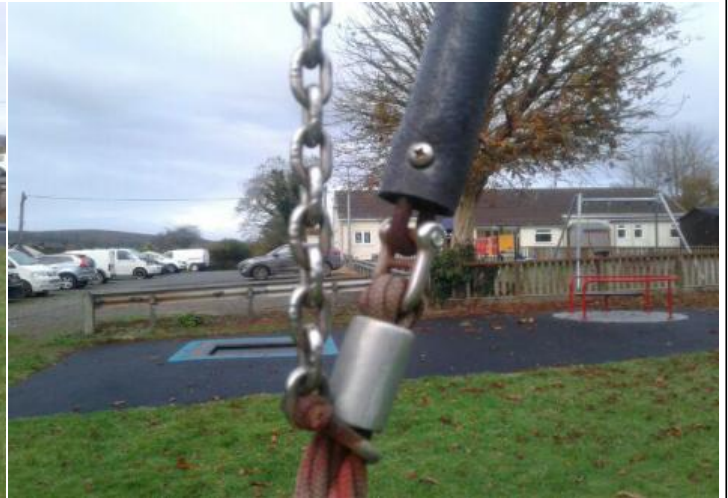
**Item:** Swings - Basket Swing - Type 1  
**Manufacturer:** Not Identified

**Finding:** There is some notable evidence of chain wear

**Action:** Monitor for any further deterioration and replace when 40% worn

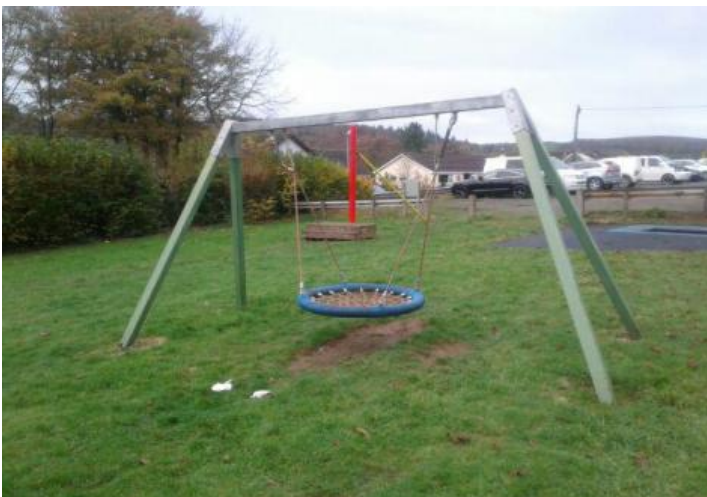
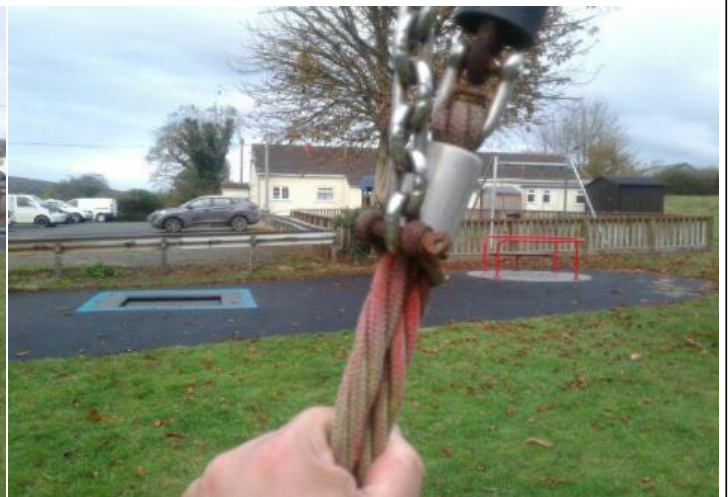
**Item:** Swings - Basket Swing - Type 1  
**Manufacturer:** Not Identified

**Finding:** There is some wear to the shackles.

**Action:** Monitor for any further deterioration and replace when 40% worn

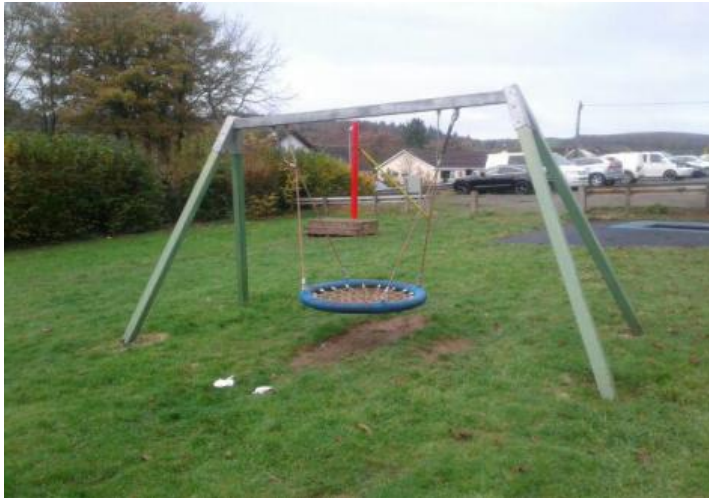
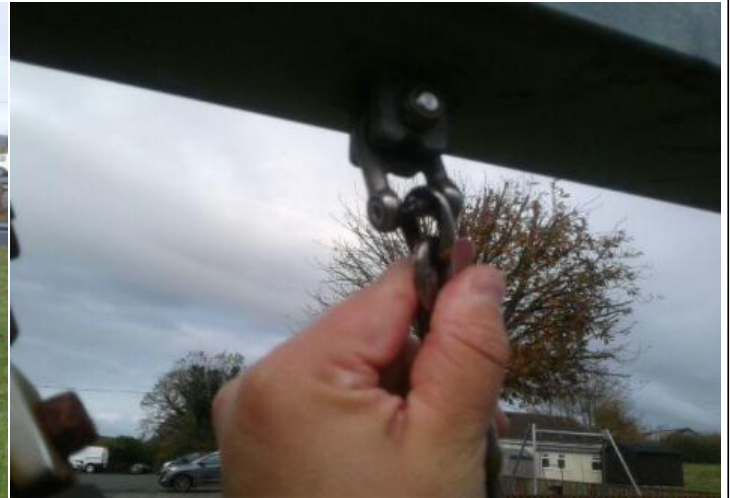
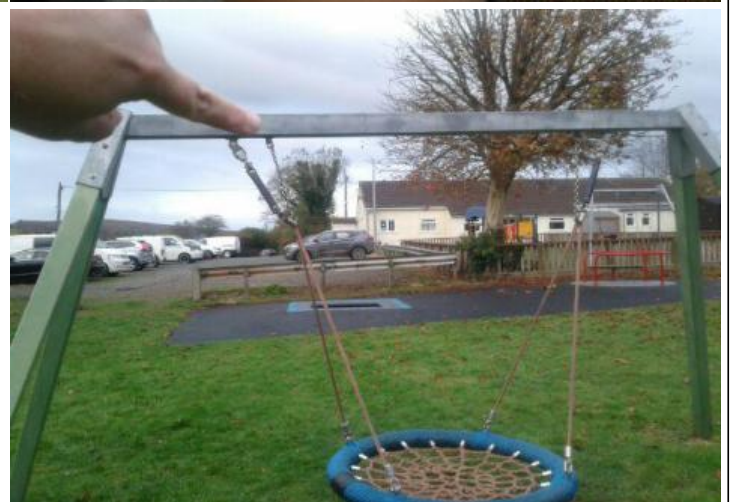
**Item:** Swings - Basket Swing - Type 1  
**Manufacturer:** Not Identified

**Finding:** The shackle links are worn in excess of 40% and require renewing ( the shackle is wearing due to the length of the secondary safety chain taking all the weight of the basket instead of the main suspension

**Action:** Replace worn shackle

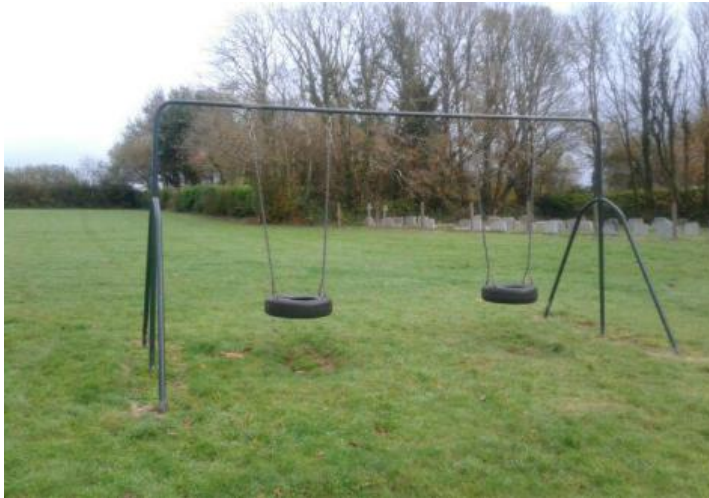
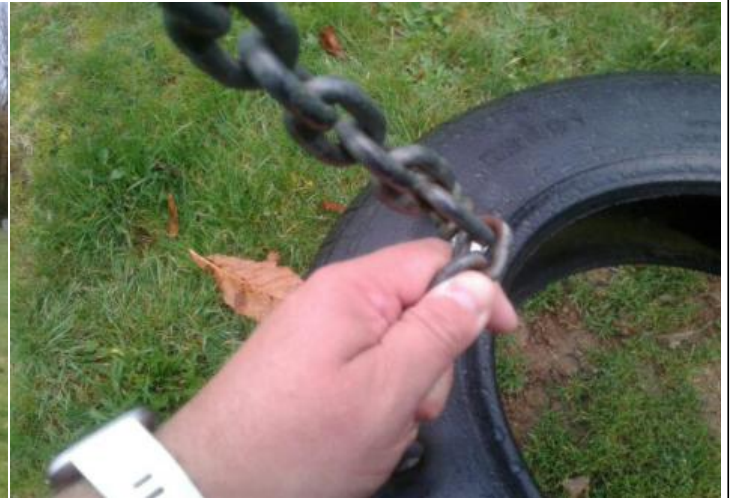
**Item:** Swings - 1 Bay Swing  
**Manufacturer:** Not Identified

**Finding:** There is some notable evidence of chain wear

**Action:** Monitor for any further deterioration and replace when 40% worn

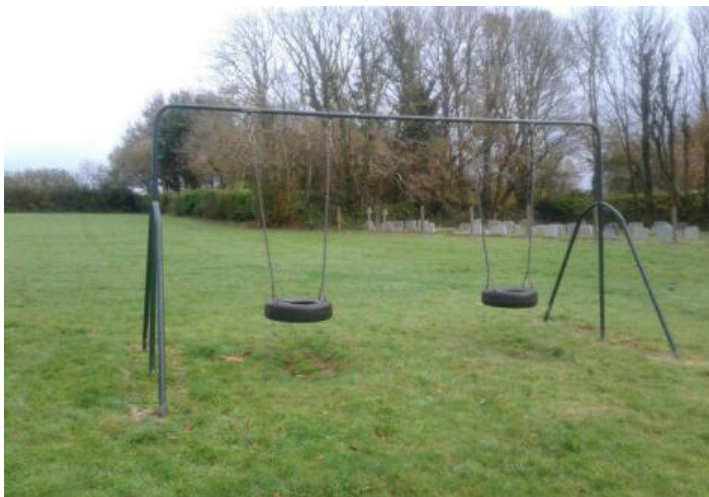
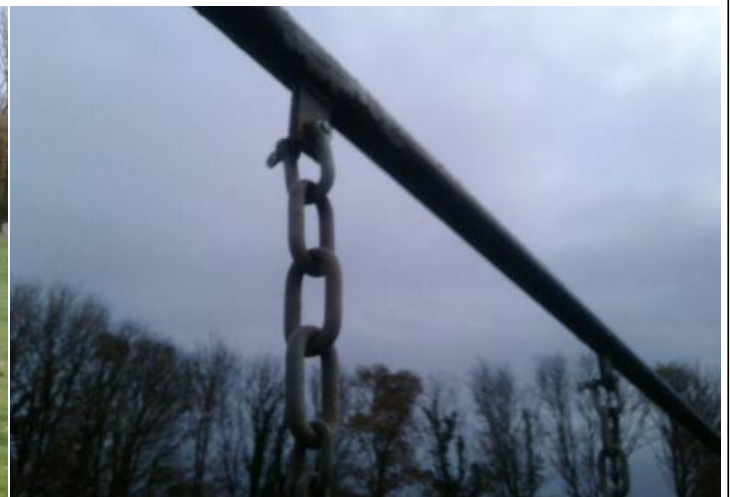
**Item:** Swings - 1 Bay Swing  
**Manufacturer:** Not Identified

**Finding:** The bushes are worn or missing

**Action:** Replace worn or missing bushes

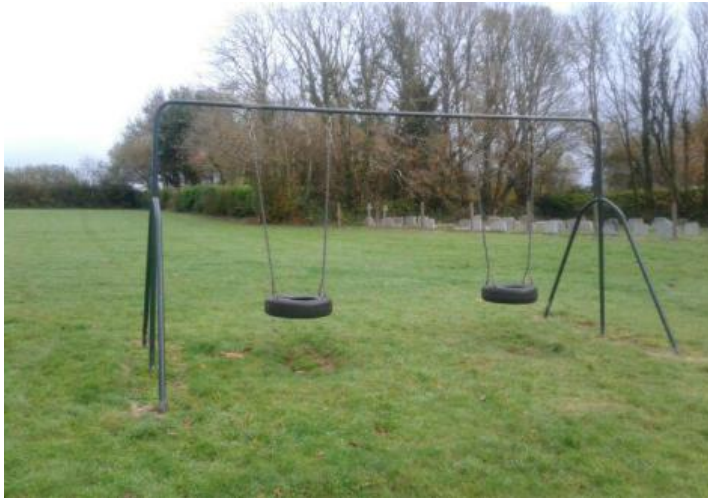
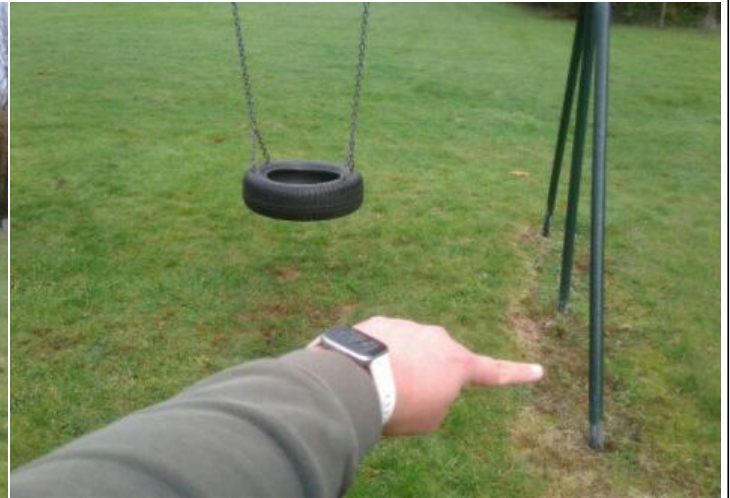
**Item:** Swings - 1 Bay Swing  
**Manufacturer:** Not Identified

**Finding:** The surface has eroded and the foundations are exposed

**Action:** Reinstate surrounding surfaces to cover the foundations

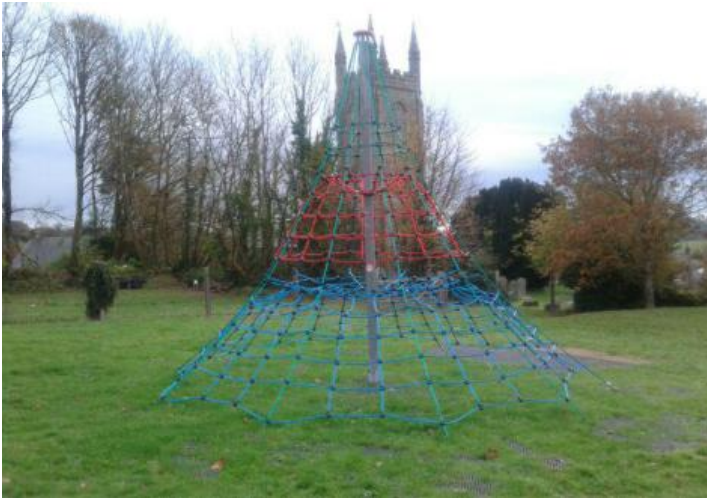
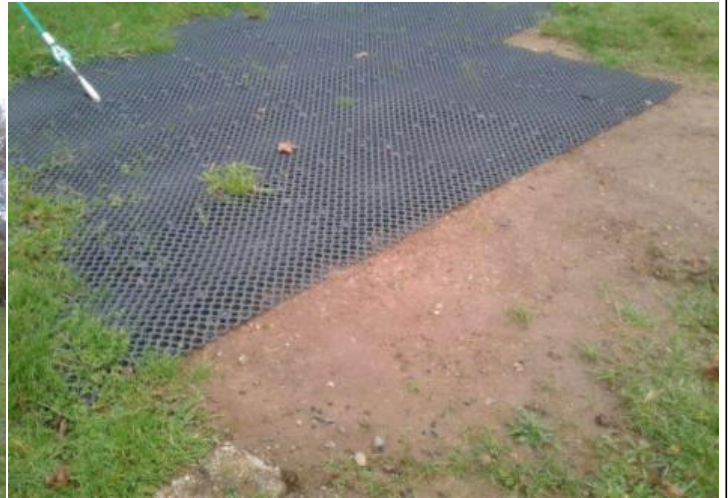
**Item:** Activity Equipment - Space Net  
**Manufacturer:** Kompan Ltd

**Finding:** The edges of the grass mat surface have not been installed in accordance with the API Code of Practice  
**Action:** Tuck in edges of grass mat to remove trip hazards

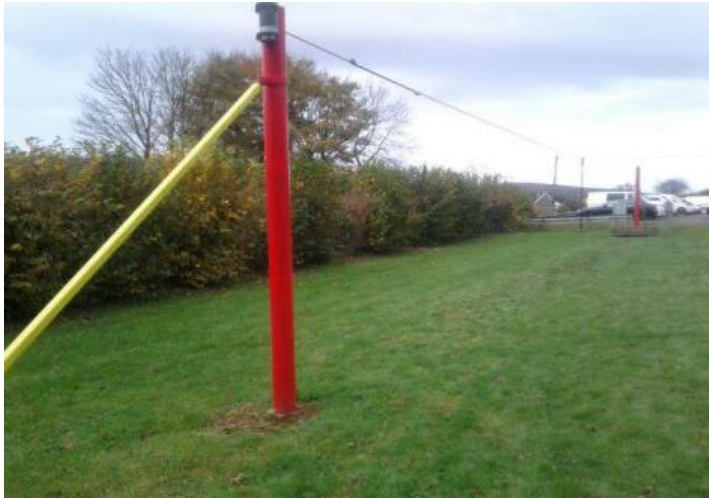
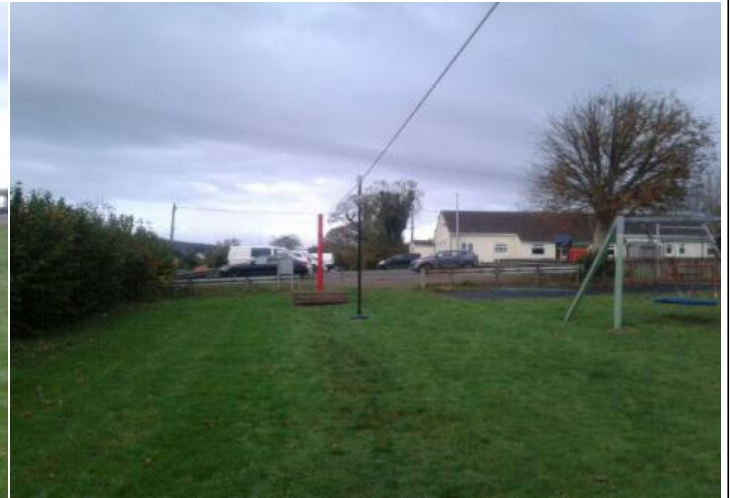
**Item:** Other - Cable Runway  
**Manufacturer:** Not Identified

**Finding:** We have completed a visual inspection of the cable and fixing points from ground level, however it is not possible to fully inspect the cable and fixings without either hiring equipment to gain access or removing the cable and inspecting at ground level. We recommend that the main cable and fixing security is thoroughly inspected at least in accordance with the manufacturers recommendations to check for damage, security or internal rusting, this will help to ensure the continued safe use of the equipment

**Action:** Inspect in accordance with the manufacturers recommendations

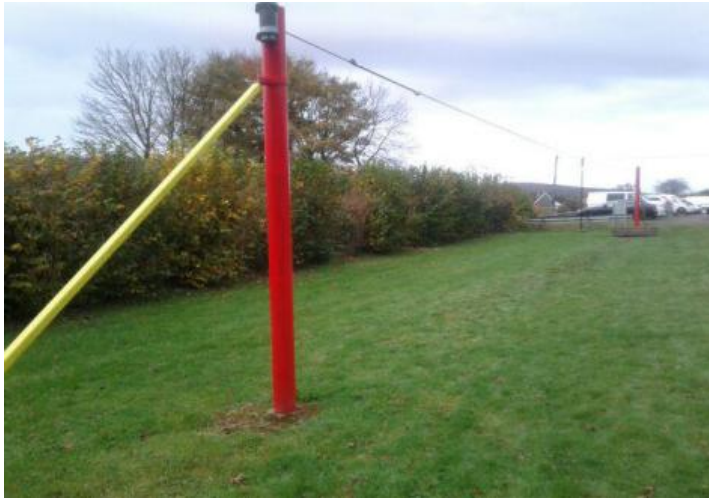
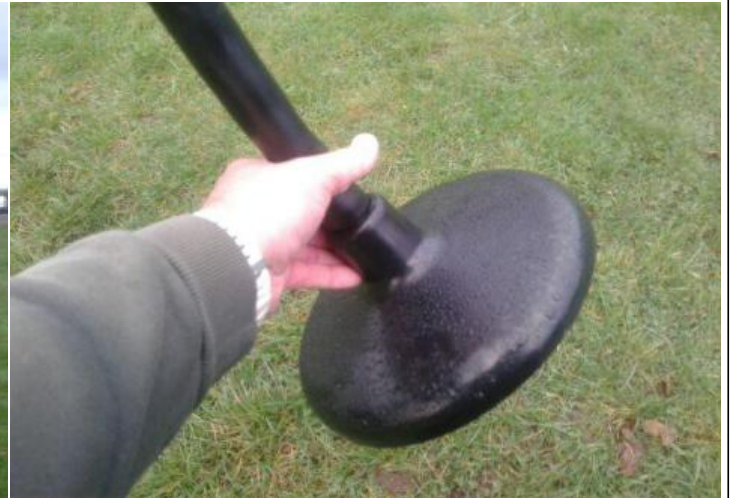
**Item:** Other - Cable Runway  
**Manufacturer:** Not Identified

**Finding:** The seat connection cannot be inspected without dismantling the seat

**Action:** Dismantle the seat to inspect the seat connection for wear
