## Operational Inspection

North Hill Parish Council

North Hill Village Hall

Lynher Close, North Hill, Launceston, Cornwall, PL15  
9PQ

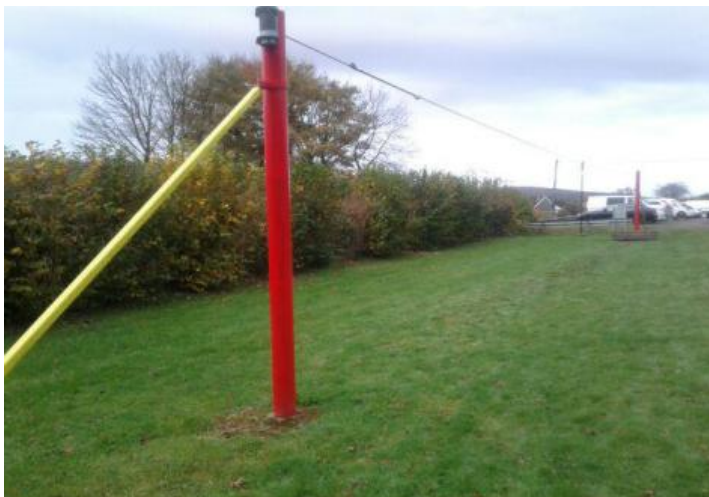
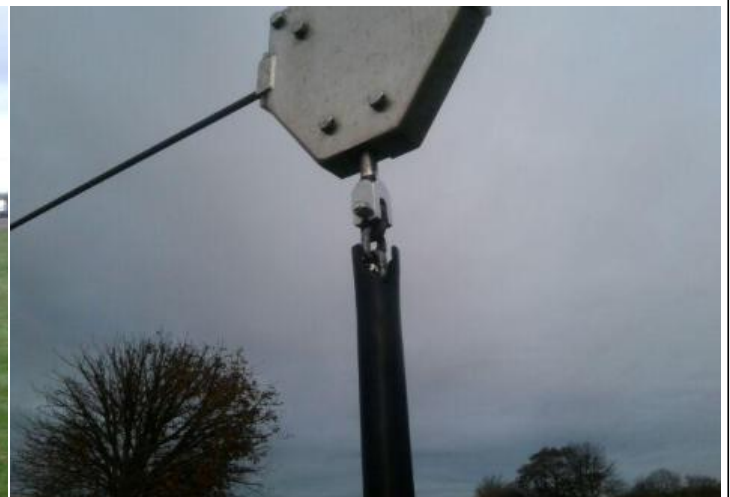
**Item:** Other - Cable Runway  
**Manufacturer:** Not Identified

**Finding:** There is some notable evidence of chain wear

**Action:** Monitor for any further deterioration and replace when 40% worn

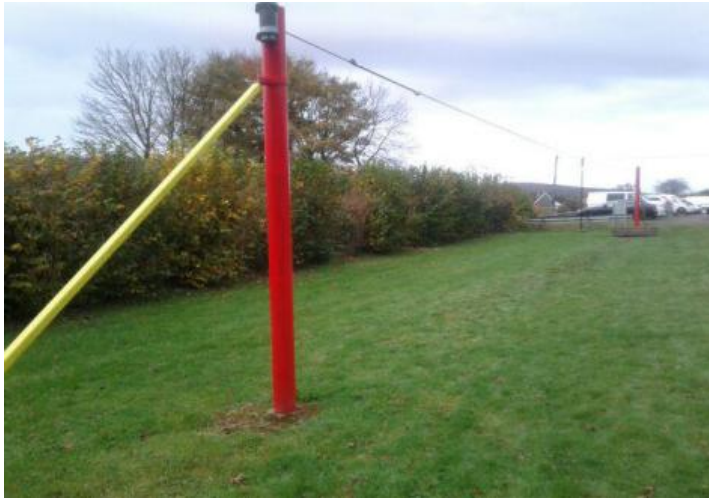
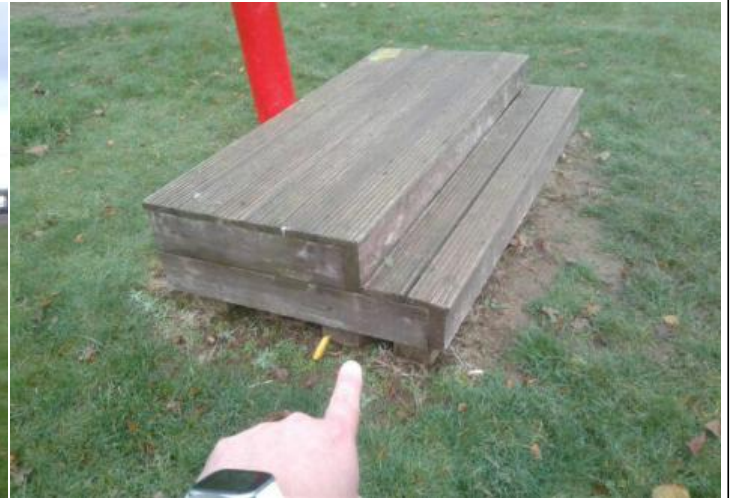
**Item:** Other - Cable Runway  
**Manufacturer:** Not Identified

**Finding:** There is some evidence of rot in the timber

**Action:** Monitor for any further deterioration and replace as required

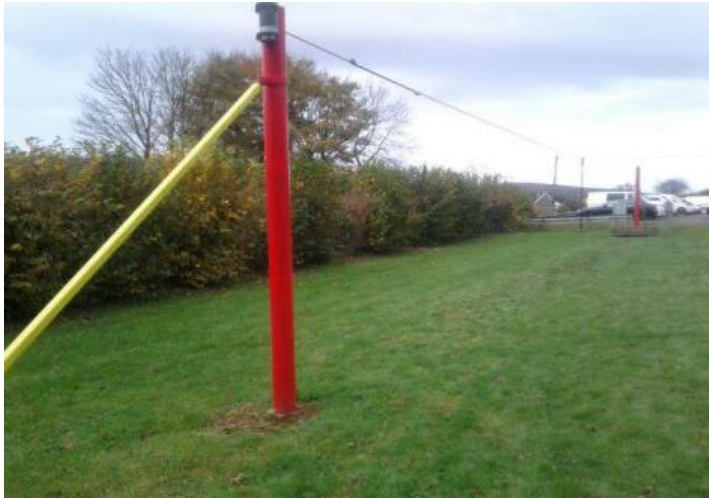
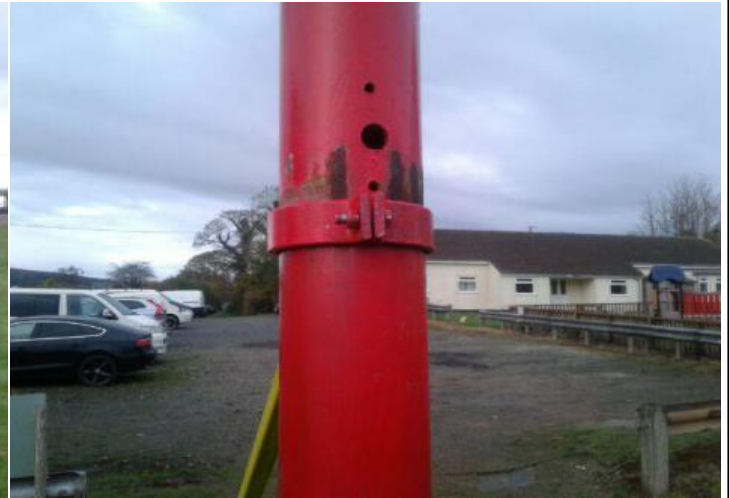
**Item:** Other - Cable Runway  
**Manufacturer:** Not Identified

**Finding:** There is/are several inserts missing

**Action:** Replace missing inserts

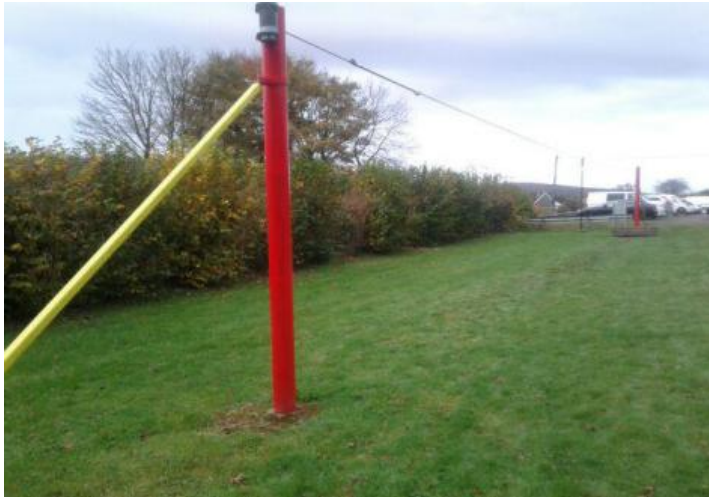
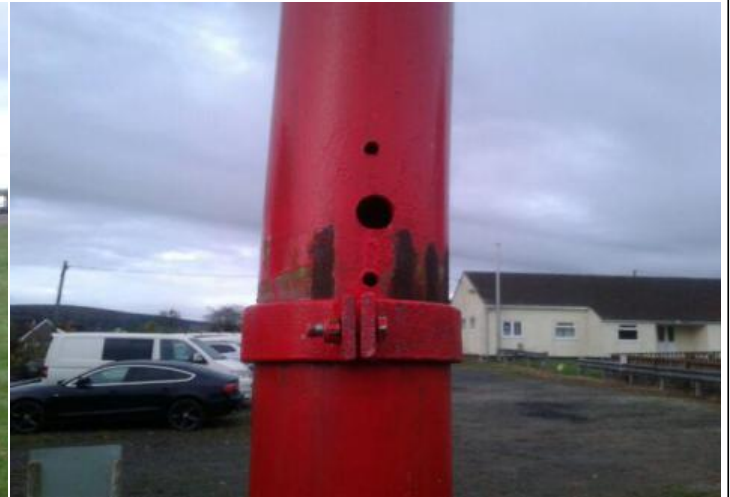
**Item:** Other - Cable Runway  
**Manufacturer:** Not Identified

**Finding:** There is surface corrosion present on the item

**Action:** Consider treating the item
