the **play inspection** company

Operational Inspection

North Hill Parish Council

North Hill Village Hall

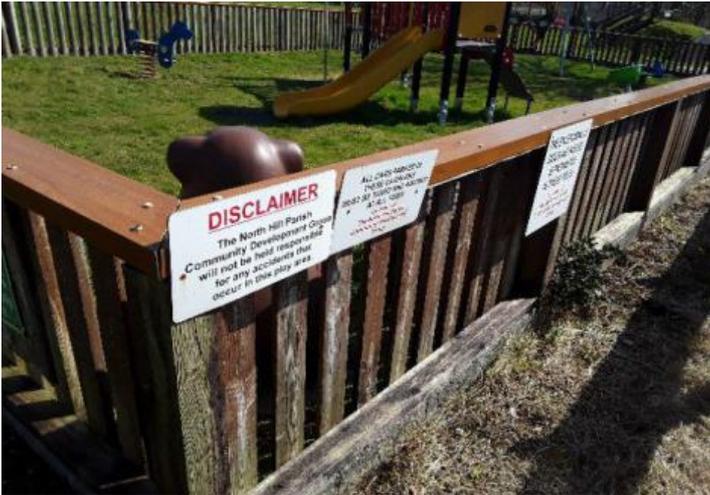
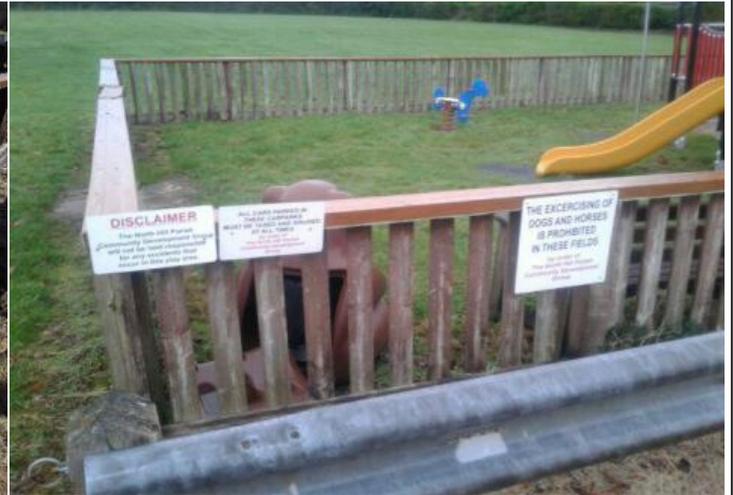
Finding: BS EN 1176 Part 7 recommends that signage shall include emergency contact details and contact details of owner / operator for reporting maintenance issues
Action: Provide additional information

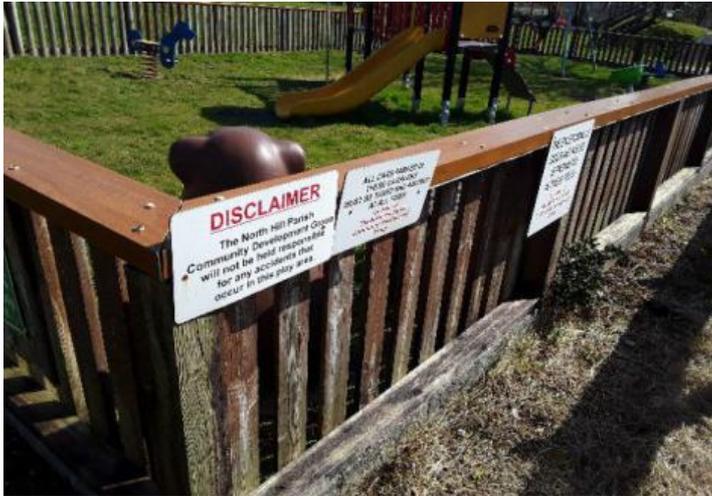
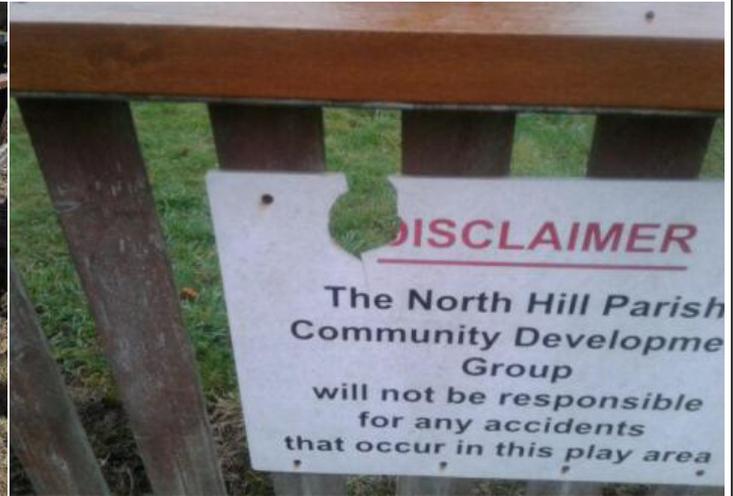
Finding: There is some damage to the sign

Action: Replace

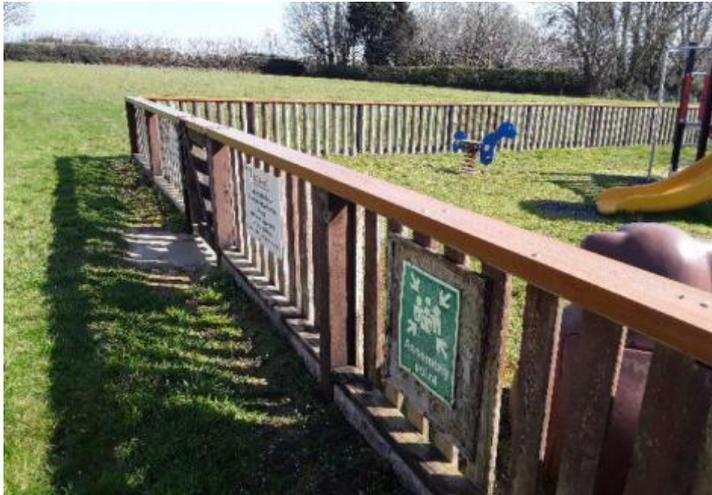
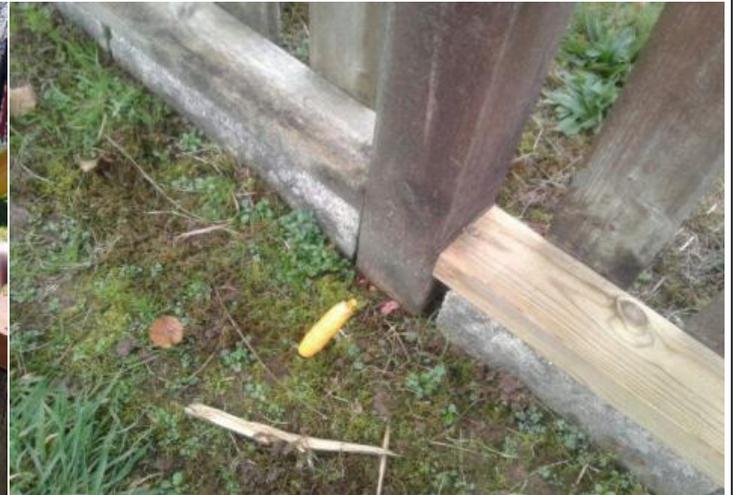
Finding: There is some evidence of rot in the timber

Action: Monitor for any further deterioration and replace as required

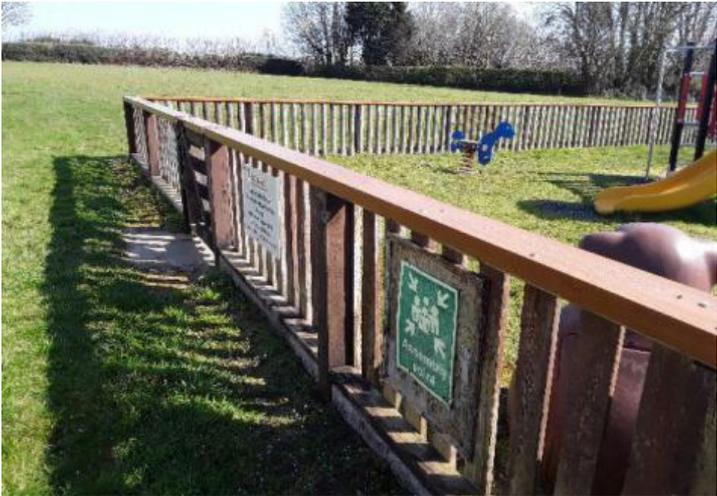
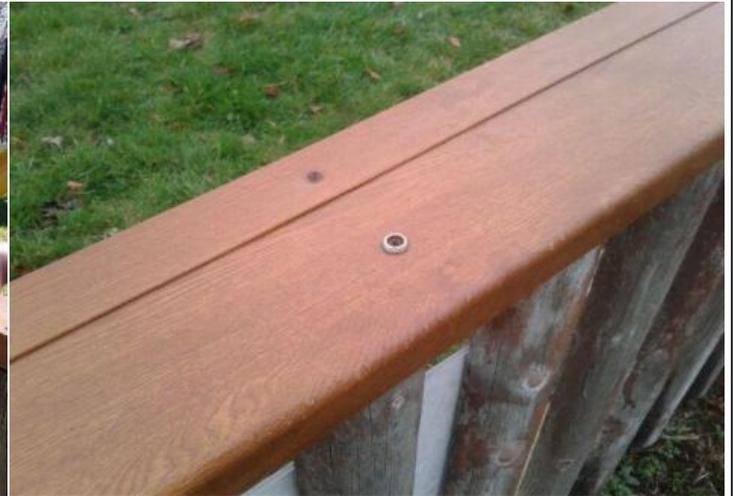
Finding: There is/are screw cap covers missing or damaged **Action:** Monitor and replace if required on the item

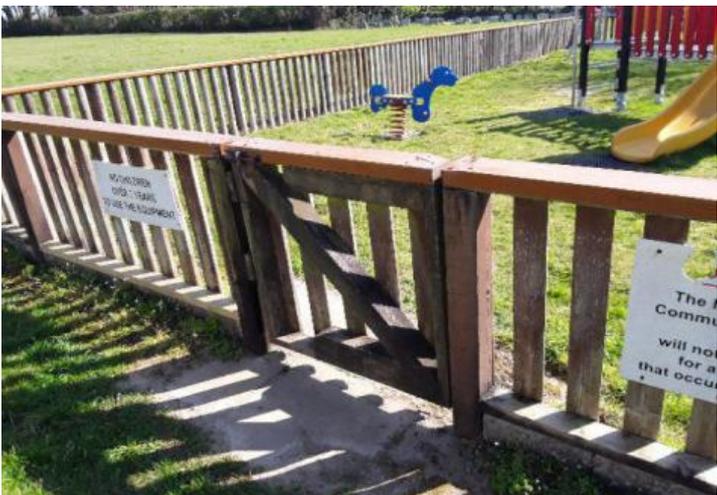
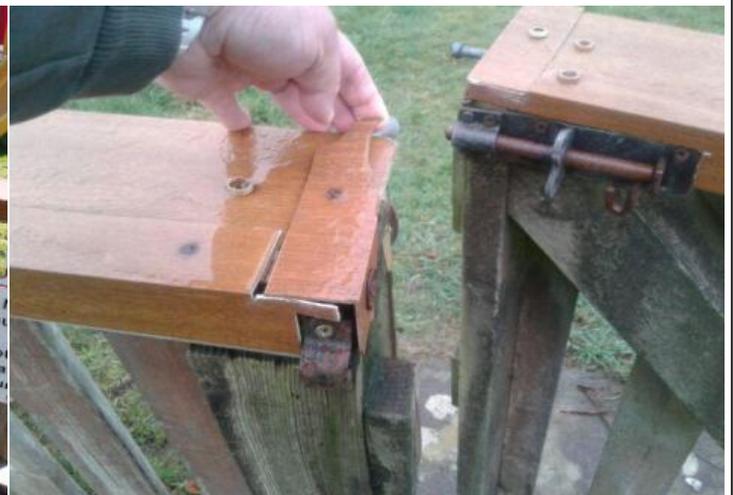
Finding: There is sharp sections of plastic on the fence next **Action:** Repair or replace to the gate

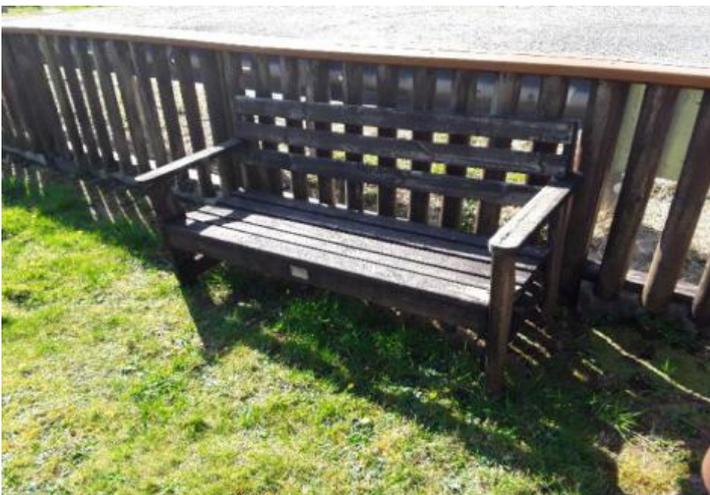
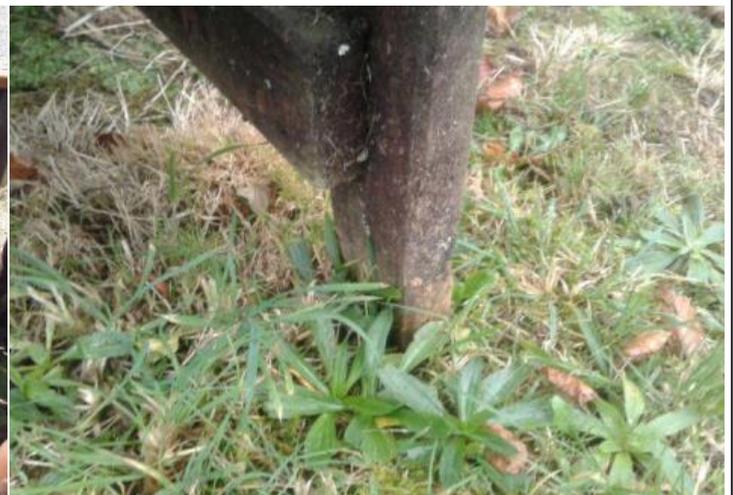
Finding: There is some strimmer / machinery damage apparent on the posts, this can penetrate the preservative applied to the timber and accelerate the rotting process

Action: Monitor for any deterioration (rot) and replace as required

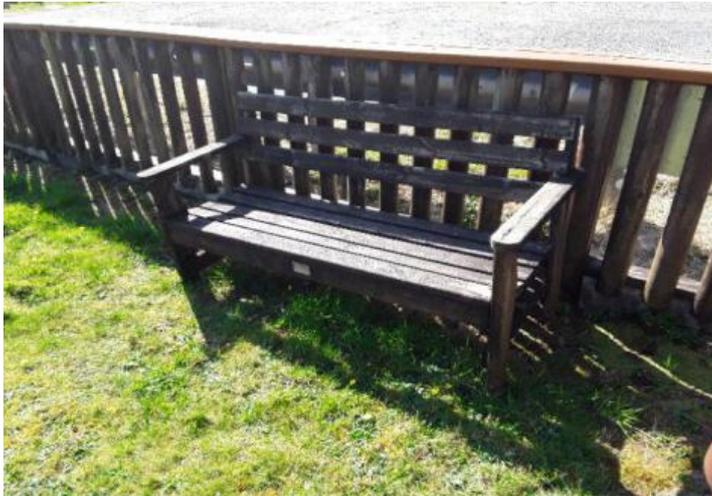
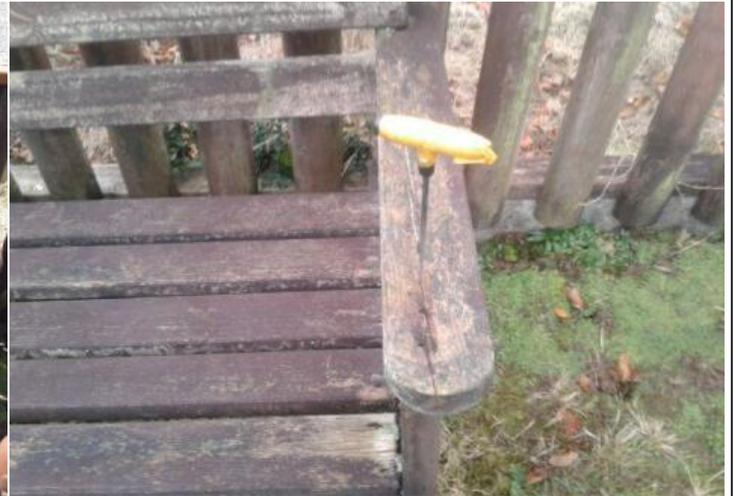
Finding: There is some evidence of rot in the timber

Action: Monitor for any further deterioration and replace as required

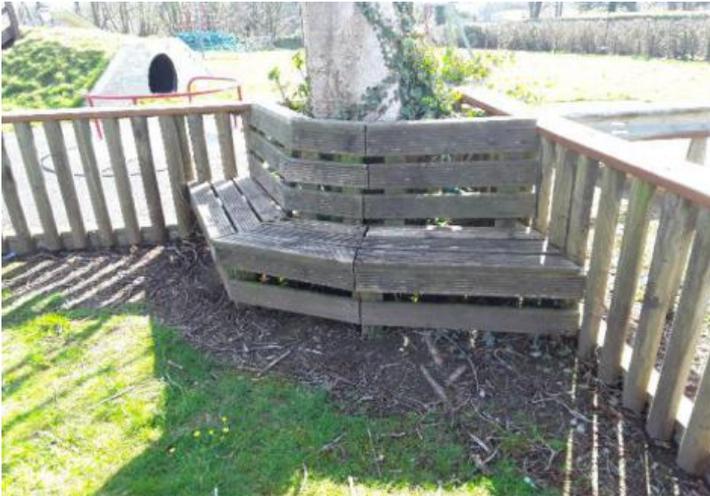
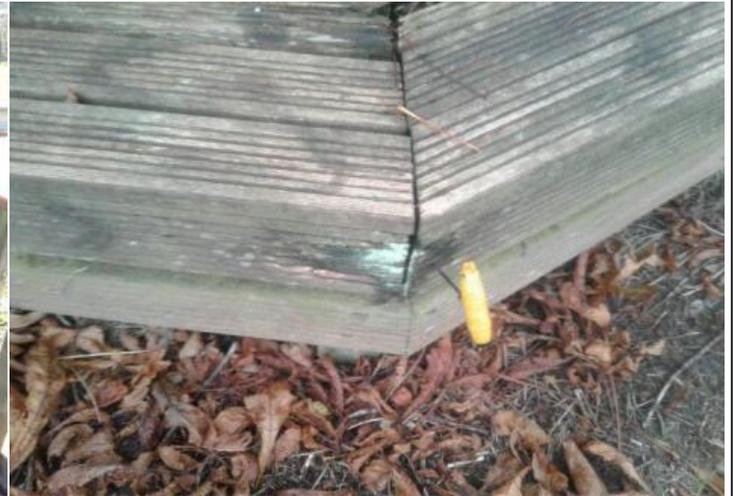
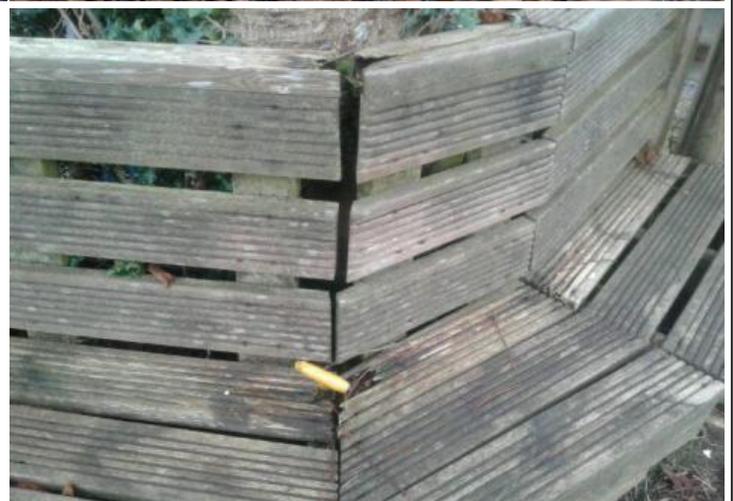
Finding: There are areas or parts of the timber on the structure that have rotted

Action: Replace all affected timbers

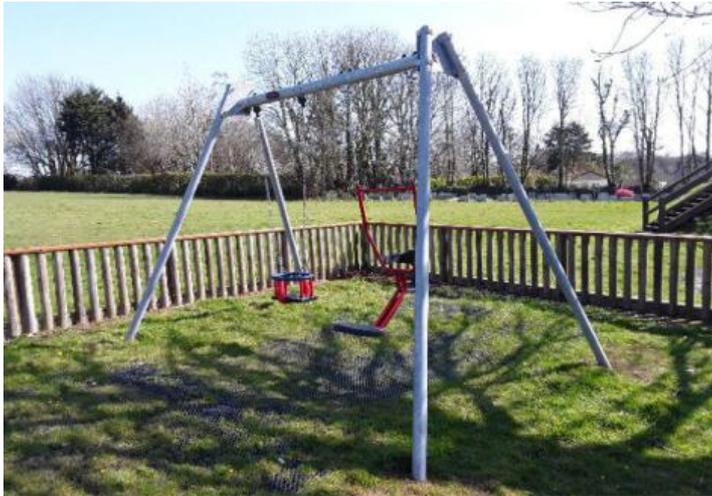
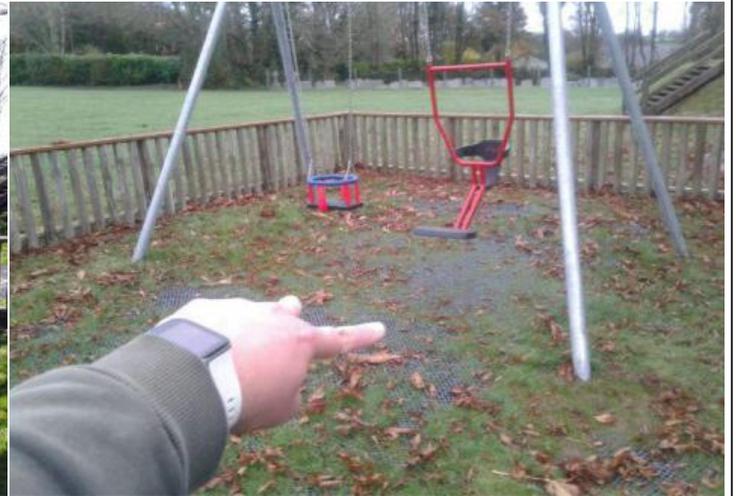
Finding: The surface has subsided in some areas

Action: Monitor for any further deterioration and repair as required

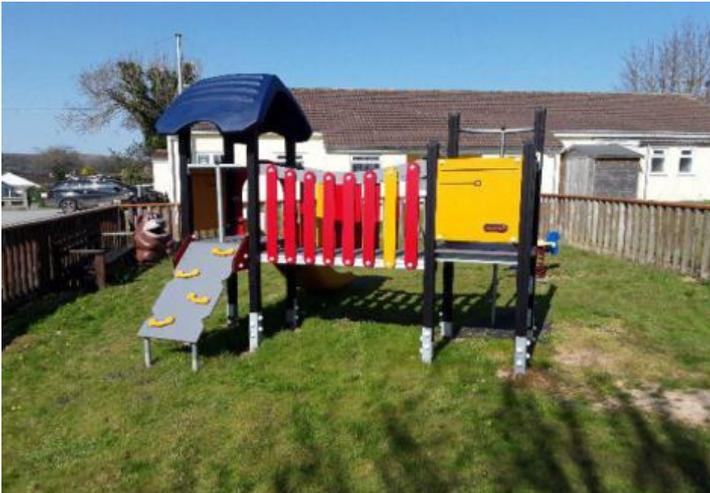
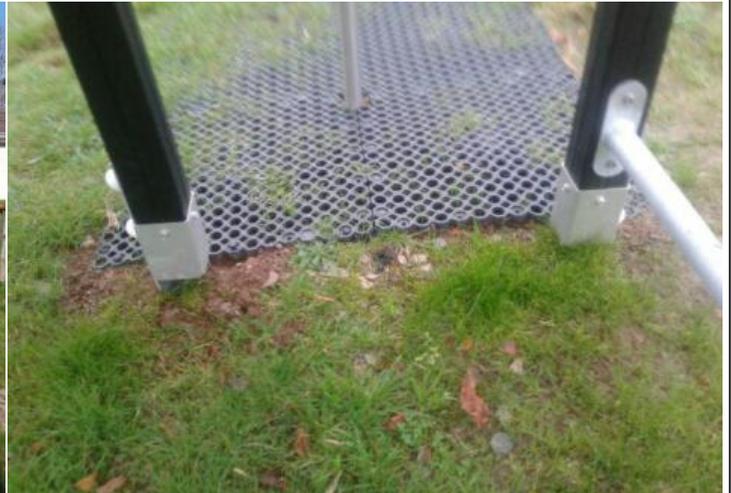
Finding: The edges of the grass mat surface have not been installed in accordance with the API Code of Practice
Action: Tuck in edges of grass mat to remove trip hazards

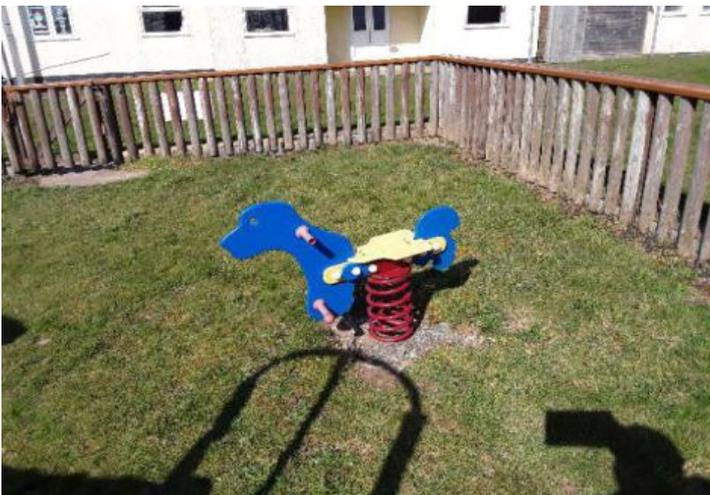
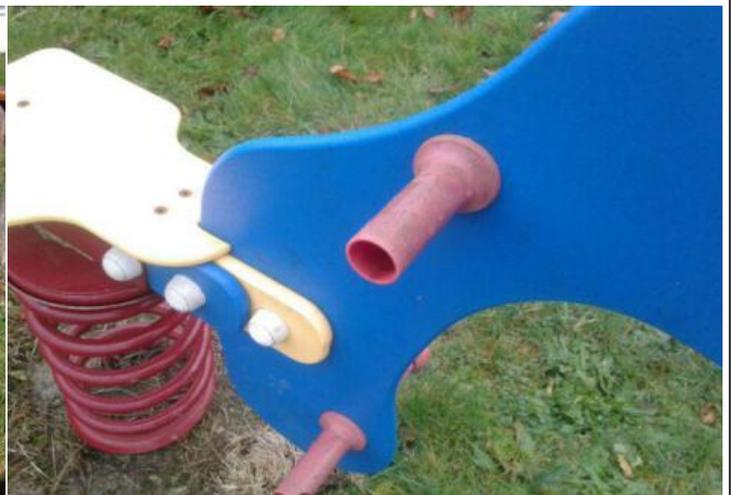
Finding: The end caps are missing on the Handgrips/Footrests

Action: Replace missing end caps

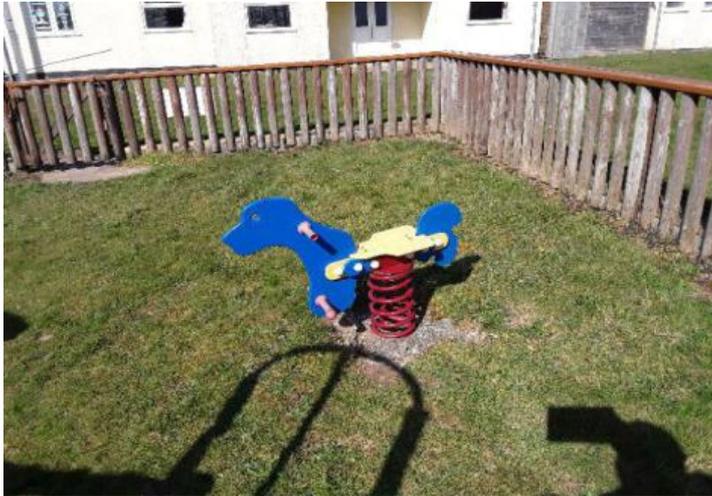
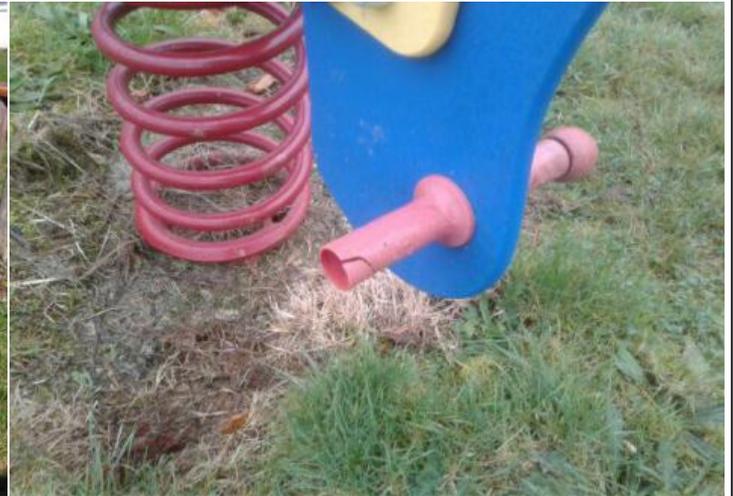
Finding: The item has been severely damaged

Action: Repair or replace the item

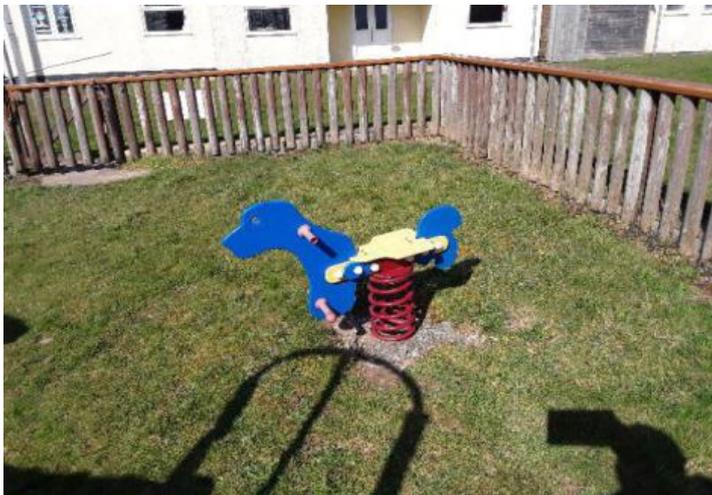
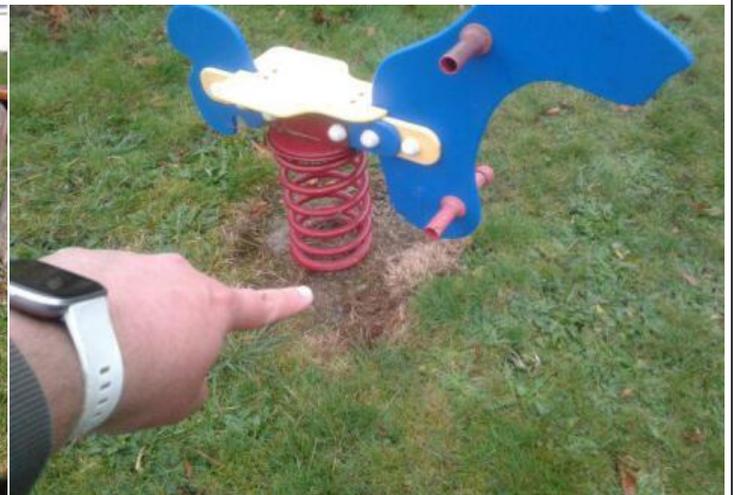
Finding: The surface has eroded and the foundations are exposed

Action: Reinstate surrounding surfaces to cover the foundations

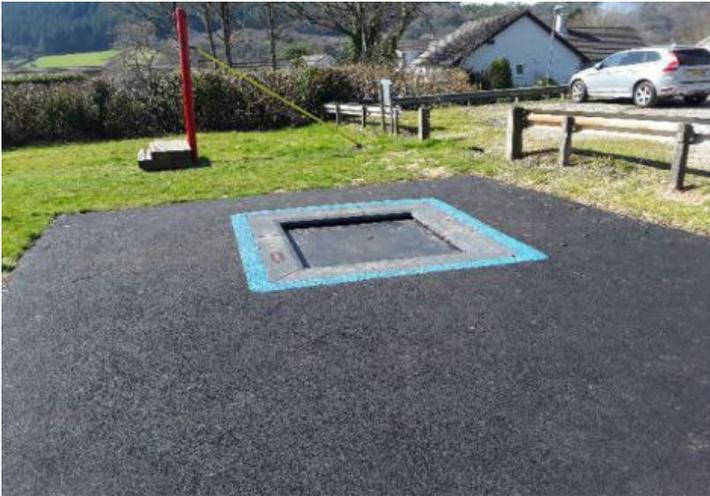
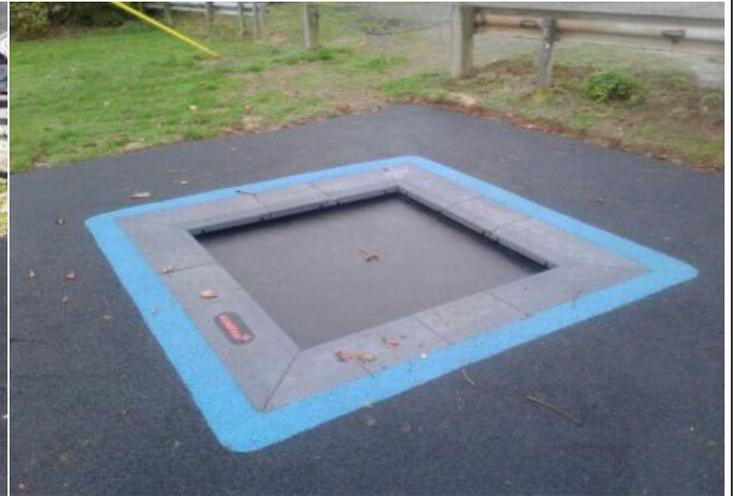
Finding: On site visits it is not possible to test the ground clearance of the Bouncing Facility bed as specified in BS EN 1176; ensure that the clearance between the Bouncing Facility Bed and the ground underneath is in accordance with the manufacturers recommendations (it was not possible to measure the depth at time of inspection measured unloaded due to the design of the bed of the bouncing facility).

Action: Refer to the manufacturers recommendations

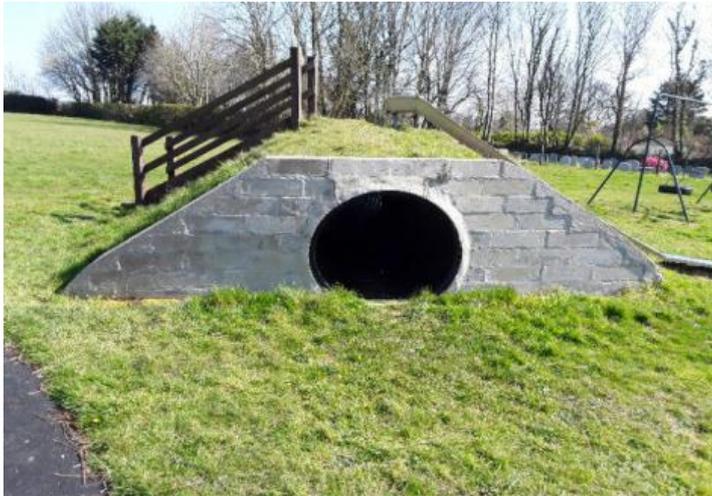
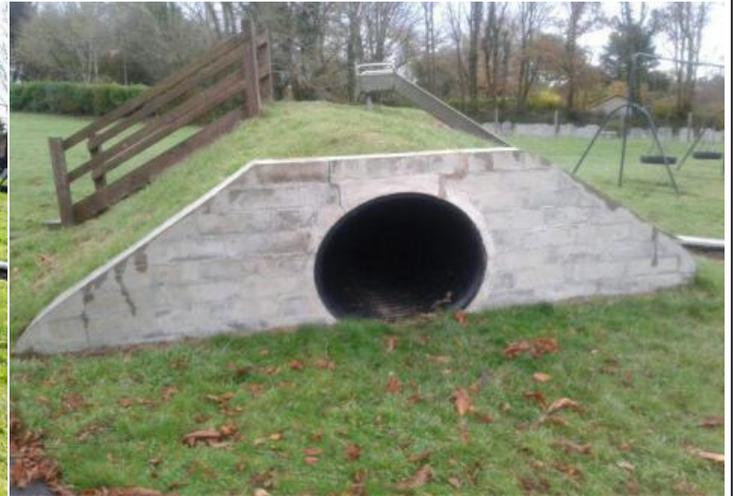
Finding: This design / configuration of tunnel mound is well established and has been successfully included in large quantities of playgrounds throughout the UK. Whilst the design does not fully meet the requirements of BS EN 1176 with regards to falls in excess of 600mm over the edge of the tunnel to the surface below, it has been risk assessed as fit for purpose and no changes are recommended to the design

Action: Monitor - No remedial work recommended

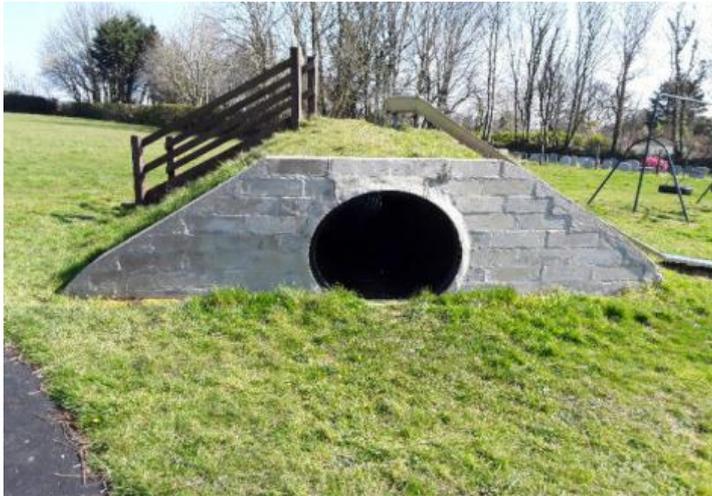
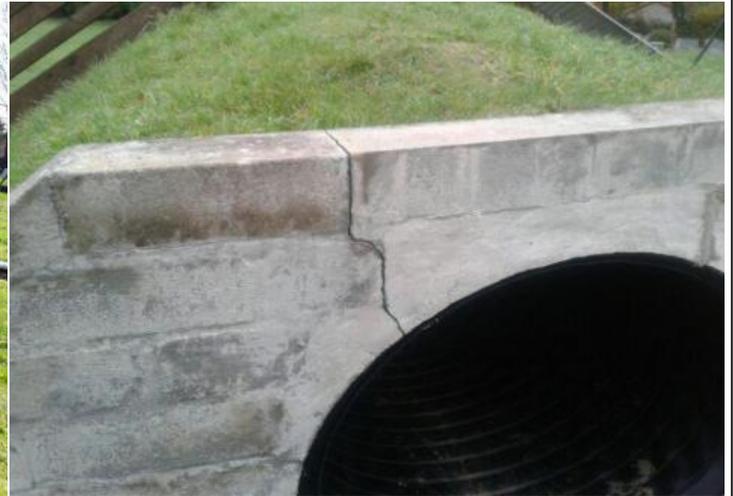
Finding: There are cracks in the wall

Action: Monitor for any further deterioration and repair as required

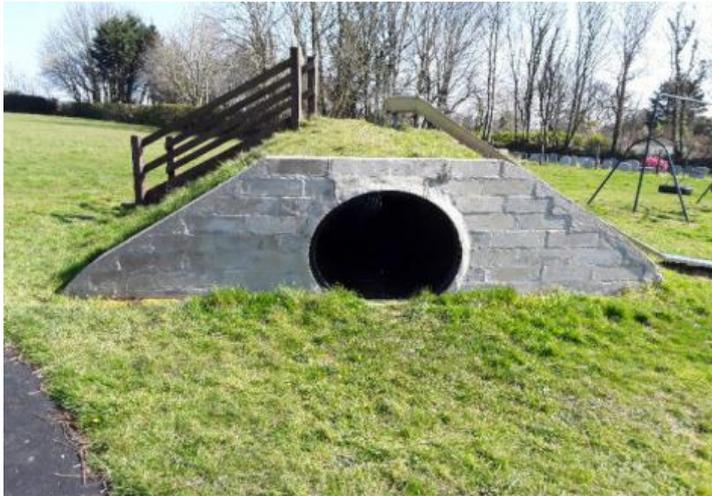
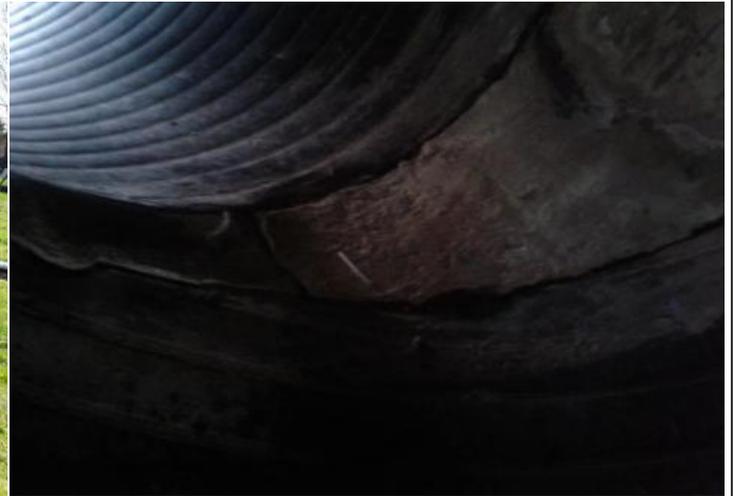
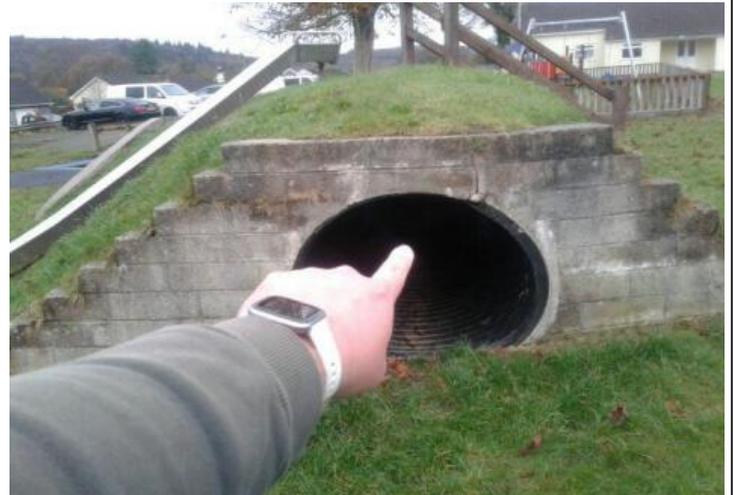
Finding: There is some minor damage to the cement work in the tunnel

Action: Monitor for any further deterioration and repair as required

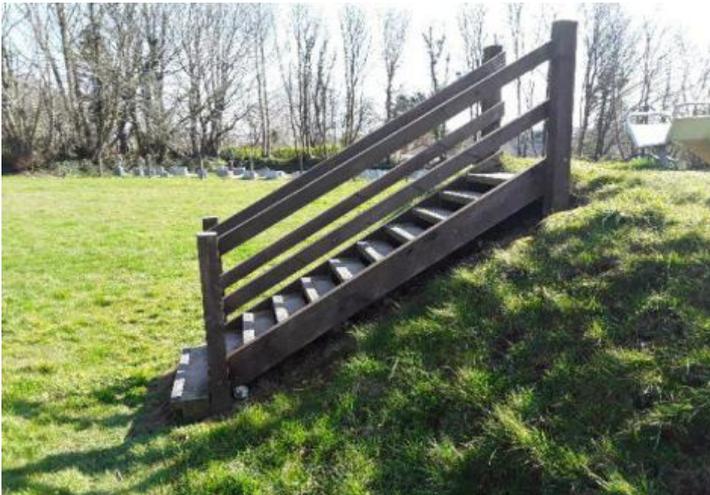
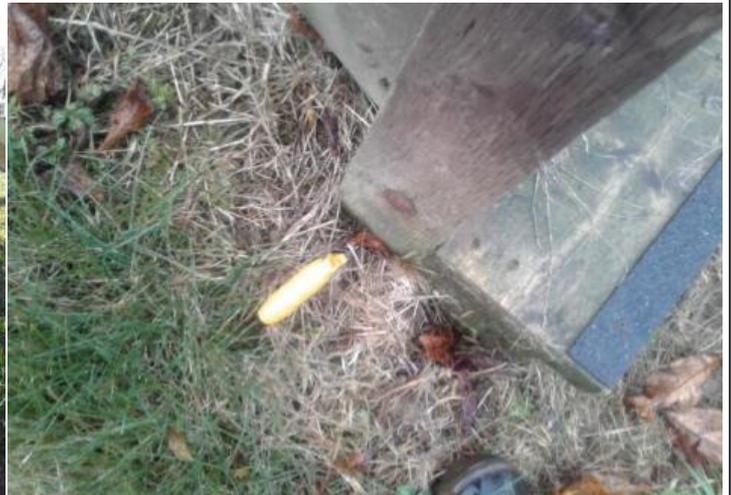
Finding: There is some evidence of rot in the timber

Action: Monitor for any further deterioration and replace as required

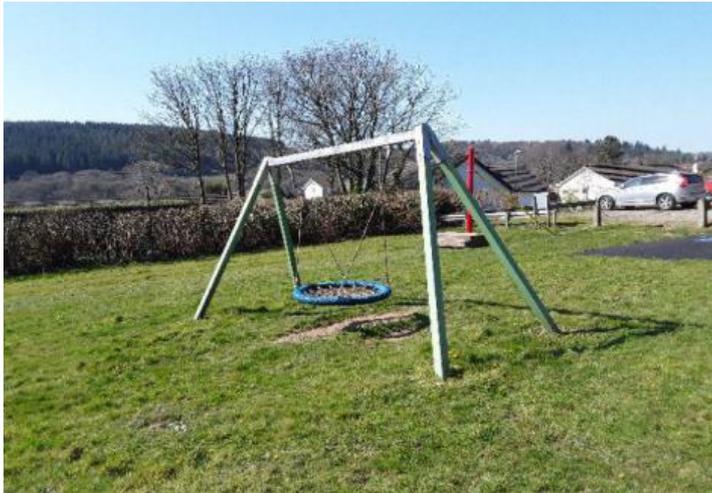
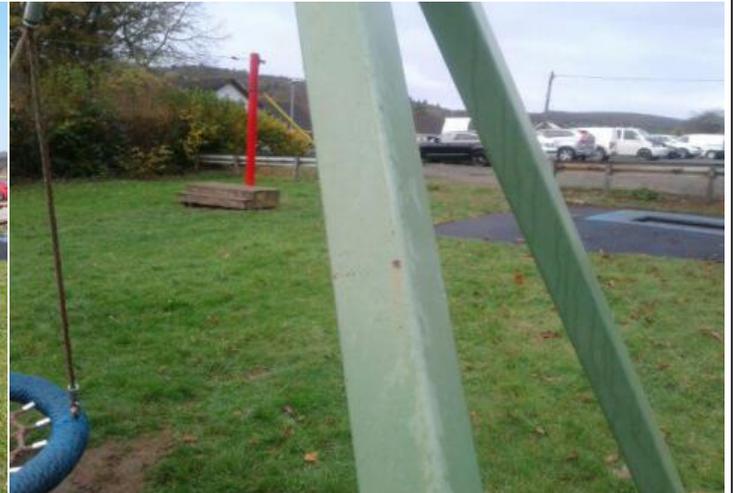
Finding: There is surface corrosion present on the item

Action: Consider treating the item

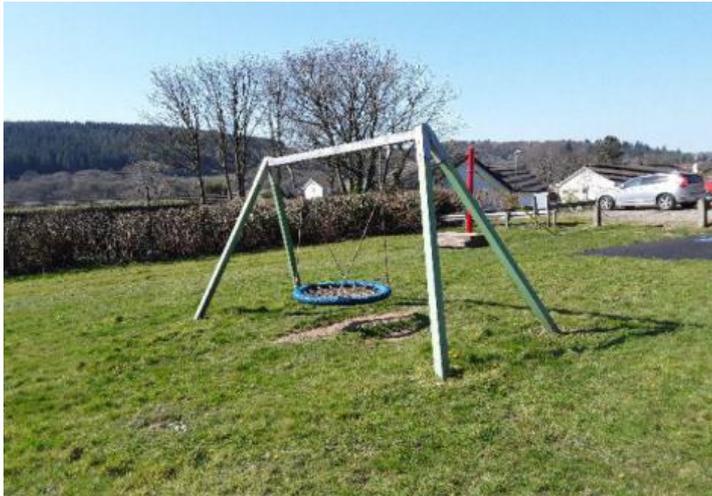
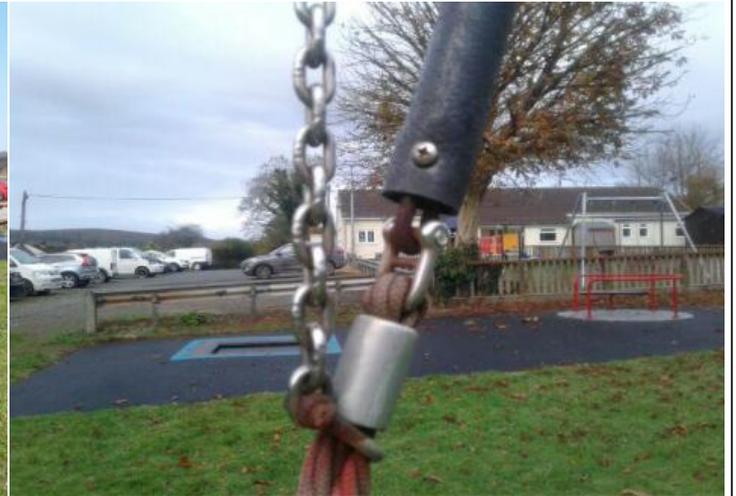
Finding: There is some notable evidence of chain wear

Action: Monitor for any further deterioration and replace when 40% worn

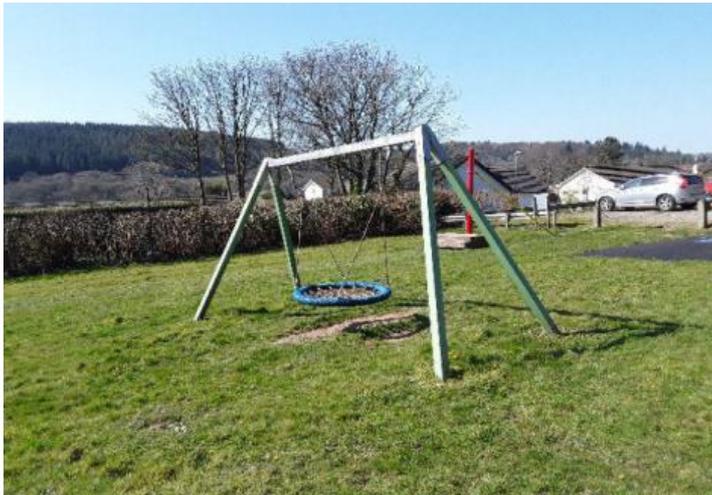
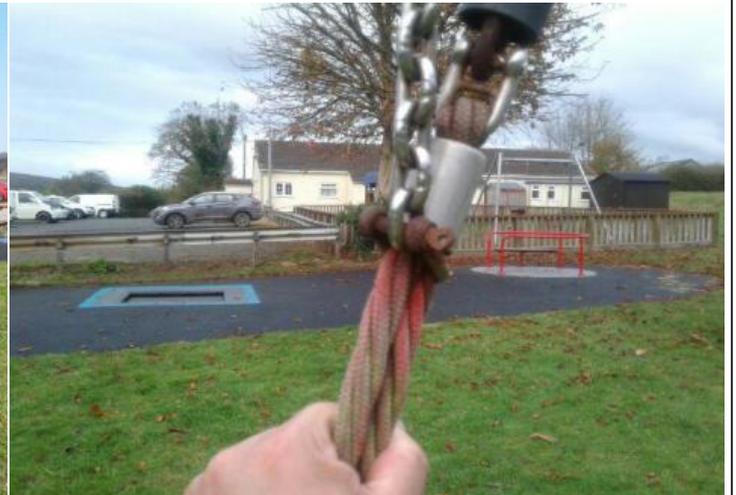
Finding: There is some wear to the shackles.

Action: Monitor for any further deterioration and replace when 40% worn

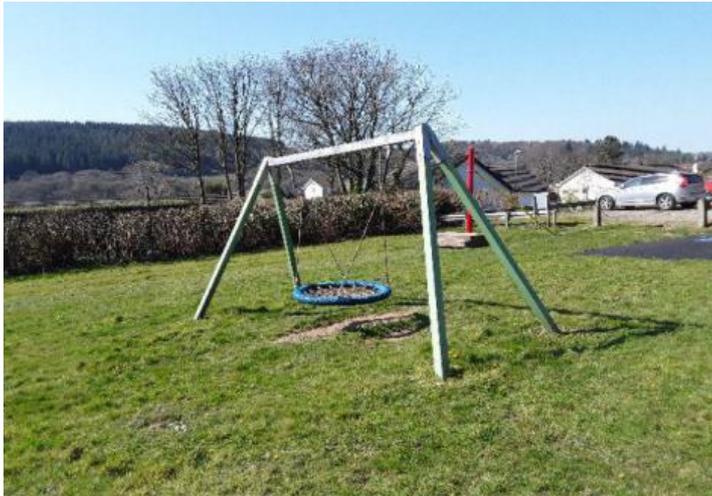
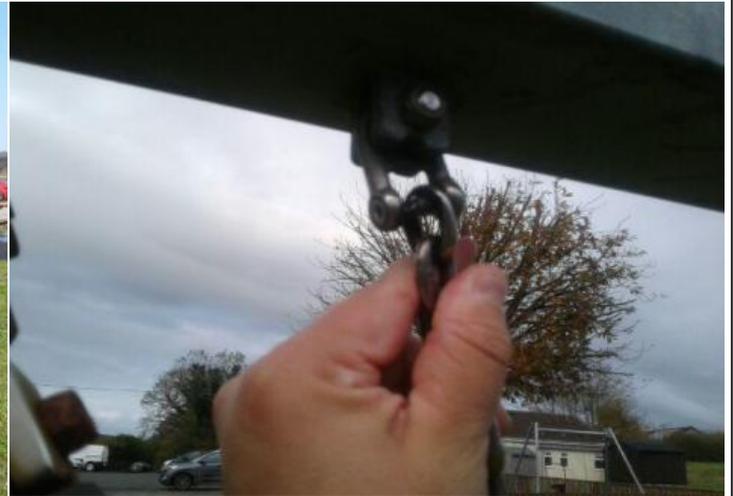
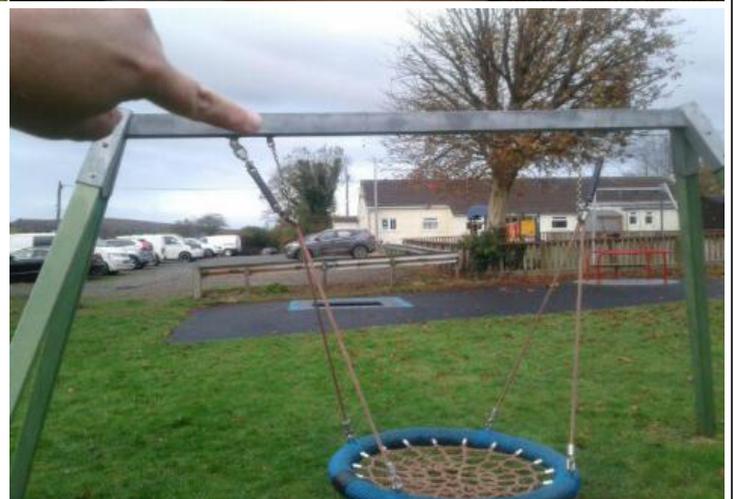
Finding: The shackle links are worn in excess of 40% and require renewing (the shackle is wearing due to the length of the secondary safety chain taking all the weight of the basket instead of the main suspension

Action: Replace worn shackle

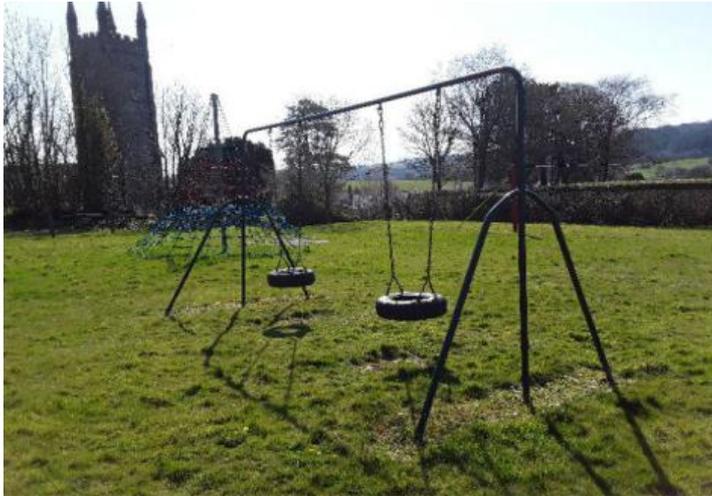
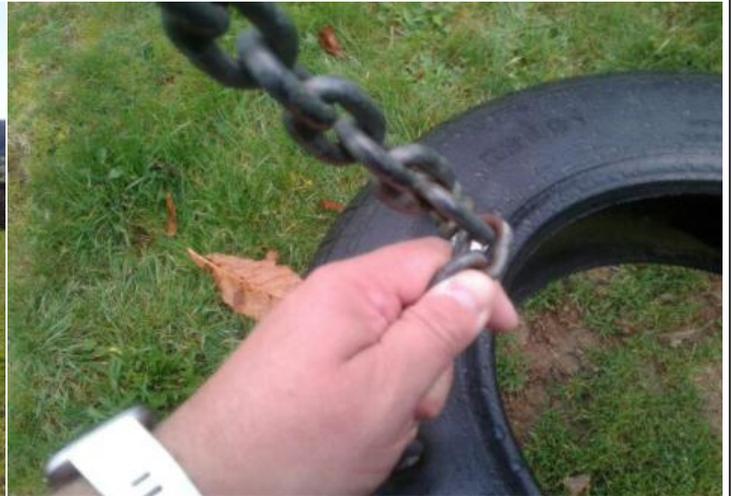
Finding: There is some notable evidence of chain wear

Action: Monitor for any further deterioration and replace when 40% worn

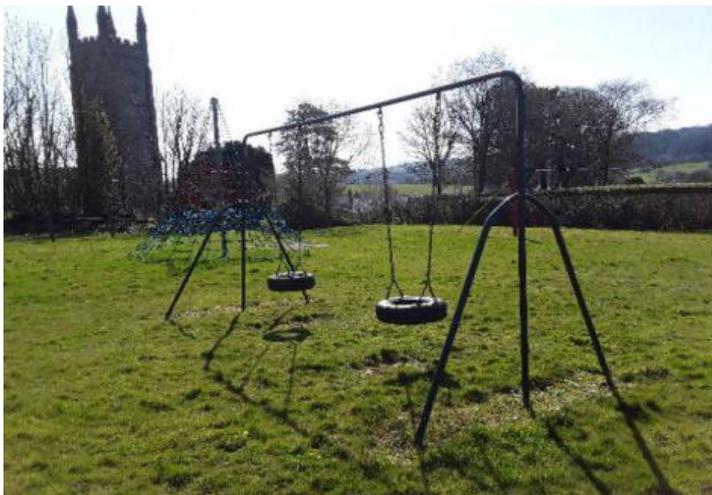
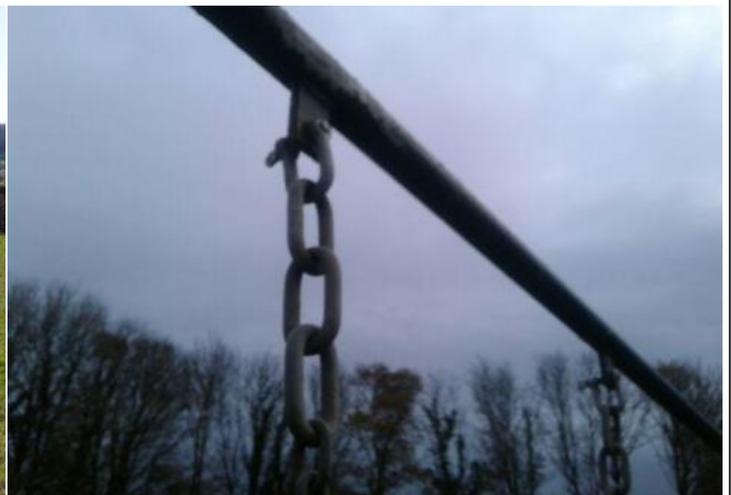
Finding: The bushes are worn or missing

Action: Replace worn or missing bushes

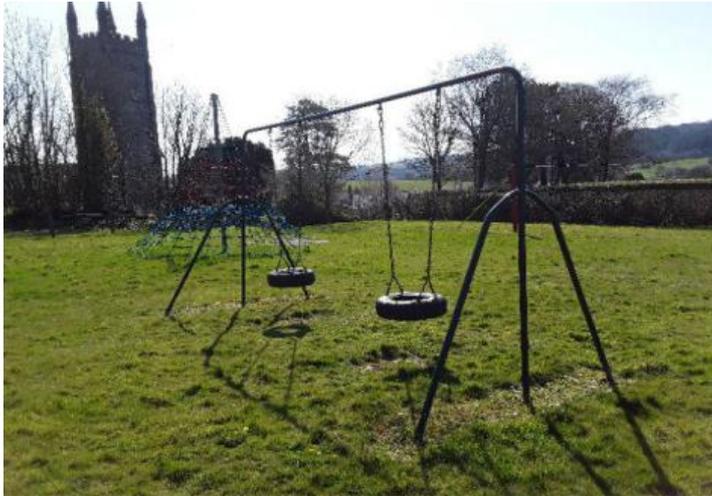
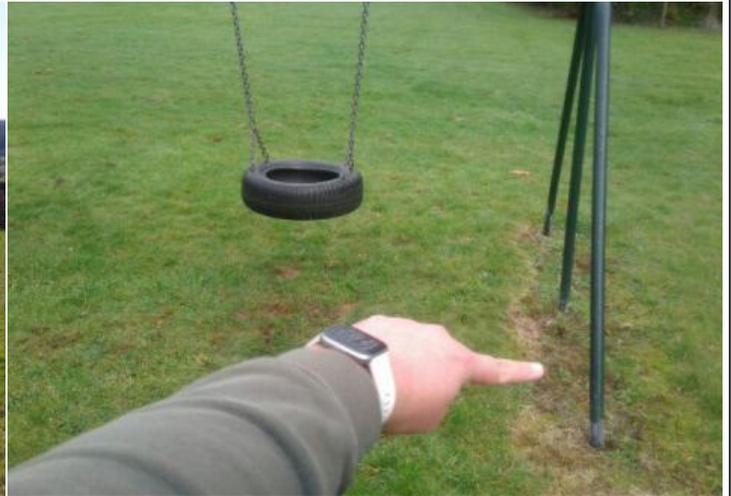
Finding: The surface has eroded and the foundations are exposed

Action: Reinstate surrounding surfaces to cover the foundations

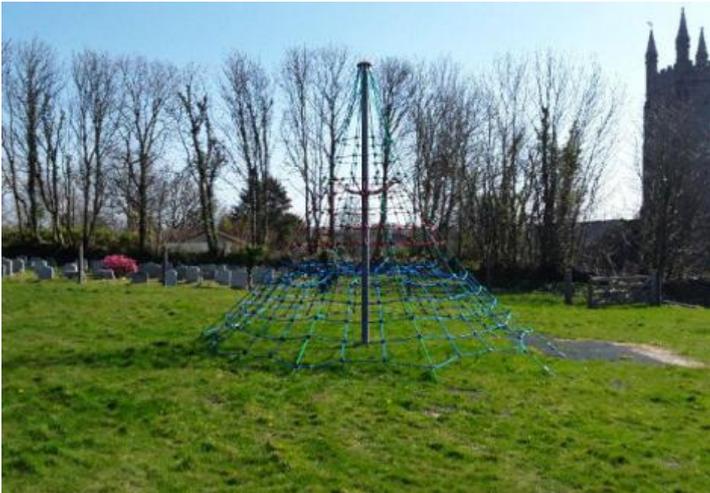
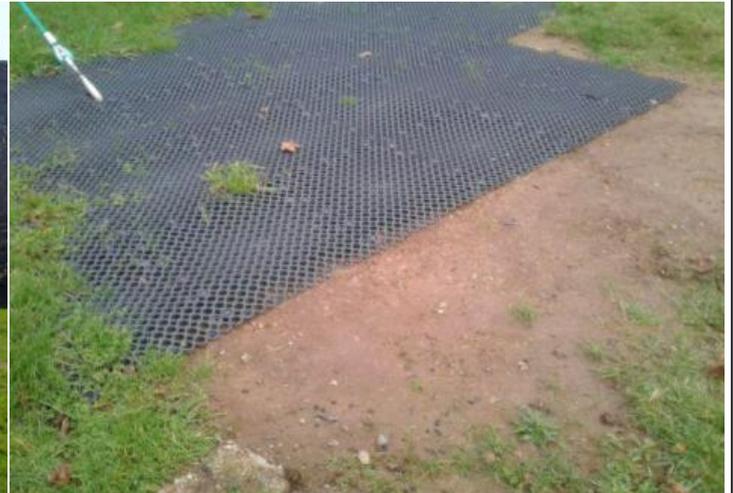
Finding: The edges of the grass mat surface have not been installed in accordance with the API Code of Practice
Action: Tuck in edges of grass mat to remove trip hazards

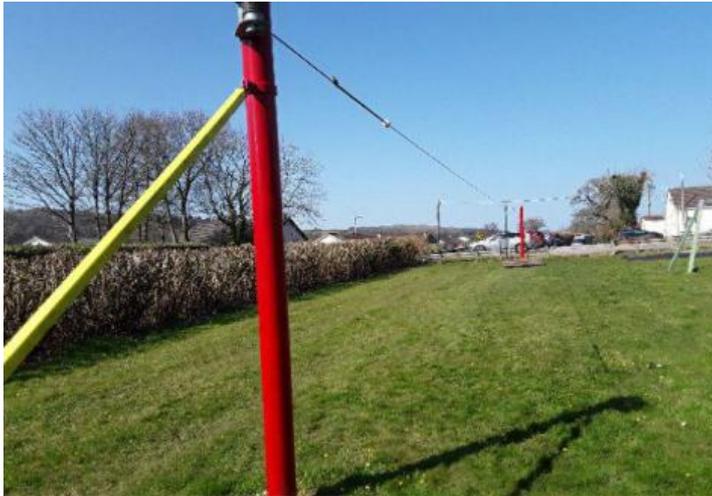
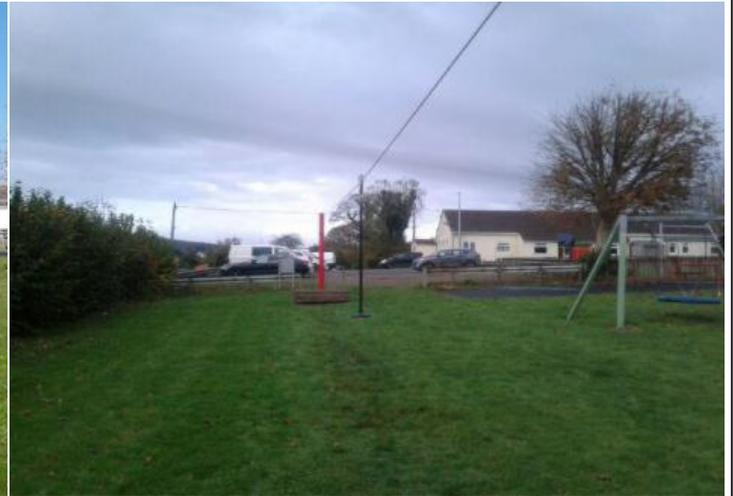
Finding: We have completed a visual inspection of the cable and fixing points from ground level, however it is not possible to fully inspect the cable and fixings without either hiring equipment to gain access or removing the cable and inspecting at ground level. We recommend that the main cable and fixing security is thoroughly inspected at least in accordance with the manufacturers recommendations to check for damage, security or internal rusting, this will help to ensure the continued safe use of the equipment

Action: Inspect in accordance with the manufacturers recommendations

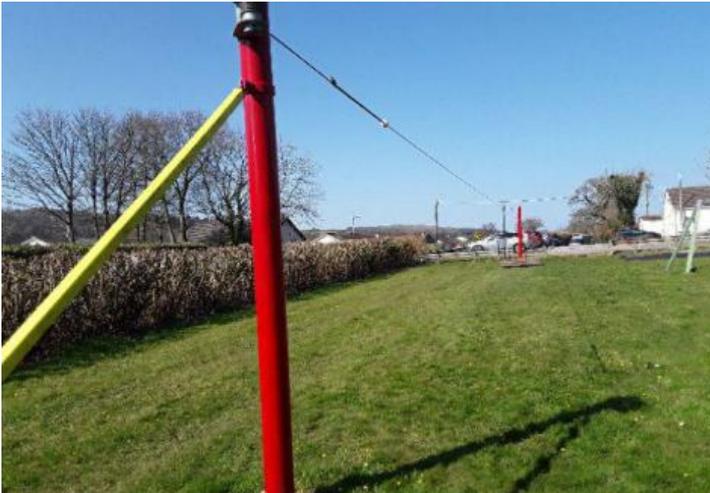
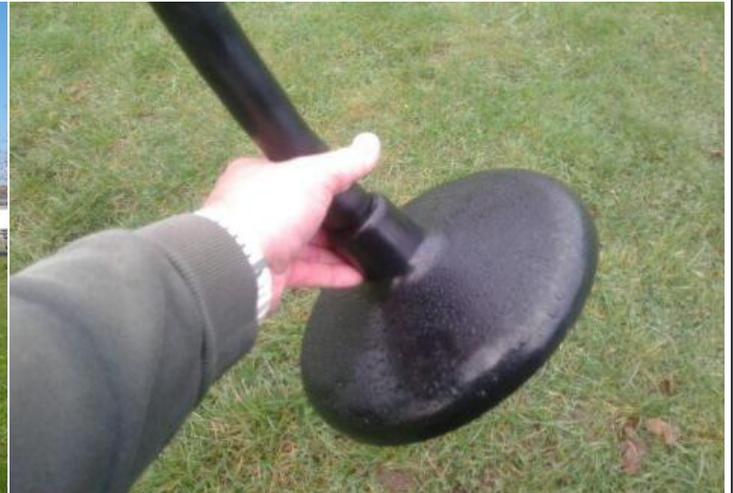
Finding: The seat connection cannot be inspected without dismantling the seat

Action: Dismantle the seat to inspect the seat connection for wear

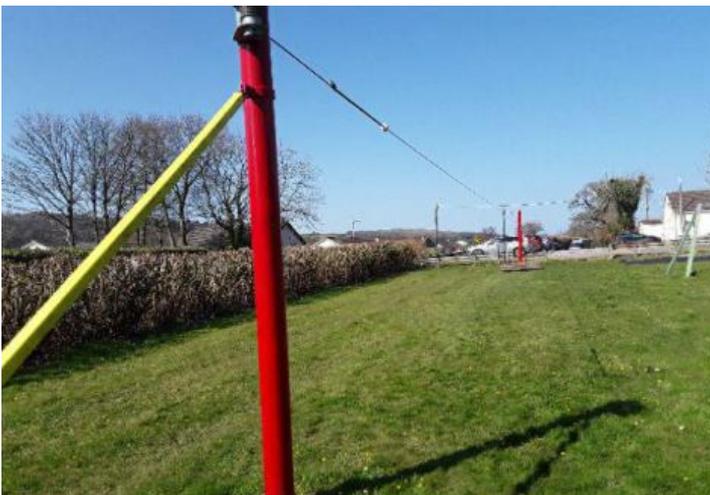
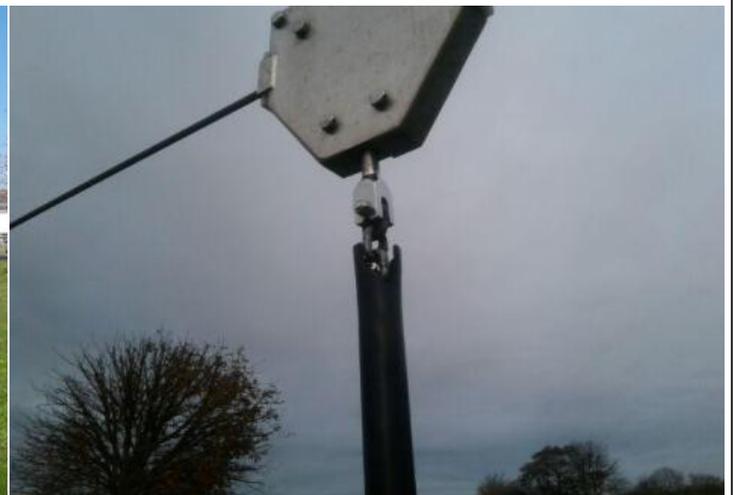
Finding: There is some notable evidence of chain wear

Action: Monitor for any further deterioration and replace when 40% worn
