the **play inspection** company

Operational Inspection

North Hill Parish Council

North Hill Village Hall

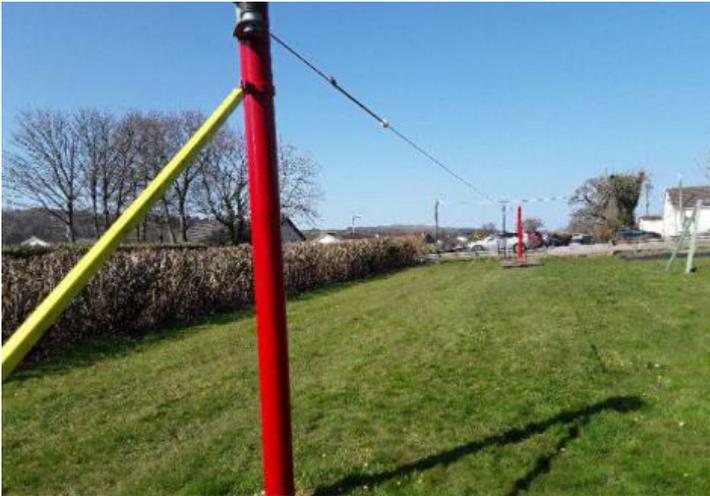
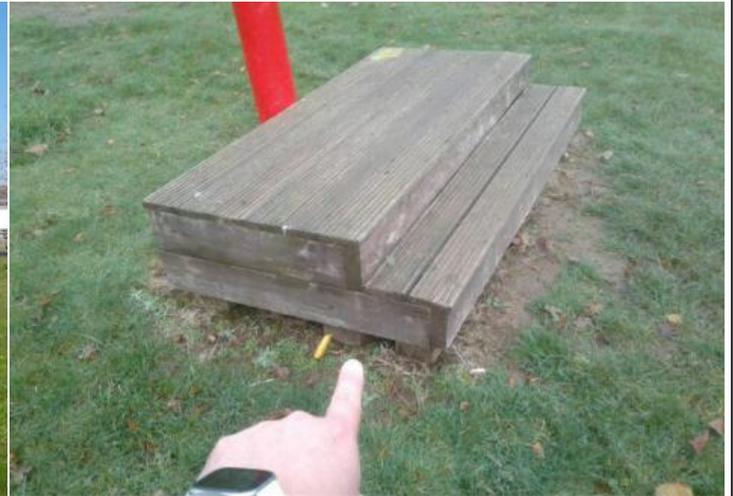
Finding: There is some evidence of rot in the timber

Action: Monitor for any further deterioration and replace as required

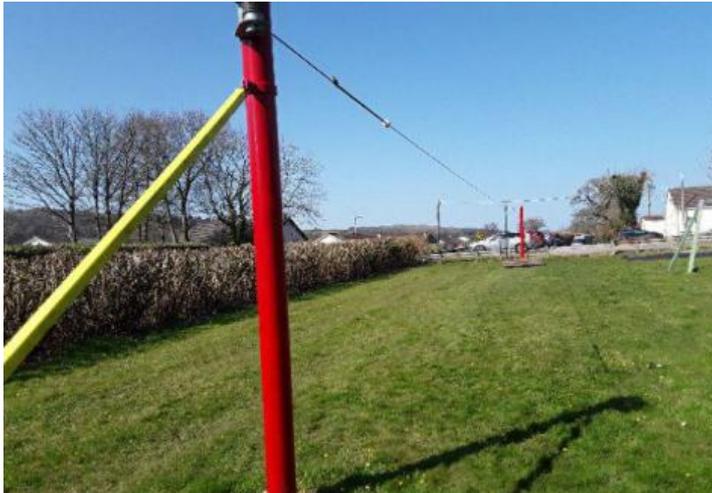
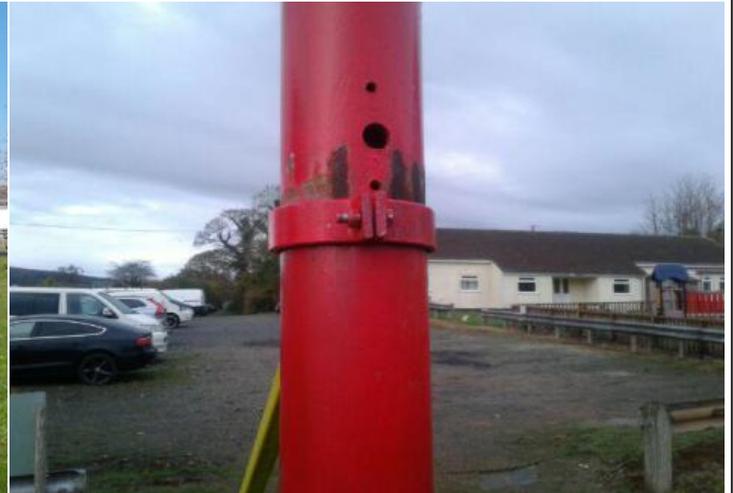
Finding: There is/are several inserts missing	Action: Replace missing inserts
--	--

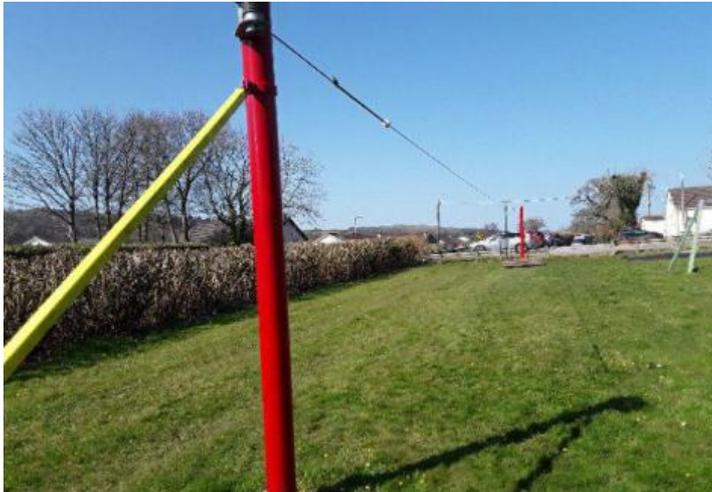
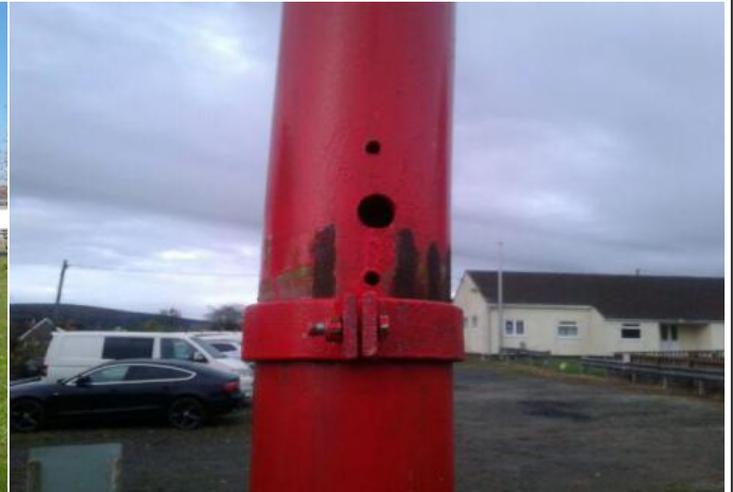
Finding: There is surface corrosion present on the item	Action: Consider treating the item
--	---
