## Operational Inspection

North Hill Parish Council

North Hill Village Hall

Lynher Close, North Hill, Launceston, Cornwall, PL15  
9PQ

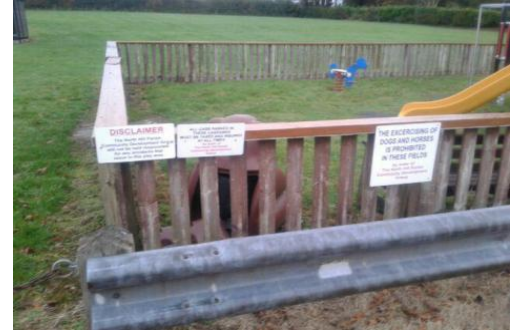
BS EN 1176 Part 7 recommends that signage shall include emergency contact details and contact details of owner / operator for reporting maintenance issues - Provide additional information

There is some damage to the sign - Replace

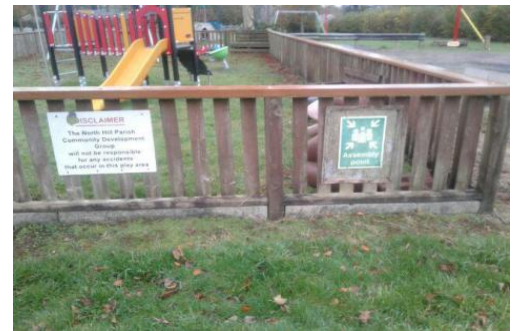
There is some evidence of rot in the timber - Monitor for any further deterioration and replace as required

There is/are screw cap covers missing or damaged on the item - Monitor and replace if required

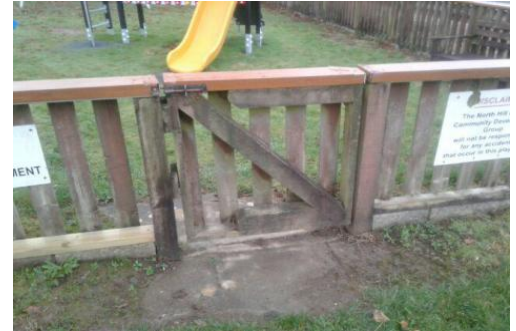
There is sharp sections of plastic on the fence next to the gate - Repair or replace

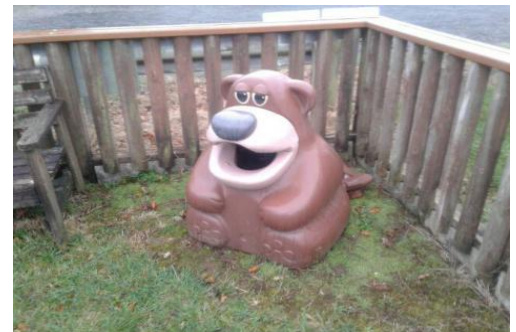
The lid or door of the litter bin is not secured - Ensure the lid or door is kept locked

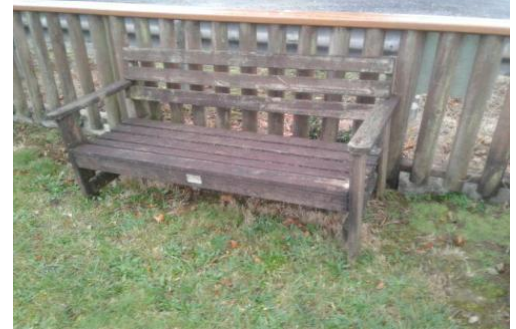
The bench is not securely fixed to the surface and there is some possibility of the item tipping or rolling over - Secure the bench to the ground

There is some evidence of rot in the timber - Monitor for any further deterioration and replace as required

There is some strimmer / machinery damage apparent on the posts, this can penetrate the preservative applied to the timber and accelerate the rotting process - Monitor for any deterioration (rot) and replace as required

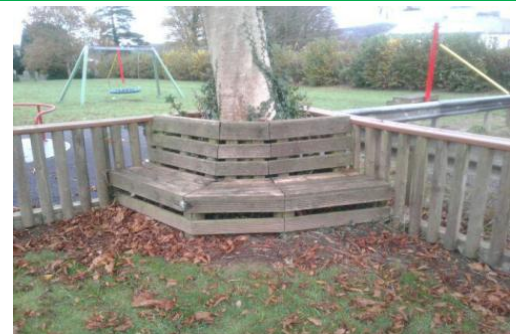
There is algae or moss on the surface of the equipment - Clean and treat appropriately

There are areas or parts of the timber on the structure that have rotted - Replace all affected timbers

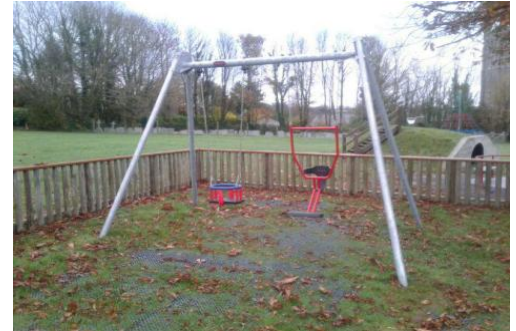
The surface has subsided in some areas - Monitor for any further deterioration and repair as required

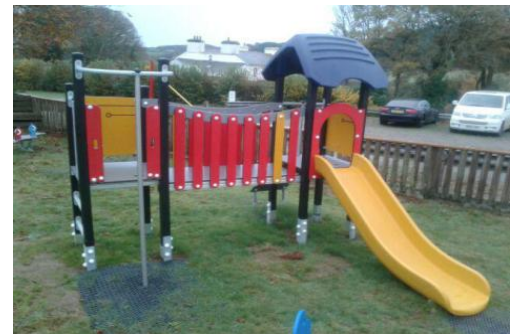
The surface has eroded in some areas - Reinstate the surface

The edges of the grass mat surface have not been installed in accordance with the API Code of Practice - Tuck in edges of grass mat to remove trip hazards

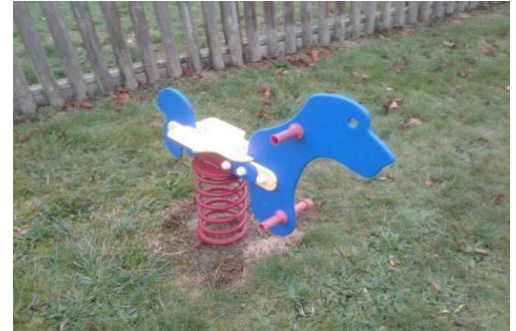
The end caps are missing on the Handgrips/Footrests -  
Replace missing end caps

The item has been severely damaged - Repair or replace  
the item

The surface has eroded and the foundations are exposed -  
Reinstate surrounding surfaces to cover the foundations

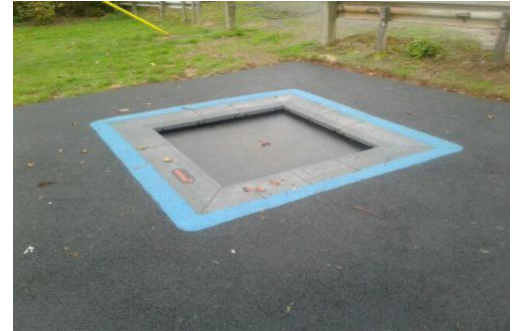
On site visits it is not possible to test the ground clearance of the Bouncing Facility bed as specified in BS EN 1176; ensure that the clearance between the Bouncing Facility Bed and the ground underneath is in accordance with the manufacturers recommendations (it was not possible to measure the depth at time of inspection measured unloaded due to the design of the bed of the bouncing facility). - Refer to the manufacturers recommendations

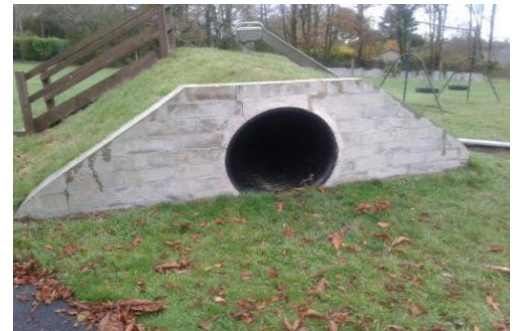
This design / configuration of tunnel mound is well established and has been successfully included in large quantities of playgrounds throughout the UK. Whilst the design does not fully meet the requirements of BS EN 1176 with regards to falls in excess of 600mm over the edge of the tunnel to the surface below, it has been risk assessed as fit for purpose and no changes are recommended to the design - Monitor - No remedial work recommended

There are cracks in the wall - Monitor for any further deterioration and repair as required

There is some minor damage to the cement work in the tunnel - Monitor for any further deterioration and repair as required

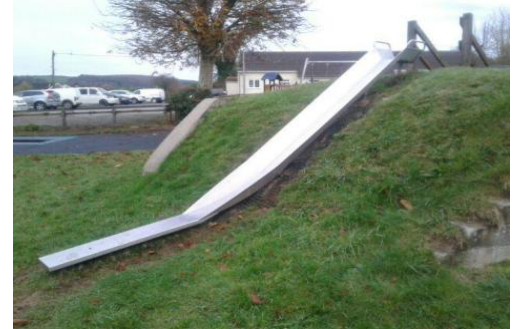
Fixing Pins have been installed in the impact areas of the grass mats - Remove pins from impact areas

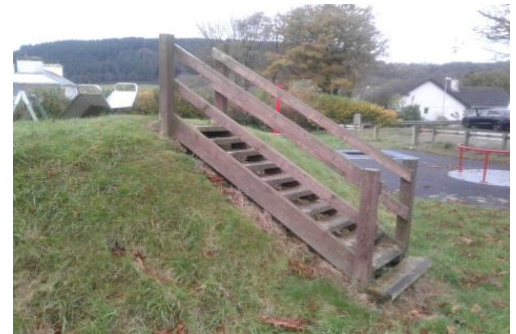
There is algae or moss on the surface of the equipment - Clean and treat appropriately

There is some evidence of rot in the timber - Monitor for any further deterioration and replace as required

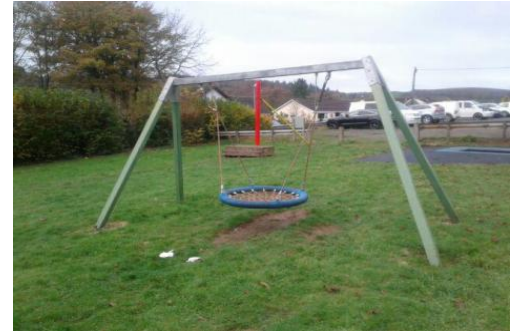
There is surface corrosion present on the item - Consider treating the item

There is some notable evidence of chain wear - Monitor for any further deterioration and replace when 40% worn

The shackle links are worn in excess of 40% and require renewing ( the shackle is wearing due to the length of the secondary safety chain taking all the weight of the basket instead of the main suspension - Replace worn shackle

There is some wear to the shackles. - Monitor for any further deterioration and replace when 40% worn

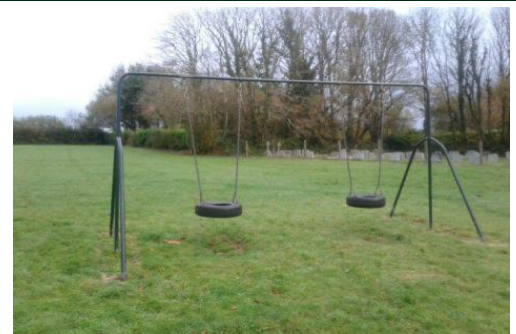
There is some notable evidence of chain wear - Monitor for any further deterioration and replace when 40% worn

The surface has eroded and the foundations are exposed - Reinstate surrounding surfaces to cover the foundations

The bushes are worn or missing - Replace worn or missing bushes

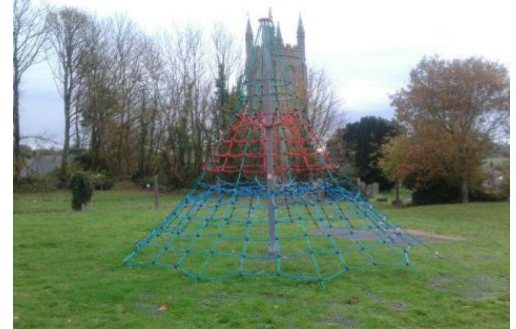
The connecting or tensioning ropes on the net are not tensioned correctly - Tighten tensioners equally to provide stability to the net structure

The edges of the grass mat surface have not been installed in accordance with the API Code of Practice - Tuck in edges of grass mat to remove trip hazards

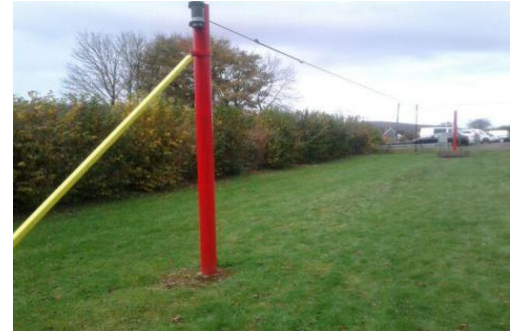
We have completed a visual inspection of the cable and fixing points from ground level, however it is not possible to fully inspect the cable and fixings without either hiring equipment to gain access or removing the cable and inspecting at ground level. We recommend that the main cable and fixing security is thoroughly inspected at least in accordance with the manufacturers recommendations to check for damage, security or internal rusting, this will help to ensure the continued safe use of the equipment - Inspect in accordance with the manufacturers recommendations

There is some notable evidence of chain wear - Monitor for any further deterioration and replace when 40% worn

There is surface corrosion present on the item - Consider treating the item

The seat connection cannot be inspected without dismantling the seat - Dismantle the seat to inspect the seat connection for wear

There is some evidence of rot in the timber - Monitor for any further deterioration and replace as required

There is/are several inserts missing - Replace missing inserts

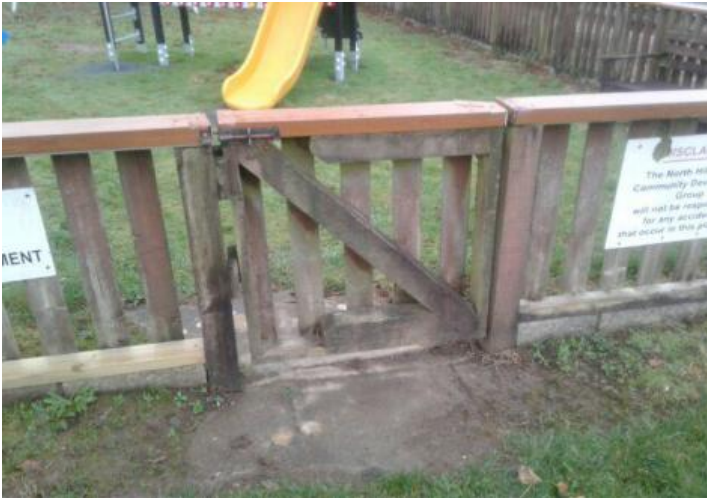
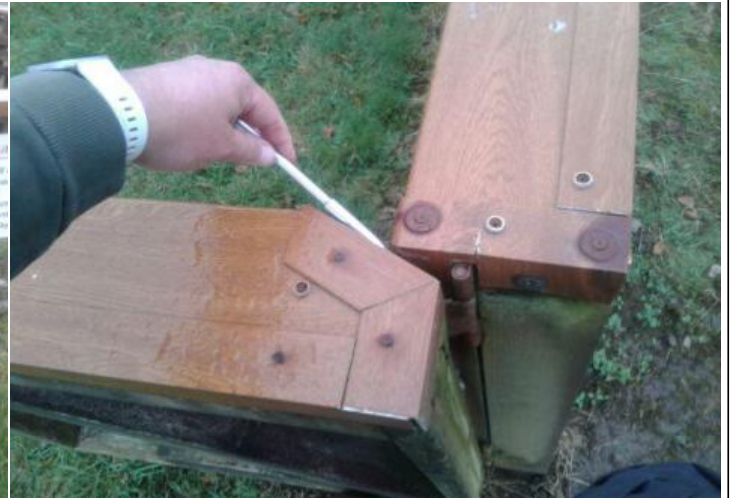
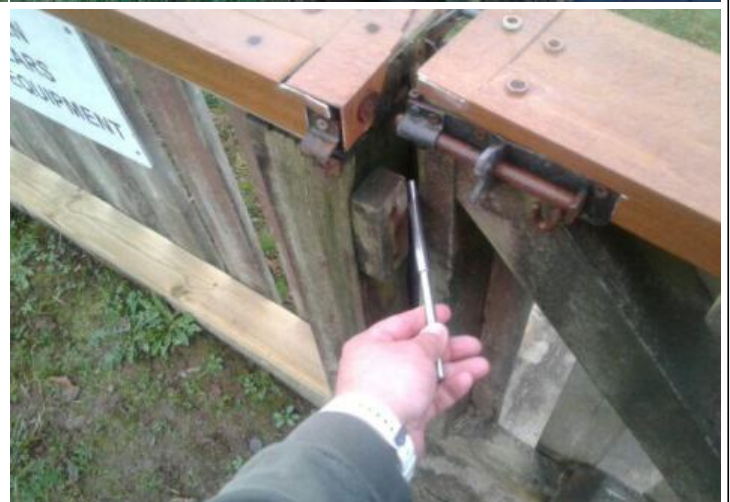
**Finding:** There are openings that are less than 12mm that could trap or crush fingers

**Action:** Where possible a 12mm gap should be maintained on both sides or between the gate leaves

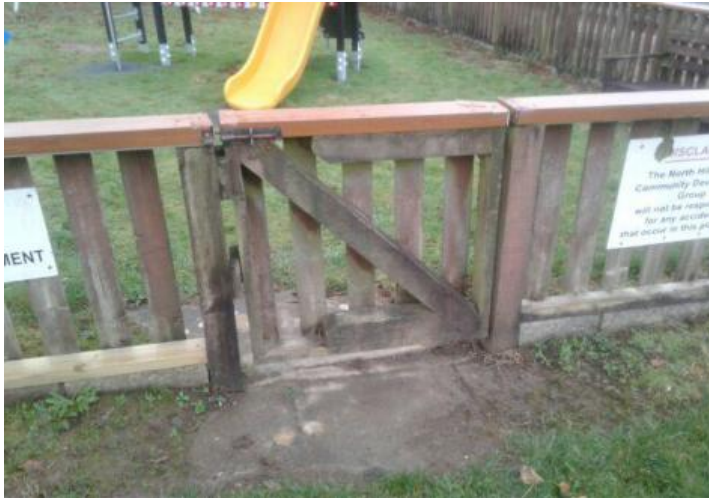
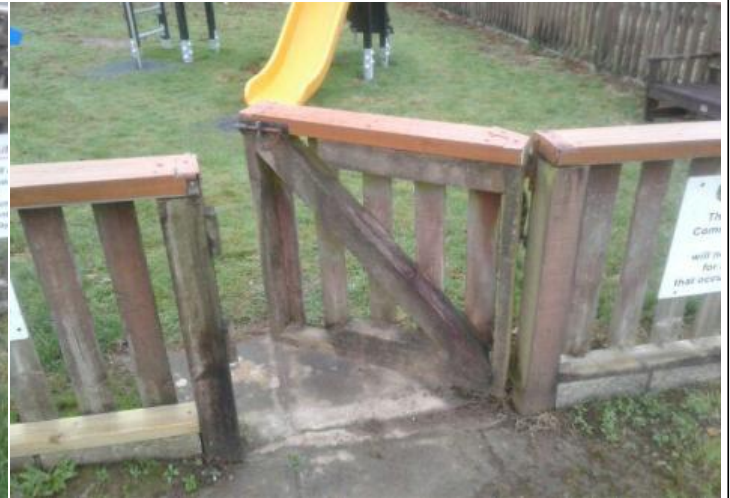
**Finding:** The gate is not operating correctly

**Action:** Take effective action to ensure the gate closes between 4 and 8 seconds

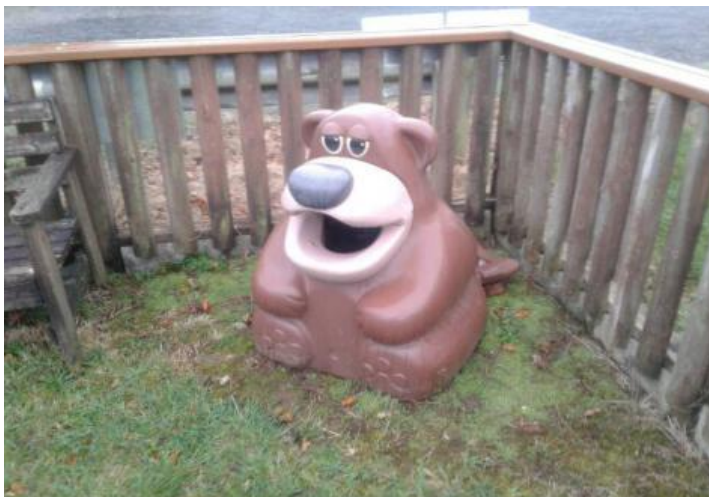
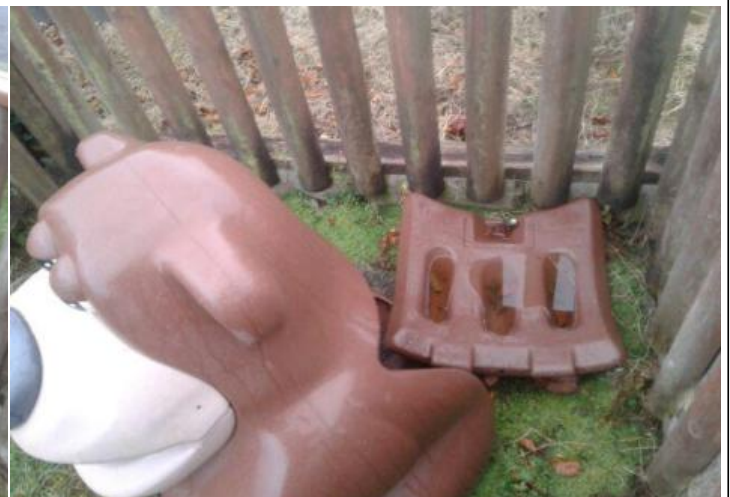
**Finding:** The lid or door of the litter bin is not secured

**Action:** Ensure the lid or door is kept locked

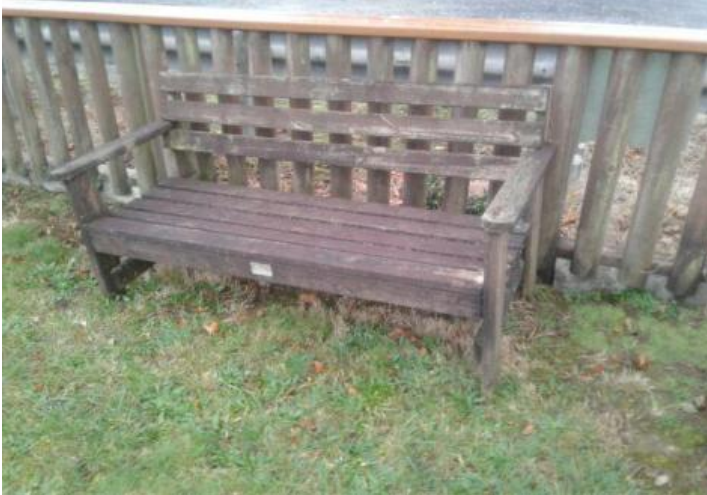
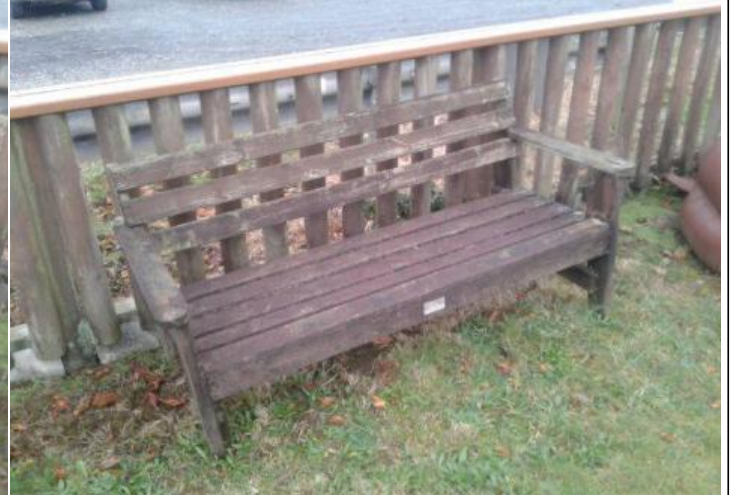
**Finding:** The bench is not securely fixed to the surface and there is some possibility of the item tipping or rolling over

**Action:** Secure the bench to the ground

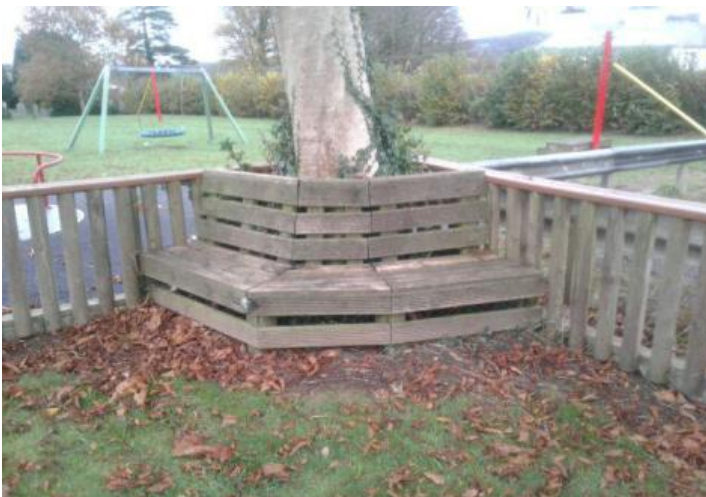
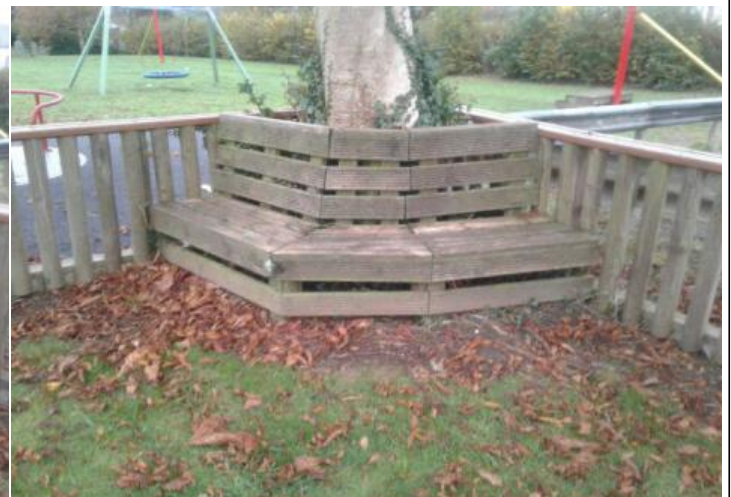
**Finding:** There is algae or moss on the surface of the equipment

**Action:** Clean and treat appropriately

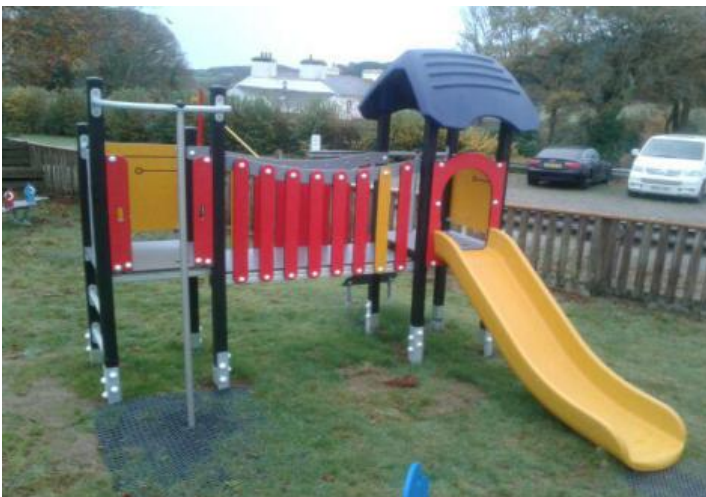
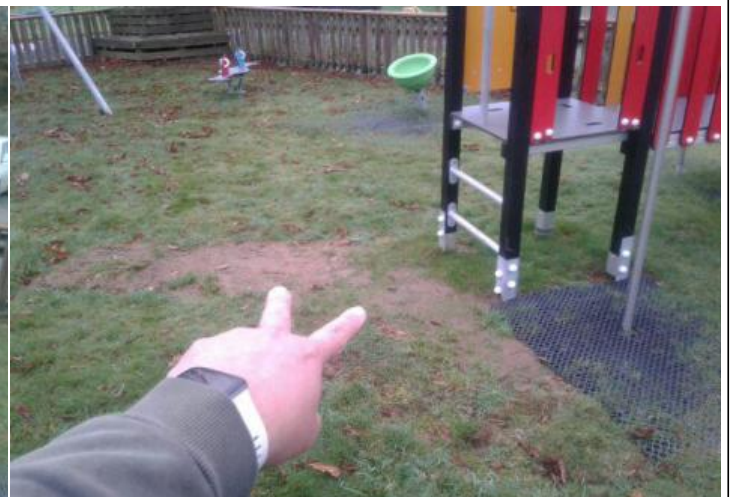
**Finding:** The surface has eroded in some areas

**Action:** Reinstate the surface

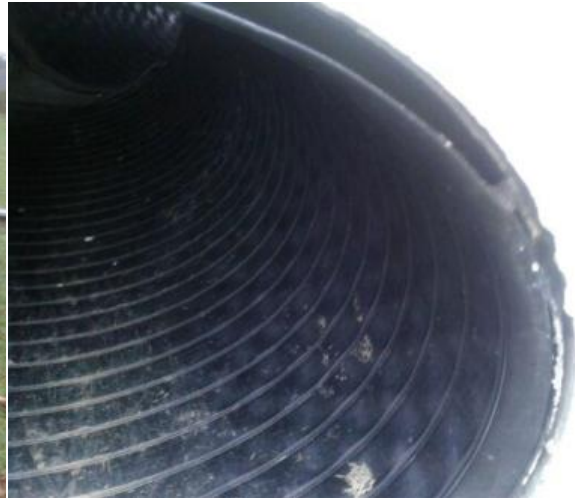
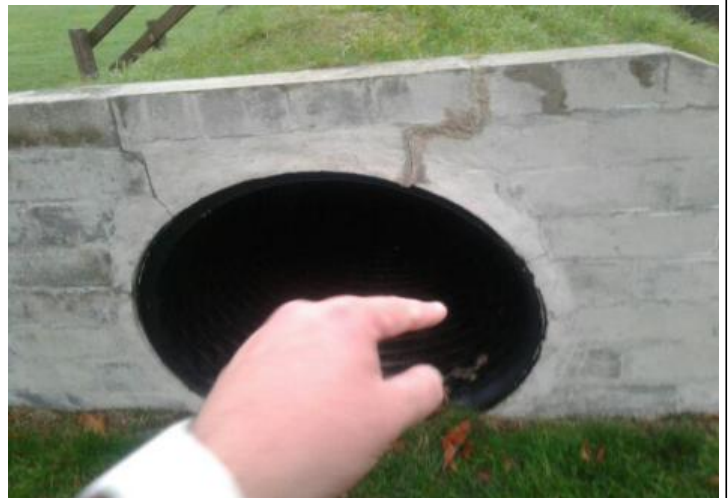
**Finding:** There are some rough edges of the plastic and concrete at the entrance on the tunnel

**Action:** Remove any sharp edges

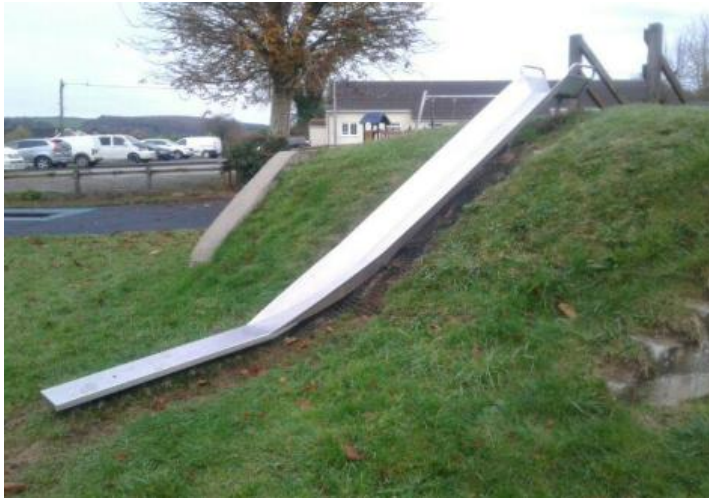
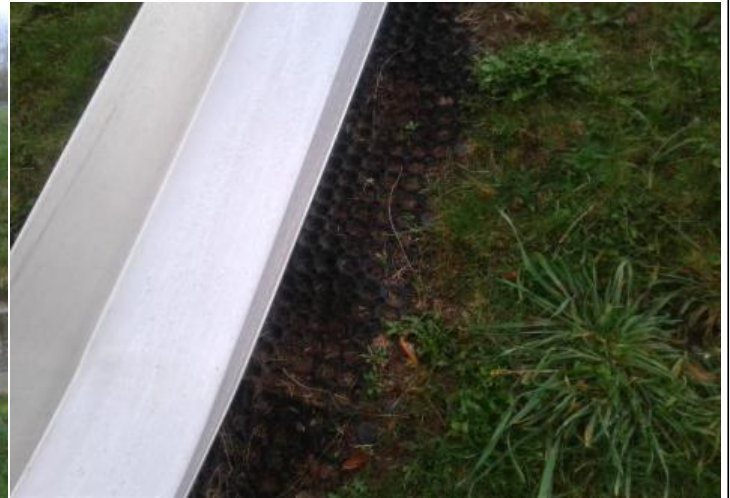
**Finding:** Fixing Pins have been installed in the impact areas of the grass mats **Action:** Remove pins from impact areas

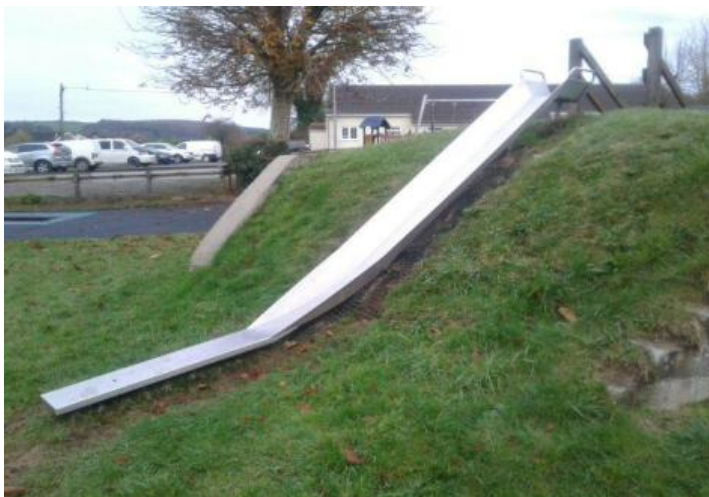
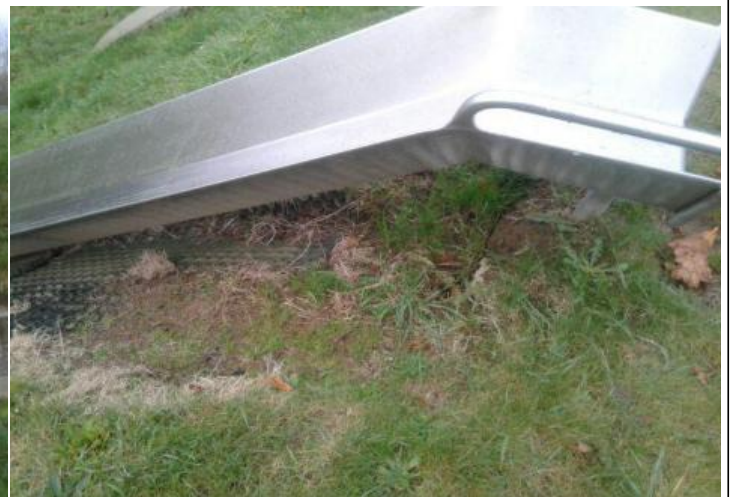
**Item:** Other - Embankment Slide  
**Manufacturer:** Not Identified

**Finding:** The surface has eroded in some areas **Action:** Reinstate the surface

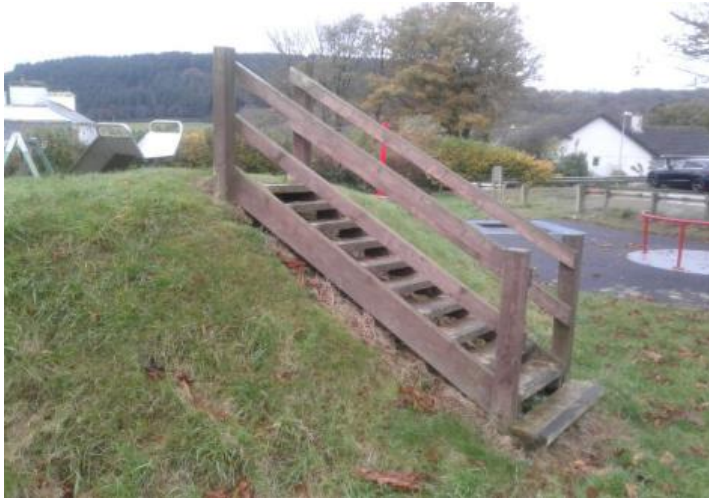
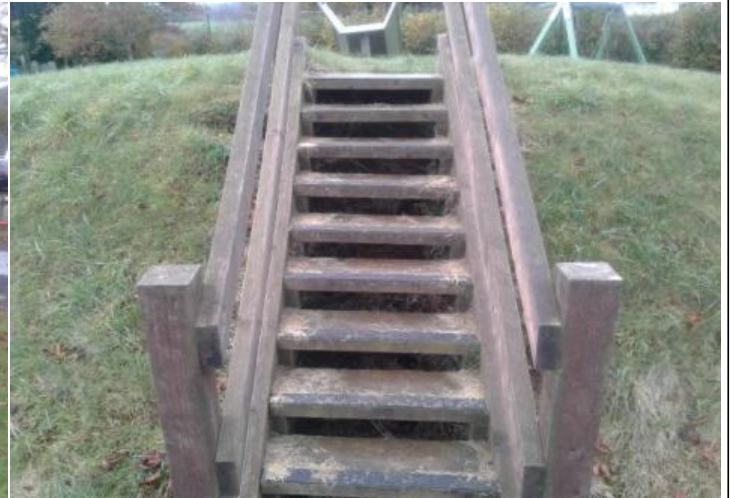
**Item:** Ancillary Items - Steps  
**Manufacturer:** Not Identified

**Finding:** There is algae or moss on the surface of the equipment

**Action:** Clean and treat appropriately

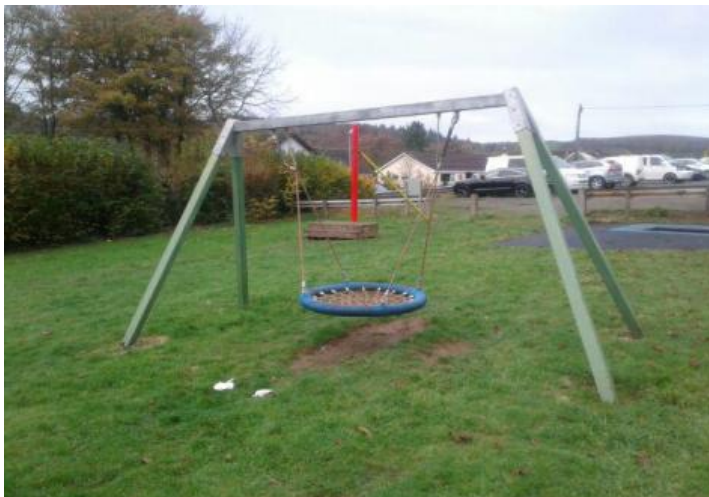
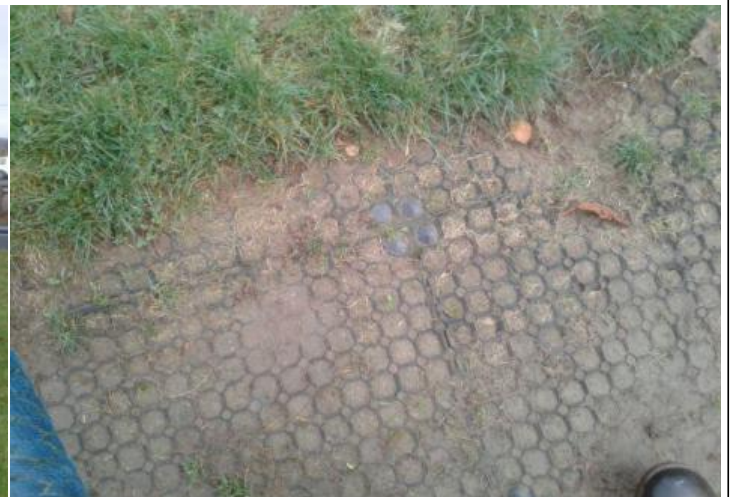
**Item:** Swings - Basket Swing - Type 1  
**Manufacturer:** Not Identified

**Finding:** Fixing Pins have been installed in the impact areas of the grass mats

**Action:** Remove pins from impact areas

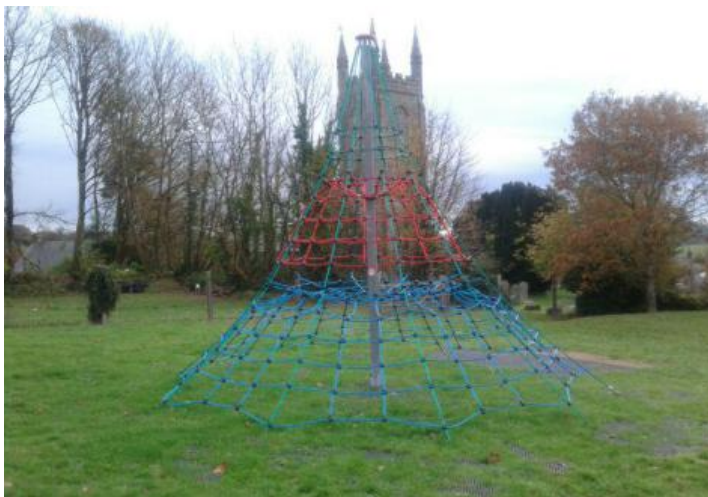
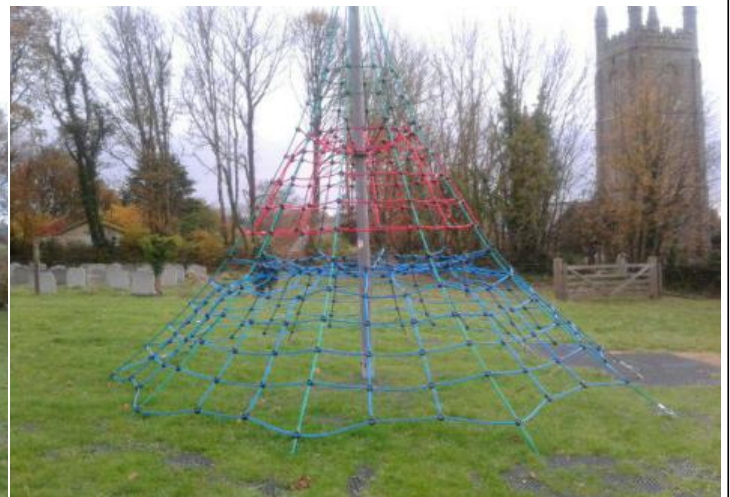
**Item:** Activity Equipment - Space Net  
**Manufacturer:** Kompan Ltd

**Finding:** The connecting or tensioning ropes on the net are not tensioned correctly

**Action:** Tighten tensioners equally to provide stability to the net structure

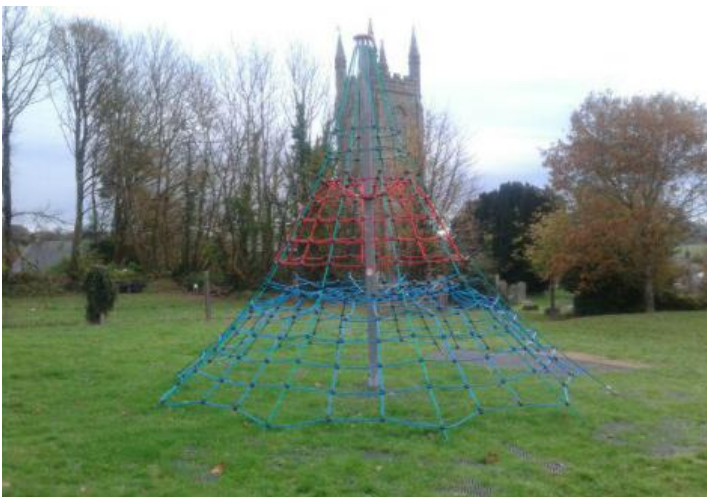
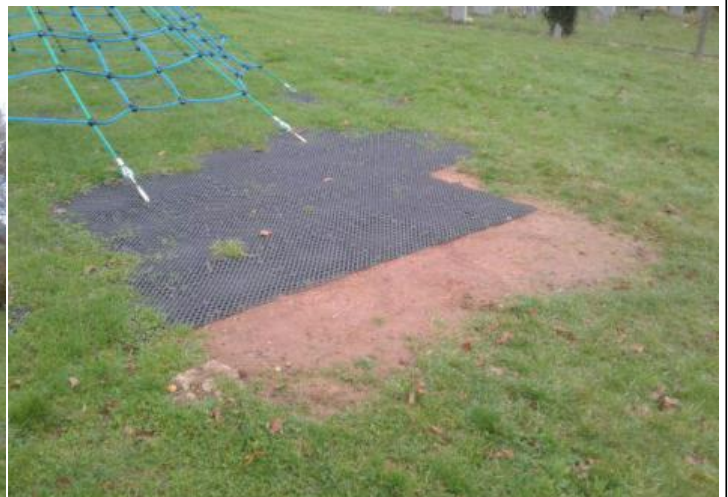
**Item:** Activity Equipment - Space Net  
**Manufacturer:** Kompan Ltd

**Finding:** The surface has eroded in some areas  
**Action:** Reinstate the surface

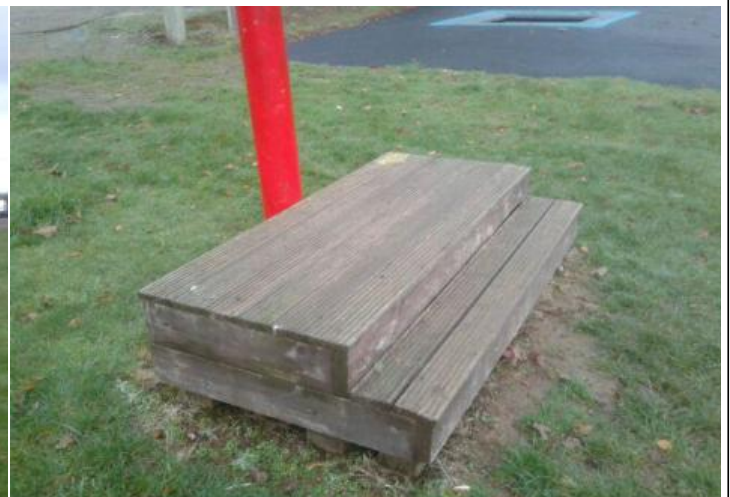
**Item:** Other - Cable Runway  
**Manufacturer:** Not Identified

**Finding:** There is algae or moss on the surface of the equipment

**Action:** Clean and treat appropriately
