the **play inspection** company

Operational Inspection

North Hill Parish Council

North Hill Village Hall

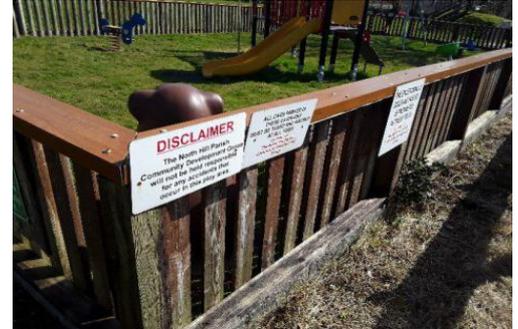
BS EN 1176 Part 7 recommends that signage shall include emergency contact details and contact details of owner / operator for reporting maintenance issues - Provide additional information

There is some damage to the sign - Replace

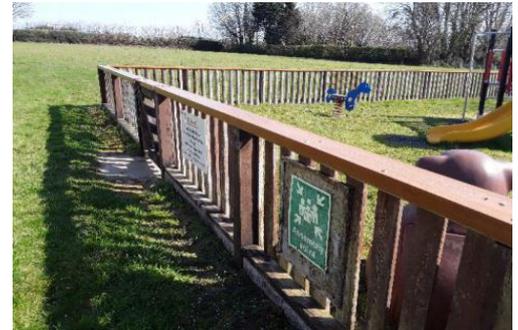
There is some evidence of rot in the timber - Monitor for any further deterioration and replace as required

There is/are screw cap covers missing or damaged on the item - Monitor and replace if required

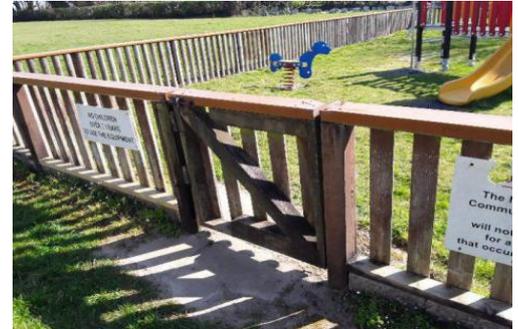
There is sharp sections of plastic on the fence next to the gate - Repair or replace

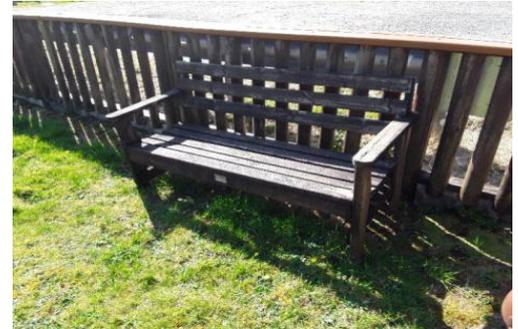
There is some strimmer / machinery damage apparent on the posts, this can penetrate the preservative applied to the timber and accelerate the rotting process - Monitor for any deterioration (rot) and replace as required

There is some evidence of rot in the timber - Monitor for any further deterioration and replace as required

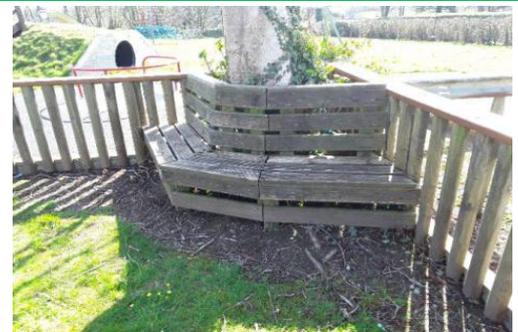
There are areas or parts of the timber on the structure that have rotted - Replace all affected timbers

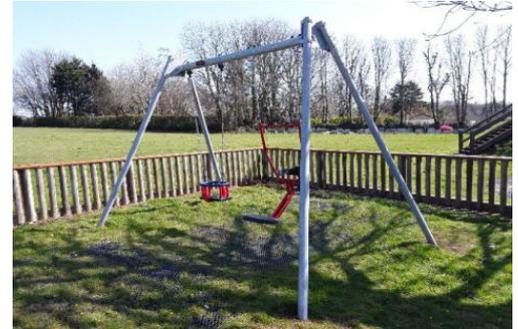
The surface has subsided in some areas - Monitor for any further deterioration and repair as required

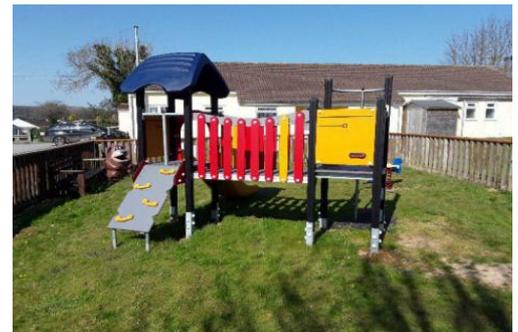
The edges of the grass mat surface have not been installed in accordance with the API Code of Practice - Tuck in edges of grass mat to remove trip hazards

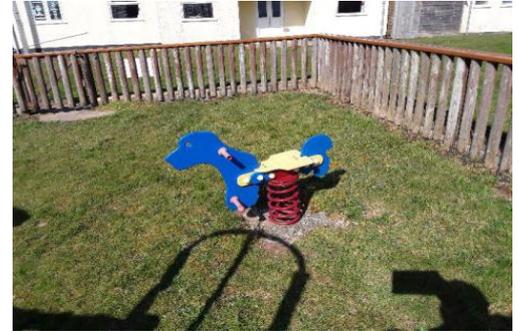
The end caps are missing on the Handgrips/Footrests -
 Replace missing end caps

The item has been severely damaged - Repair or replace
 the item

The surface has eroded and the foundations are exposed -
 Reinstate surrounding surfaces to cover the foundations

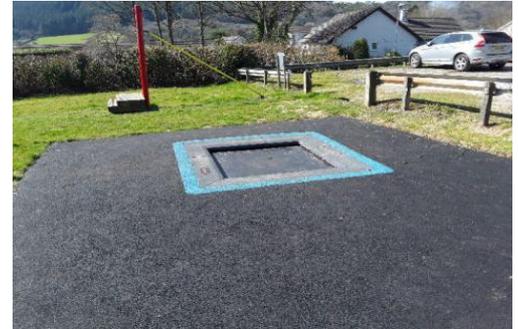
On site visits it is not possible to test the ground clearance of the Bouncing Facility bed as specified in BS EN 1176; ensure that the clearance between the Bouncing Facility Bed and the ground underneath is in accordance with the manufacturers recommendations (it was not possible to measure the depth at time of inspection measured unloaded due to the design of the bed of the bouncing facility). - Refer to the manufacturers recommendations

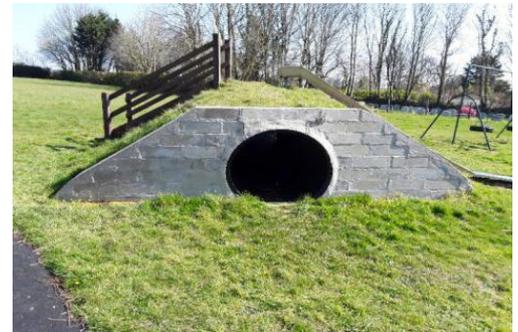
This design / configuration of tunnel mound is well established and has been successfully included in large quantities of playgrounds throughout the UK. Whilst the design does not fully meet the requirements of BS EN 1176 with regards to falls in excess of 600mm over the edge of the tunnel to the surface below, it has been risk assessed as fit for purpose and no changes are recommended to the design - Monitor - No remedial work recommended

There are cracks in the wall - Monitor for any further deterioration and repair as required

There is some minor damage to the cement work in the tunnel - Monitor for any further deterioration and repair as required

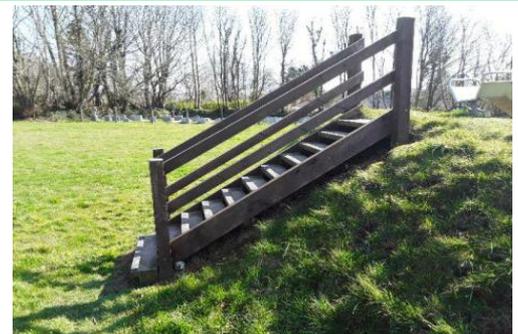
There is some evidence of rot in the timber - Monitor for any further deterioration and replace as required

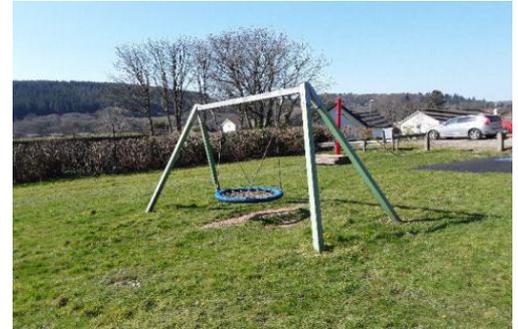
There is surface corrosion present on the item - Consider treating the item

There is some notable evidence of chain wear - Monitor for any further deterioration and replace when 40% worn

There is some wear to the shackles. - Monitor for any further deterioration and replace when 40% worn

The shackle links are worn in excess of 40% and require renewing (the shackle is wearing due to the length of the secondary safety chain taking all the weight of the basket instead of the main suspension - Replace worn shackle

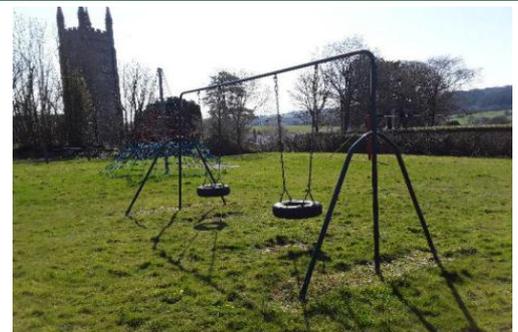
There is some notable evidence of chain wear - Monitor for any further deterioration and replace when 40% worn

The bushes are worn or missing - Replace worn or missing bushes

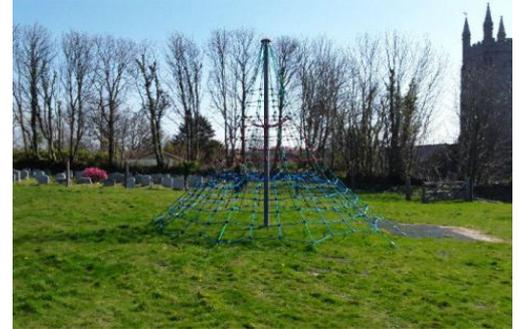
The connecting or tensioning ropes on the net are not tensioned correctly - Tighten tensioners equally to provide stability to the net structure

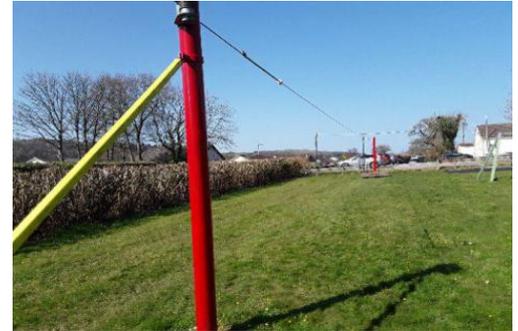
We have completed a visual inspection of the cable and fixing points from ground level, however it is not possible to fully inspect the cable and fixings without either hiring equipment to gain access or removing the cable and inspecting at ground level. We recommend that the main cable and fixing security is thoroughly inspected at least in accordance with the manufacturers recommendations to check for damage, security or internal rusting, this will help to ensure the continued safe use of the equipment - Inspect in accordance with the manufacturers recommendations

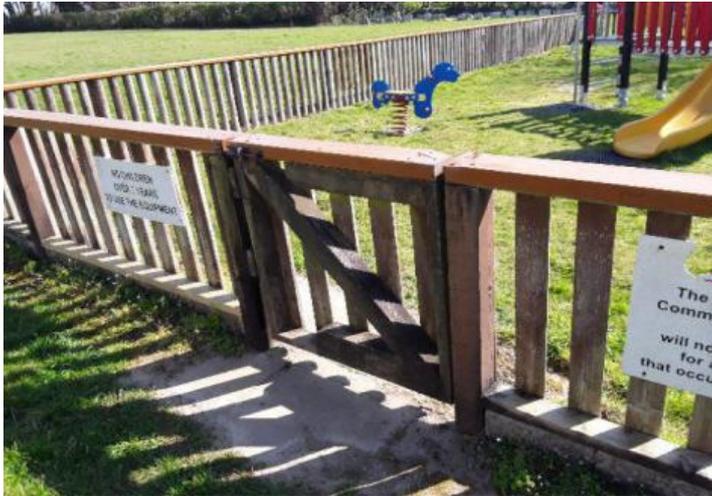
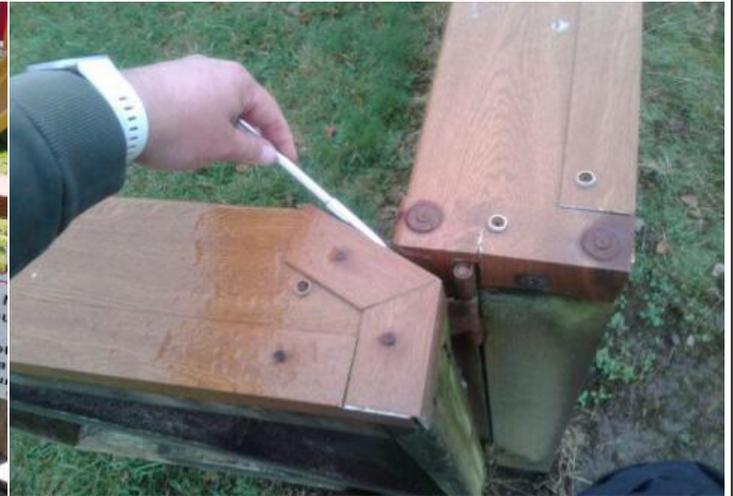
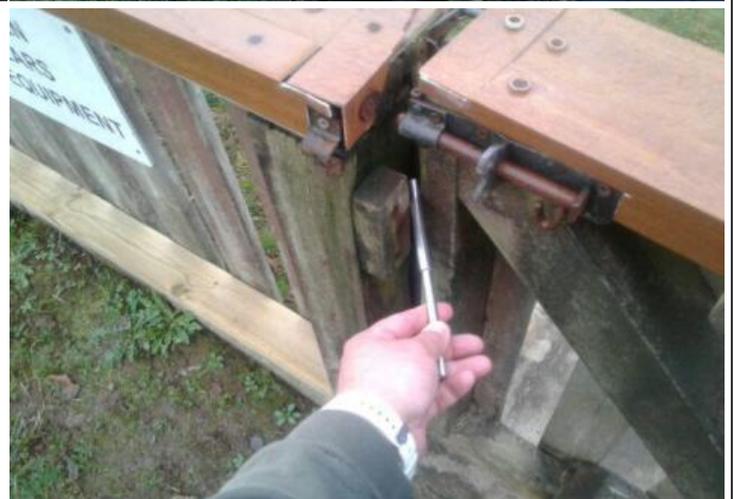
Finding: There are openings that are less than 12mm that could trap or crush fingers

Action: Where possible a 12mm gap should be maintained on both sides or between the gate leaves

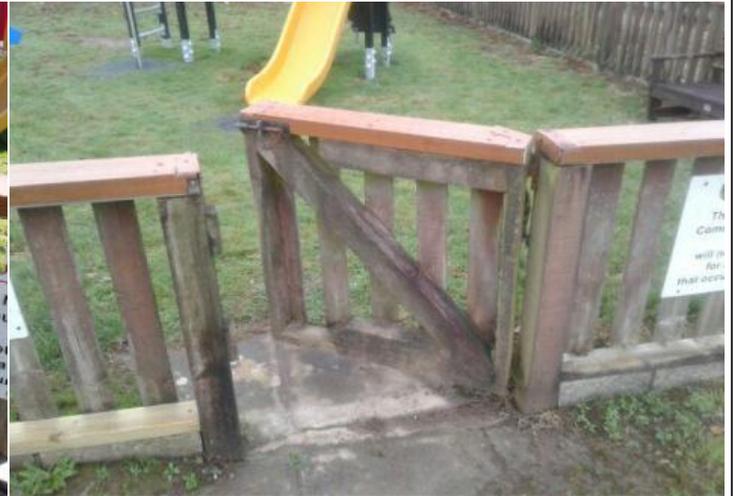
Finding: The gate is not operating correctly

Action: Take effective action to ensure the gate closes between 4 and 8 seconds

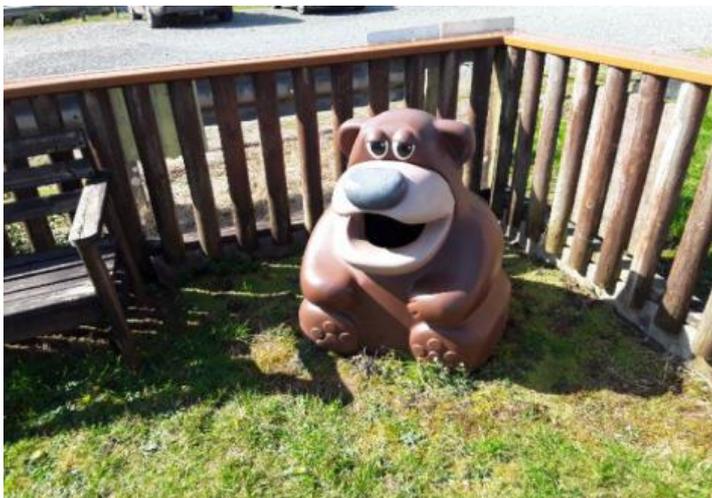
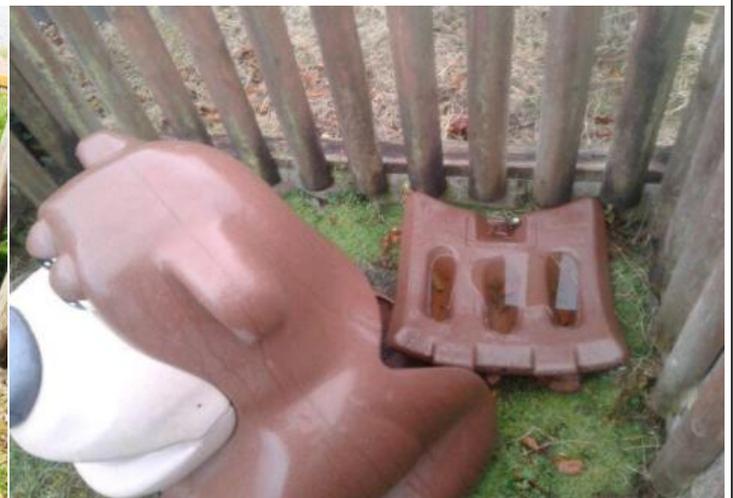
Finding: The lid or door of the litter bin is not secured

Action: Ensure the lid or door is kept locked

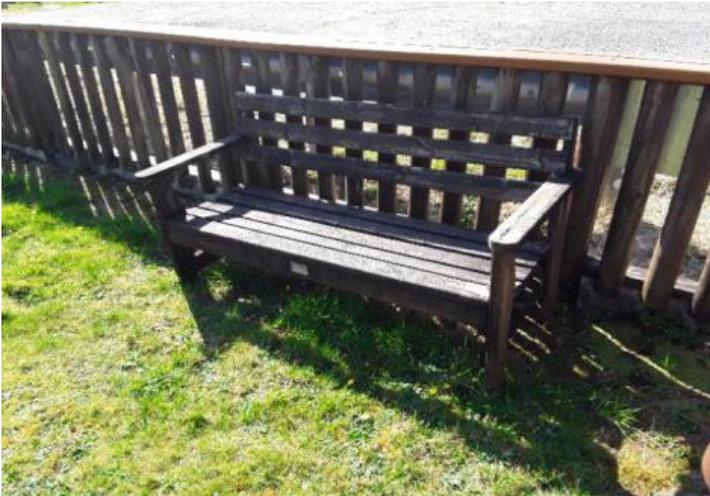
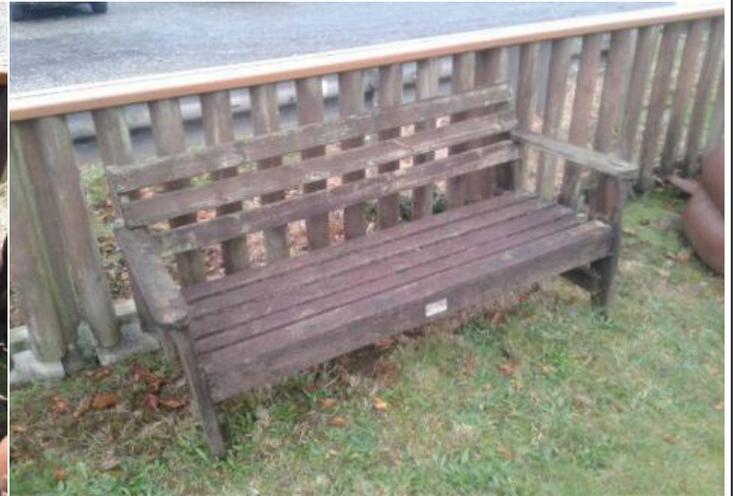
Finding: The bench is not securely fixed to the surface and there is some possibility of the item tipping or rolling over

Action: Secure the bench to the ground

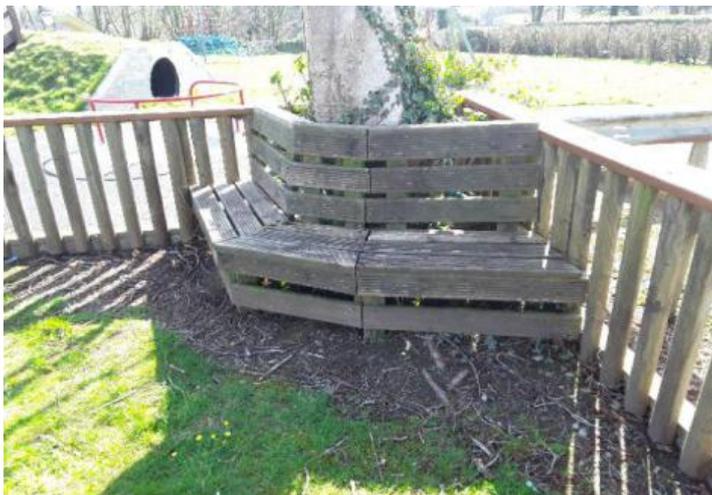
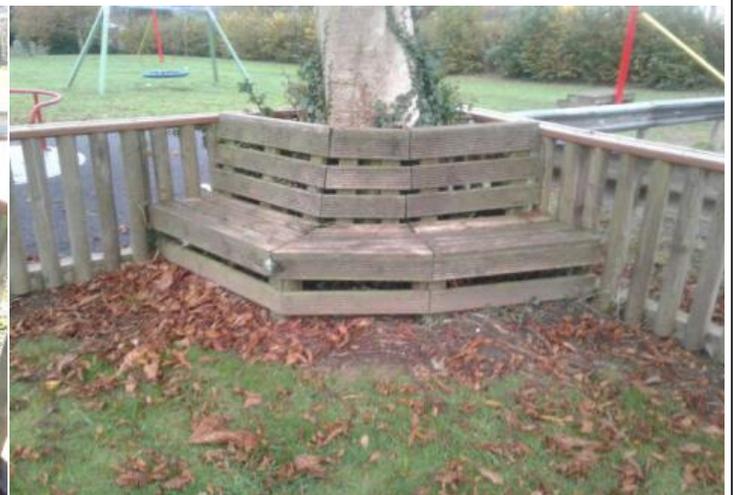
Finding: There is algae or moss on the surface of the equipment

Action: Clean and treat appropriately

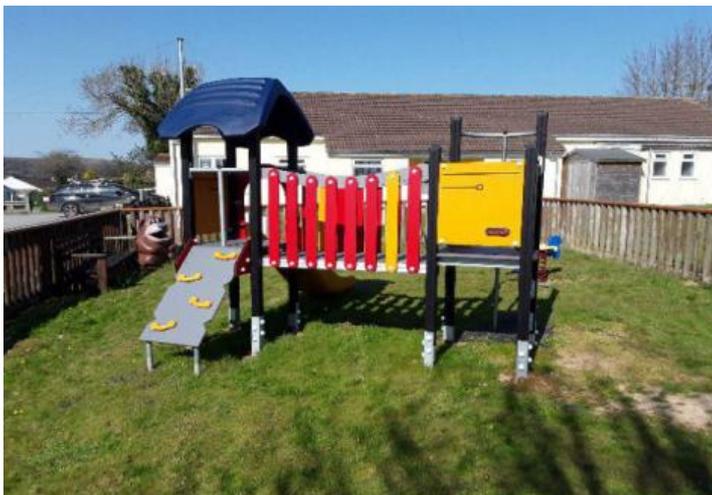
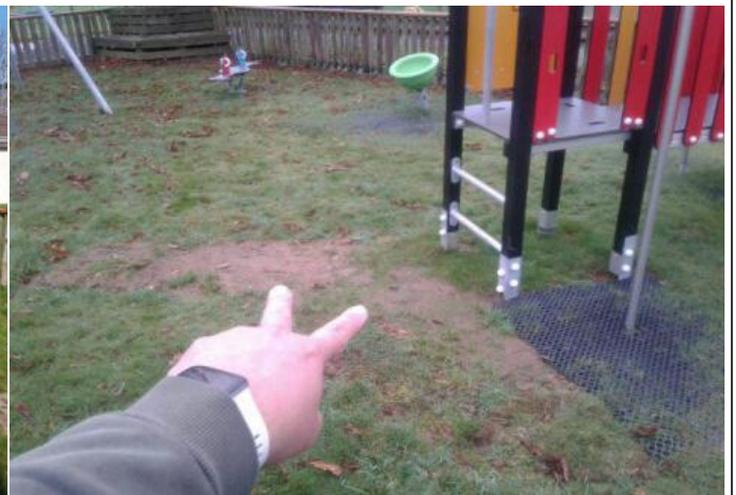
Finding: The surface has eroded in some areas

Action: Reinstate the surface

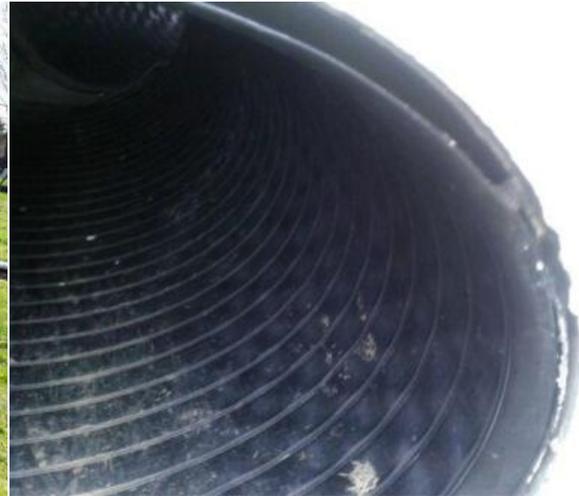
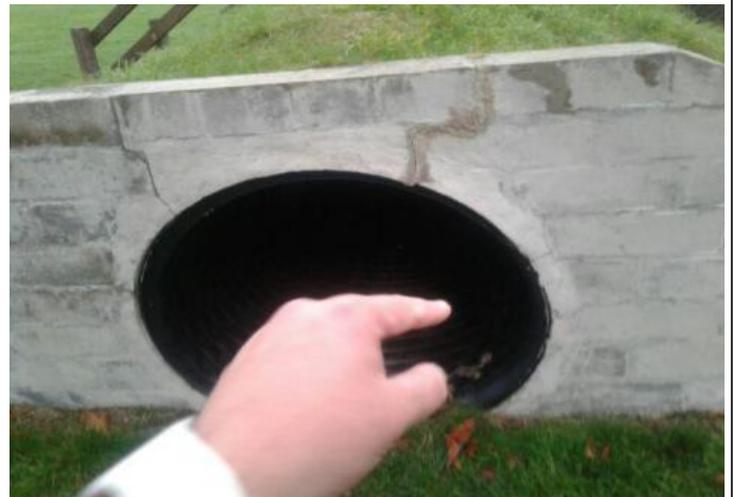
Finding: There are some rough edges of the plastic and concrete at the entrance on the tunnel

Action: Remove any sharp edges

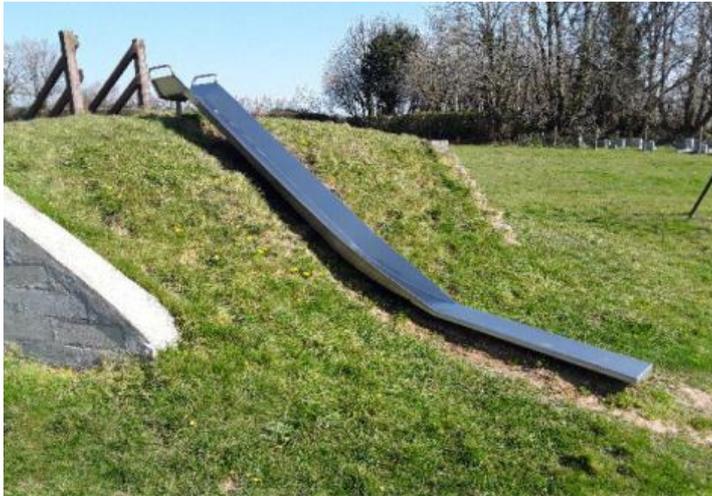
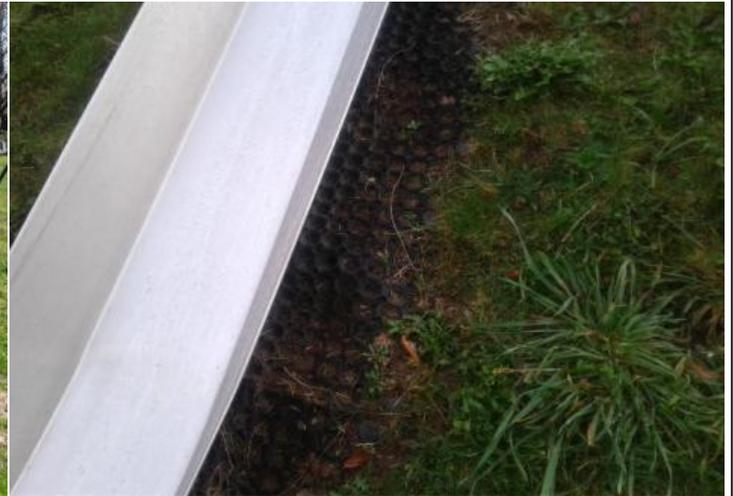
Finding: Fixing Pins have been installed in the impact areas of the grass mats
Action: Remove pins from impact areas

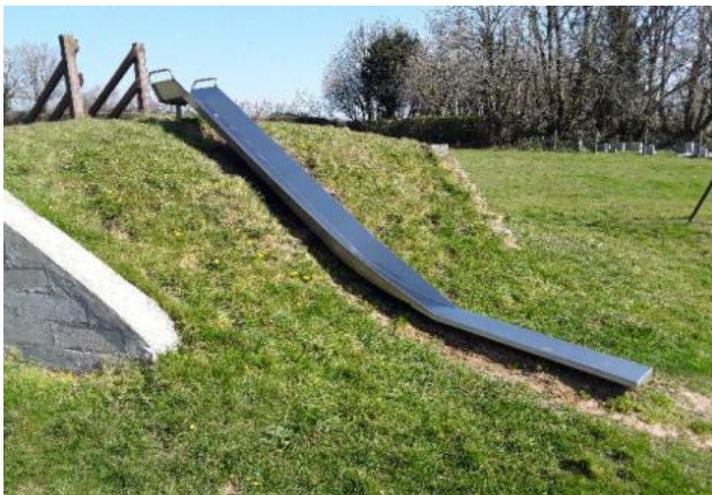
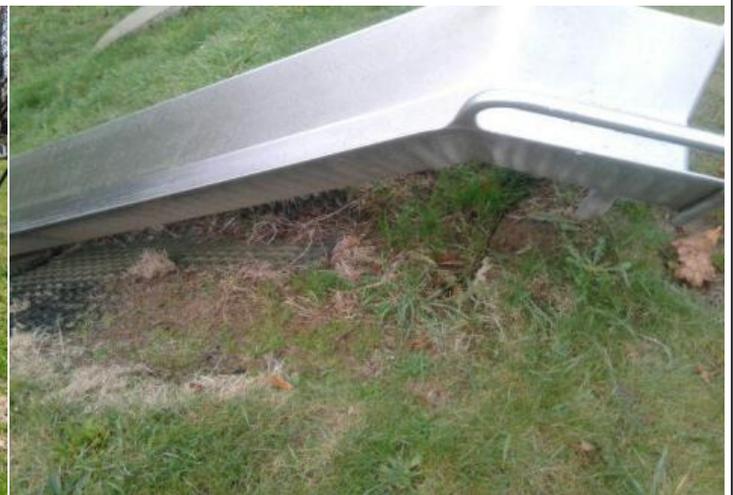
Finding: The surface has eroded in some areas
Action: Reinstate the surface

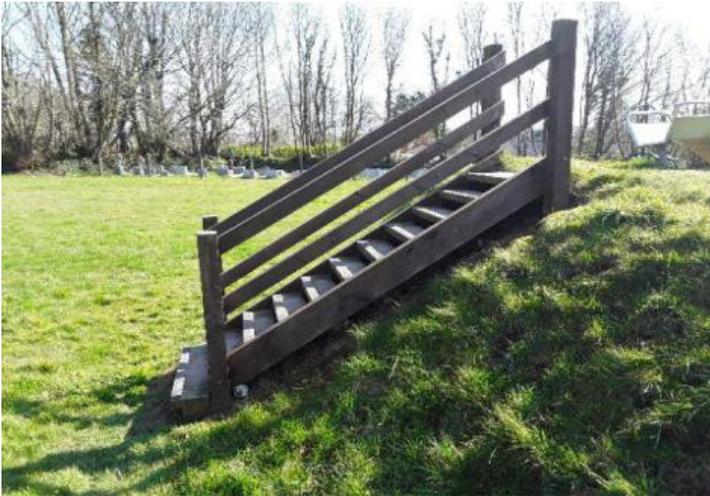
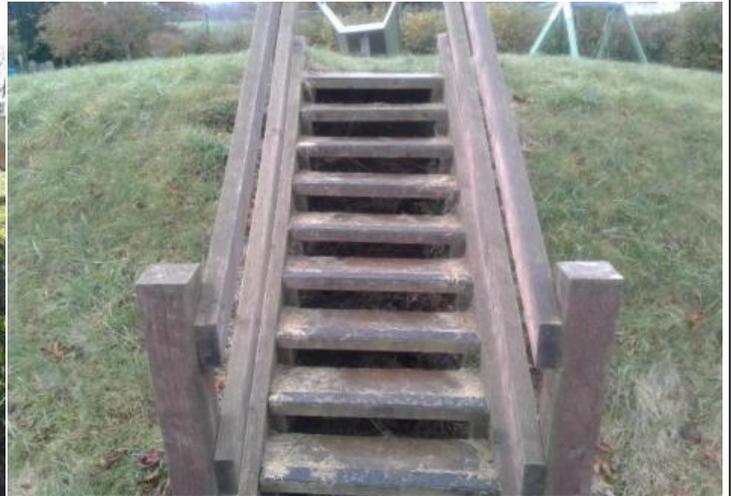
Item: Ancillary Items - Steps
Manufacturer: Not Identified

Finding: There is algae or moss on the surface of the equipment

Action: Clean and treat appropriately

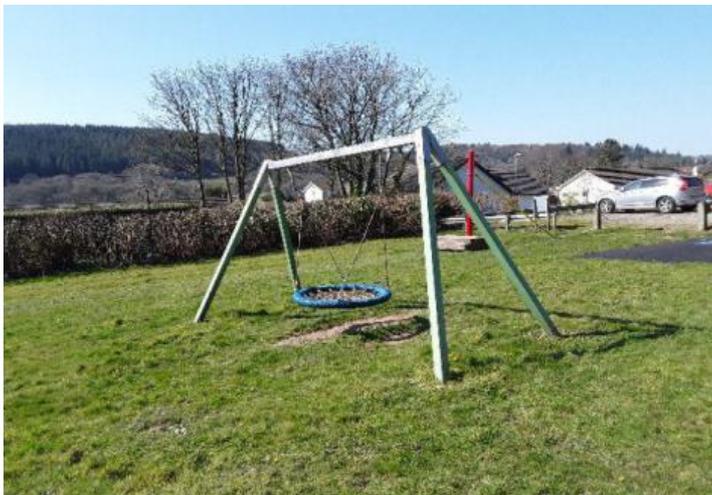
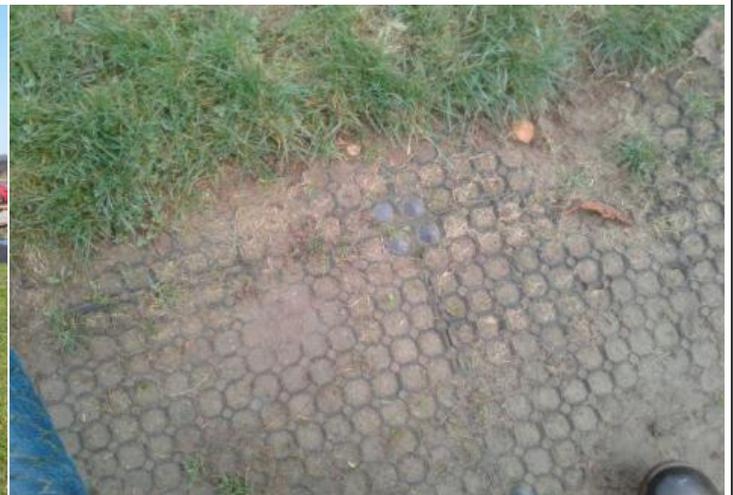
Item: Swings - Basket Swing - Type 1
Manufacturer: Not Identified

Finding: Fixing Pins have been installed in the impact areas of the grass mats

Action: Remove pins from impact areas

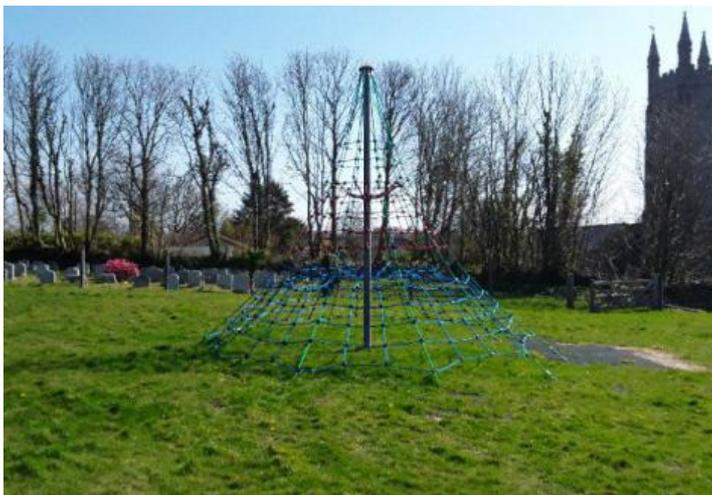
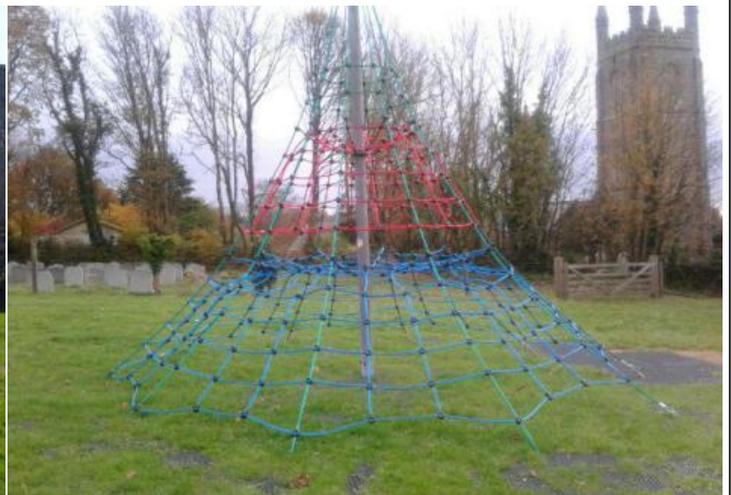
Item: Activity Equipment - Space Net
Manufacturer: Kompan Ltd

Finding: The connecting or tensioning ropes on the net are not tensioned correctly

Action: Tighten tensioners equally to provide stability to the net structure

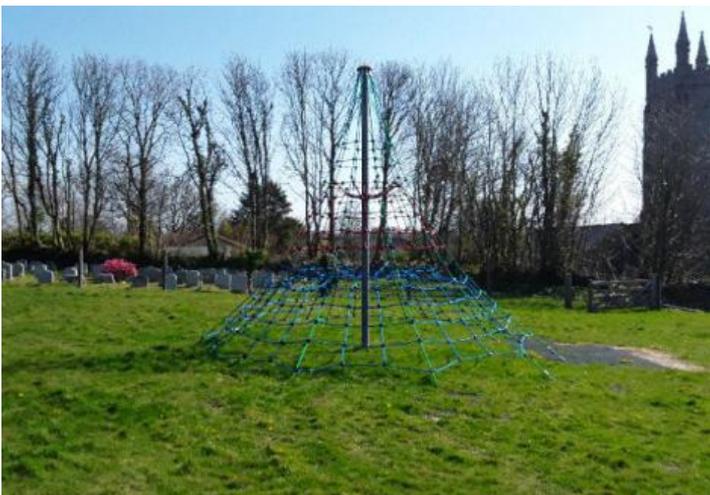
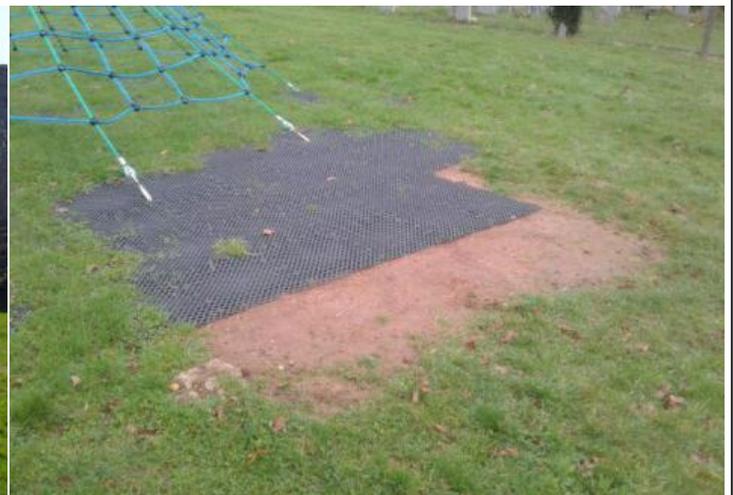
Item: Activity Equipment - Space Net
Manufacturer: Kompan Ltd

Finding: The surface has eroded in some areas
Action: Reinstate the surface

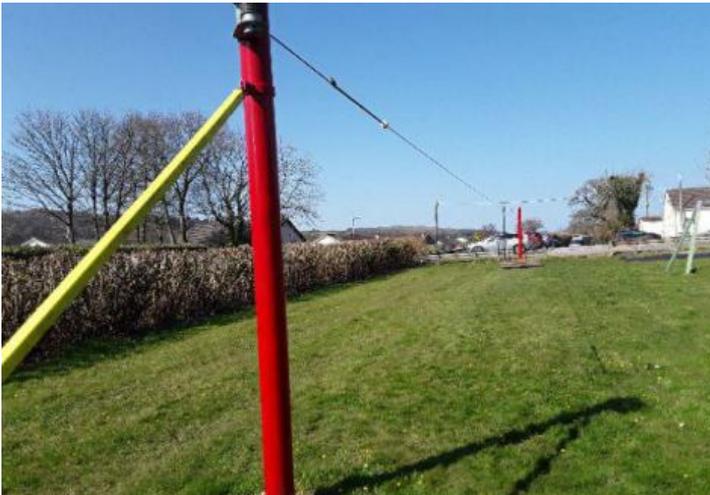
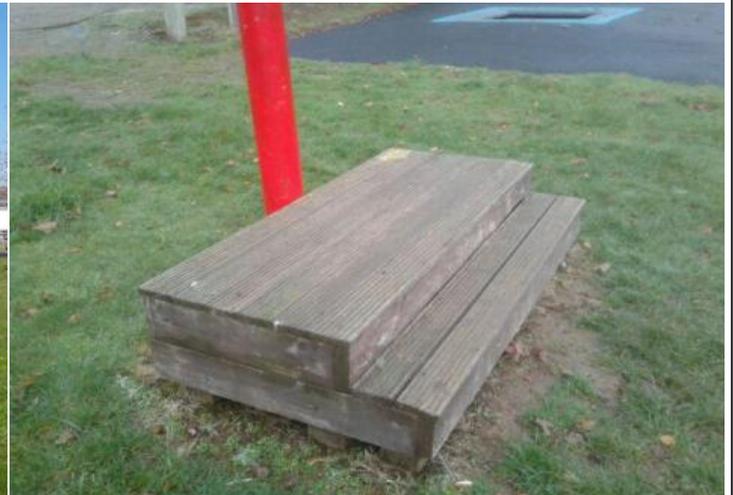
Item: Other - Cable Runway
Manufacturer: Not Identified

Finding: There is algae or moss on the surface of the equipment

Action: Clean and treat appropriately
